The purpose of this workshop is to present the findings of the Counsilman-Hunsaker (CH) Aquatics Commissioning Report, review the condition and remaining service life of the Teton County / Jackson Recreation Center aquatic facilities, discuss current maintenance efforts, and obtain policy direction regarding future aquatics planning.

CH was retained to perform an independent assessment of the Recreation Center aquatic facilities, associated mechanical systems, and long-term capital needs. The assessment documents existing conditions, identifies code and operational deficiencies, estimates short-term investments necessary to maintain operations, and outlines long-term replacement considerations.

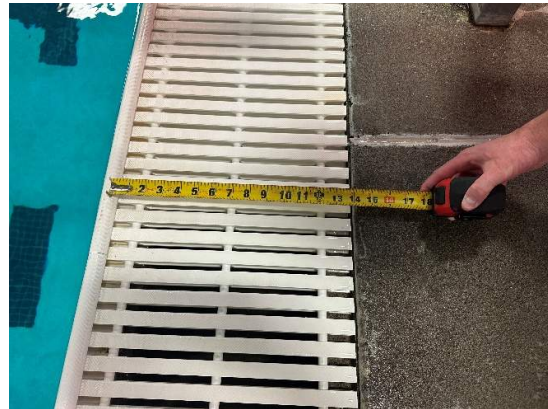
The lap pool utilizes a deck-level concrete gutter perimeter overflow system for water recirculation. The gutter system is equipped with a thin PVC handhold and 14" wide perpendicular PVC gutter grating, which was observed to be in good shape, secure, and free from significant cracking or warping.

A tiled concrete gutter should be considered in lieu of a plastic handhold. The levelness of a tiled gutter can be adjusted via mud bed / setting material if settlement ever occurs. For a new design, geotechnical engineers should be informed of a max differential settlement requirement of  $\frac{1}{2}$ " for gutter pools, and soil improvements should be considered during a replacement if this cannot be met with typical construction/backfill practices.

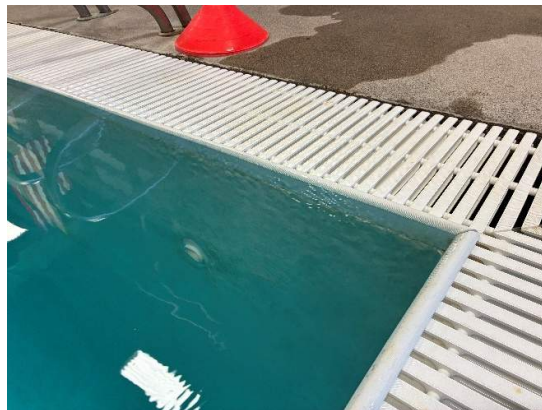
The lap pool has two (2) main drains. The main drain grates were observed from the pool deck and appeared to be the 12"x12" main drain cover, part number WG1032BHF2 by Hayward – operations team to confirm.

Upon pool replacement, consider floor inlets as a part of the design to ensure a “fast pool”, meet current Teton Health District Code, and prevent any interference with timing system equipment and competitive swimmers.

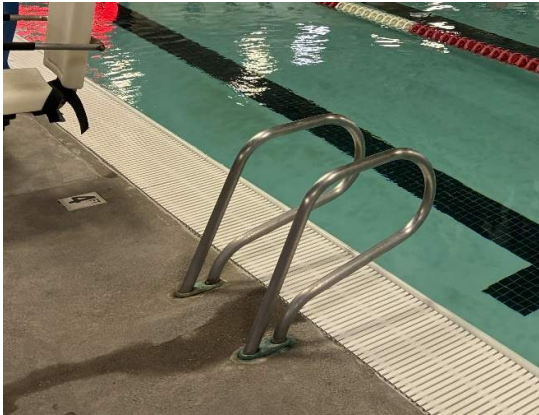
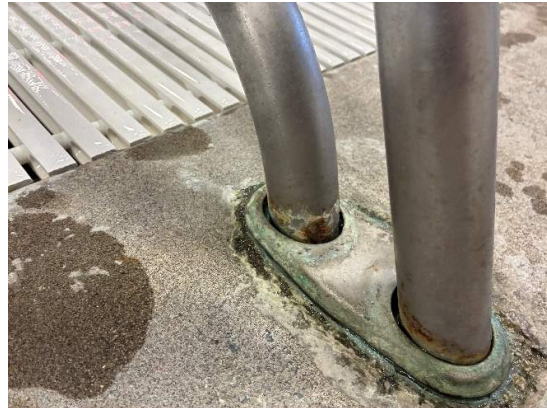
The lap pool features three (3) pairs of stainless steel grab rails that were generally observed to be in fair condition. The stainless-steel material of the rails themselves appears sound. However, the associated escutcheons (decorative covers where the rail meets the deck) were observed to have visible surface-level corrosion. The grab rails remain secure in their anchors, as they exhibit only a slight, acceptable amount of rocking.

If a stainless-steel gutter is not installed, then C-H recommends cleaning and passivating all stainless-steel grab rails and escutcheons to inhibit future corrosion and extend the life of this equipment.

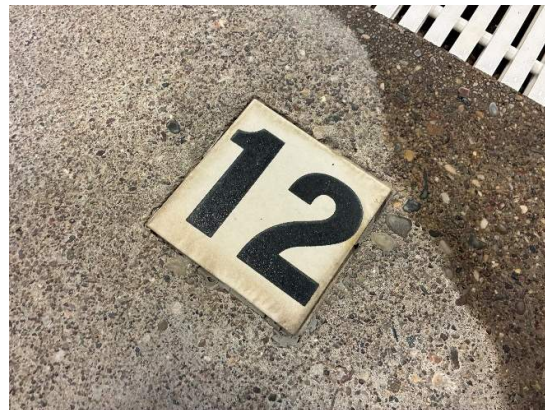
The lap pool currently features tile horizontal depth markers and vinyl adhesive horizontal "NO DIVING" warning markers. However, no vertical depth markers were observed on the vertical wall of the pool, which is a requirement of both the Teton Health District Code and the MAHC.

For a new pool, ensure that all depth markers and warning signs are descriptive, placed on both vertical and horizontal surfaces, have text at least 4" tall, and include the international "NO DIVING" symbol.

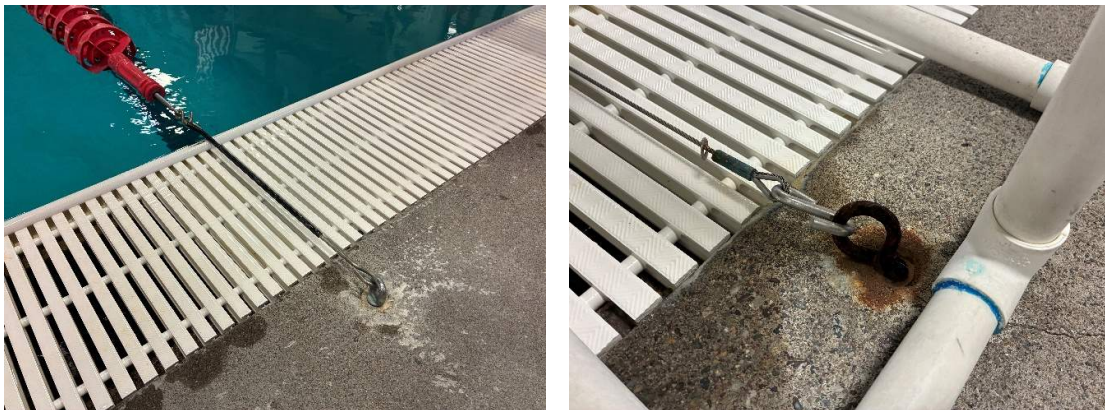
The lap pool is equipped with seven (7) floating lane lines secured by deck-anchored eyebolts and extensions. The lane lines themselves were observed to be in good condition, showing no discoloration or damage to the rotating discs.

With a new pool design, integrate lane line anchors into the gutter grating with new technology from manufacturers such as Daldorado.
