**AGENDA**  
**Planning and Zoning Commission**  
**August 19, 2020 – REGULAR MEETING**

II. **ITEM P20-056:** DEVELOPMENT PLAN FOR PHASES 2 THROUGH 5 OF THE CORE SERVICES VEHICLE MAINTENANCE FACILITY AT 55 KARNS MEADOW DRIVE

02/28/20

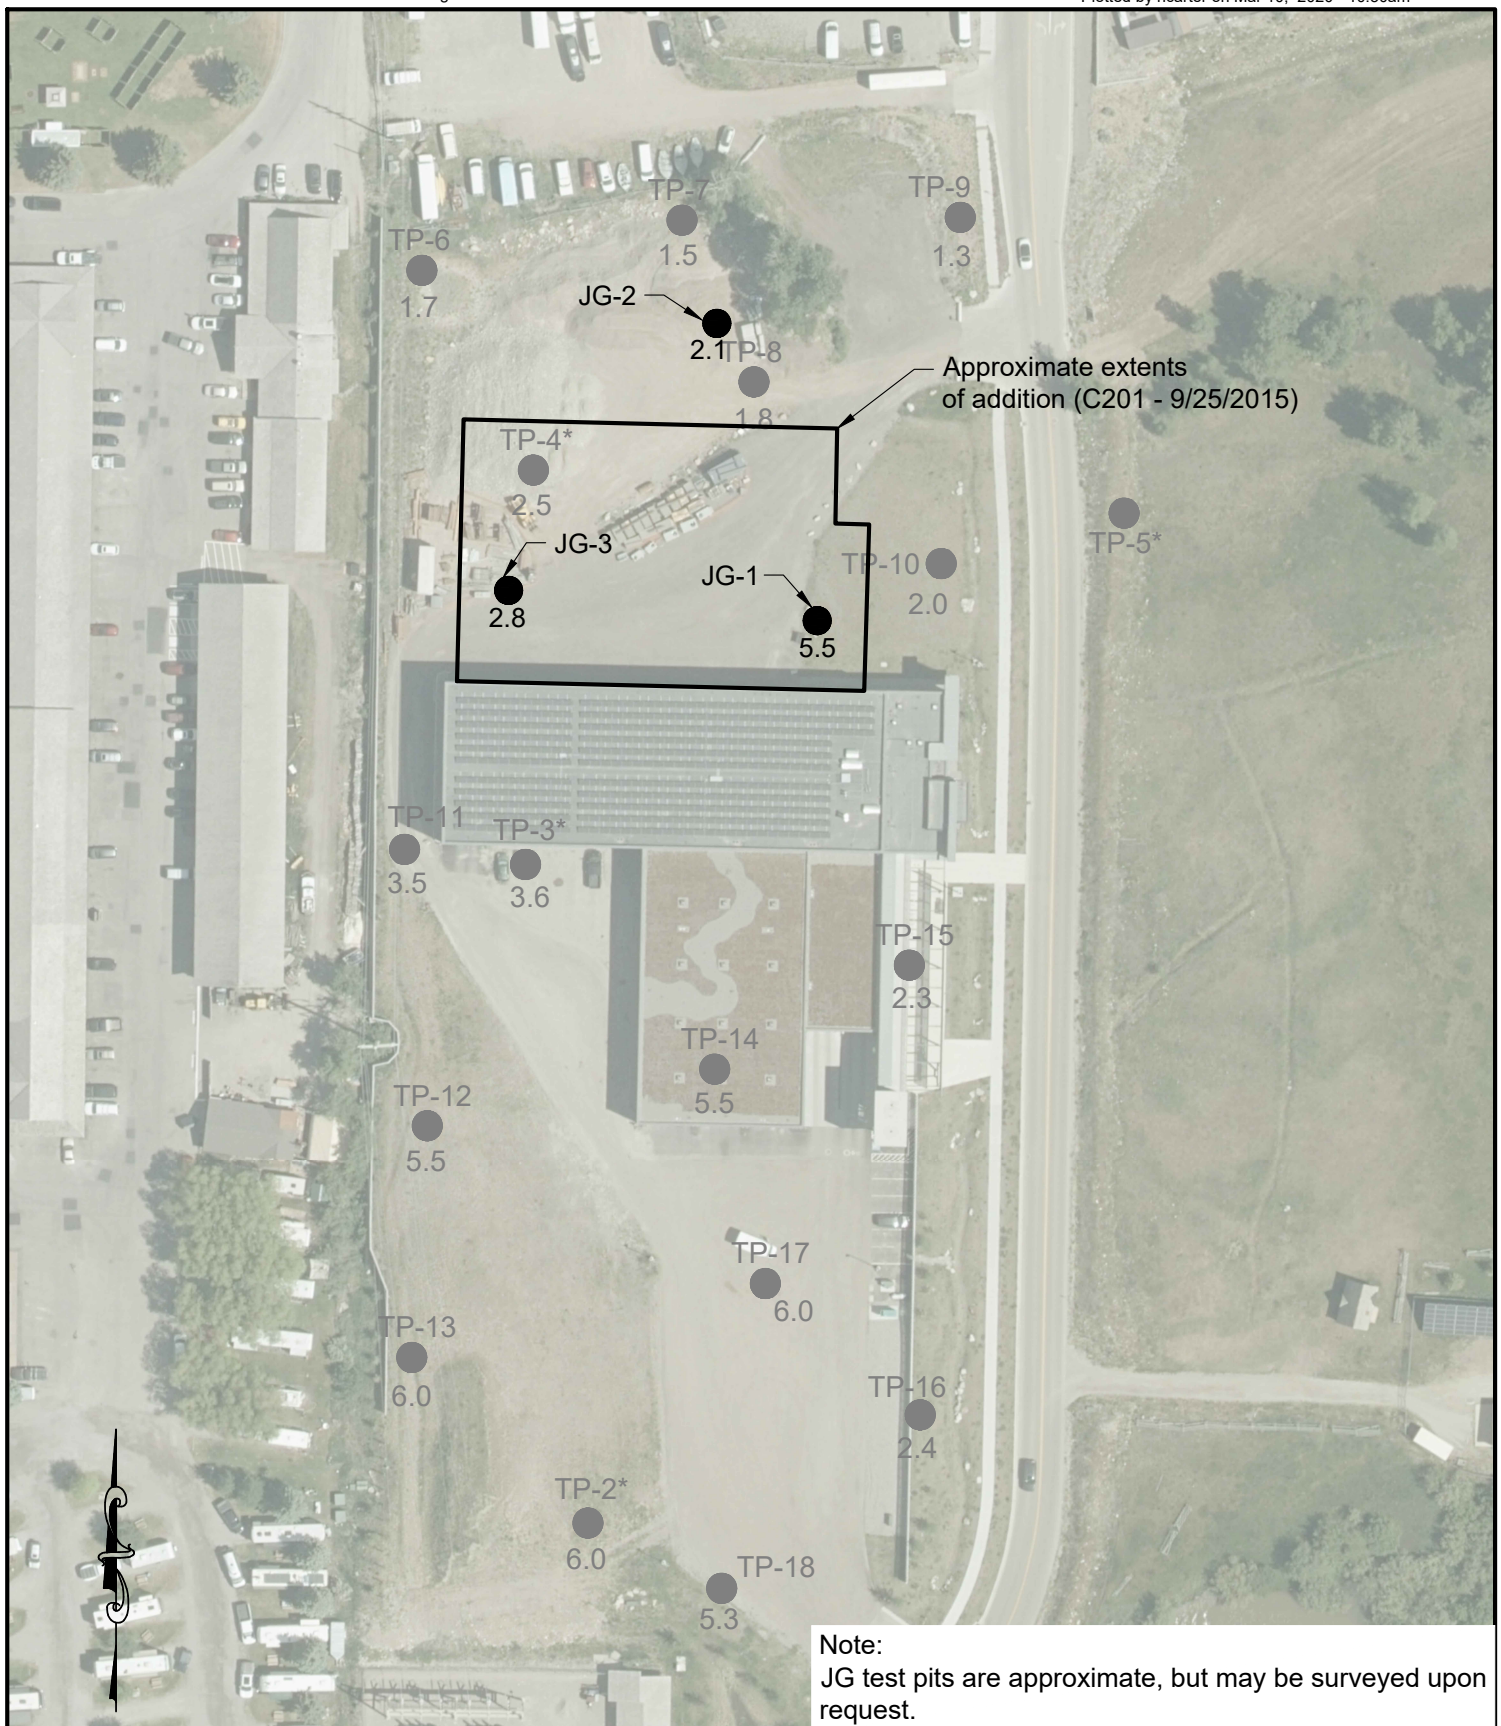
- TP-2\* - Test pits excavated by WAI in 2010. Asterisk indicates monitoring well was installed. Number indicates depth to alluvium.
- JG-1 - Test pits excavated by JG in 2020. Number indicates depth to alluvium.

In summary, the test pits excavated in 2010 as well as the test pits excavated in 2020 encountered a fill and topsoil layer of varying thickness overlying the alluvial flood plain deposits. The report describes the geological site conditions and includes a site location and geologic map and test pit logs. The report provides engineering analyses (including pavement design, settlement, bearing capacity, lateral pressures, and soil friction) and offers recommendations for construction of foundation elements.
