### **Planning and Zoning Commission**

**March 15, 2023 – REGULAR MEETING**

# STAFF REPORT

| <b>Agenda Item:</b> | P23-015: Amendment to PUD Snake River Canyon Ranch (Teton County) | <b>Public Comment:</b> | Yes |

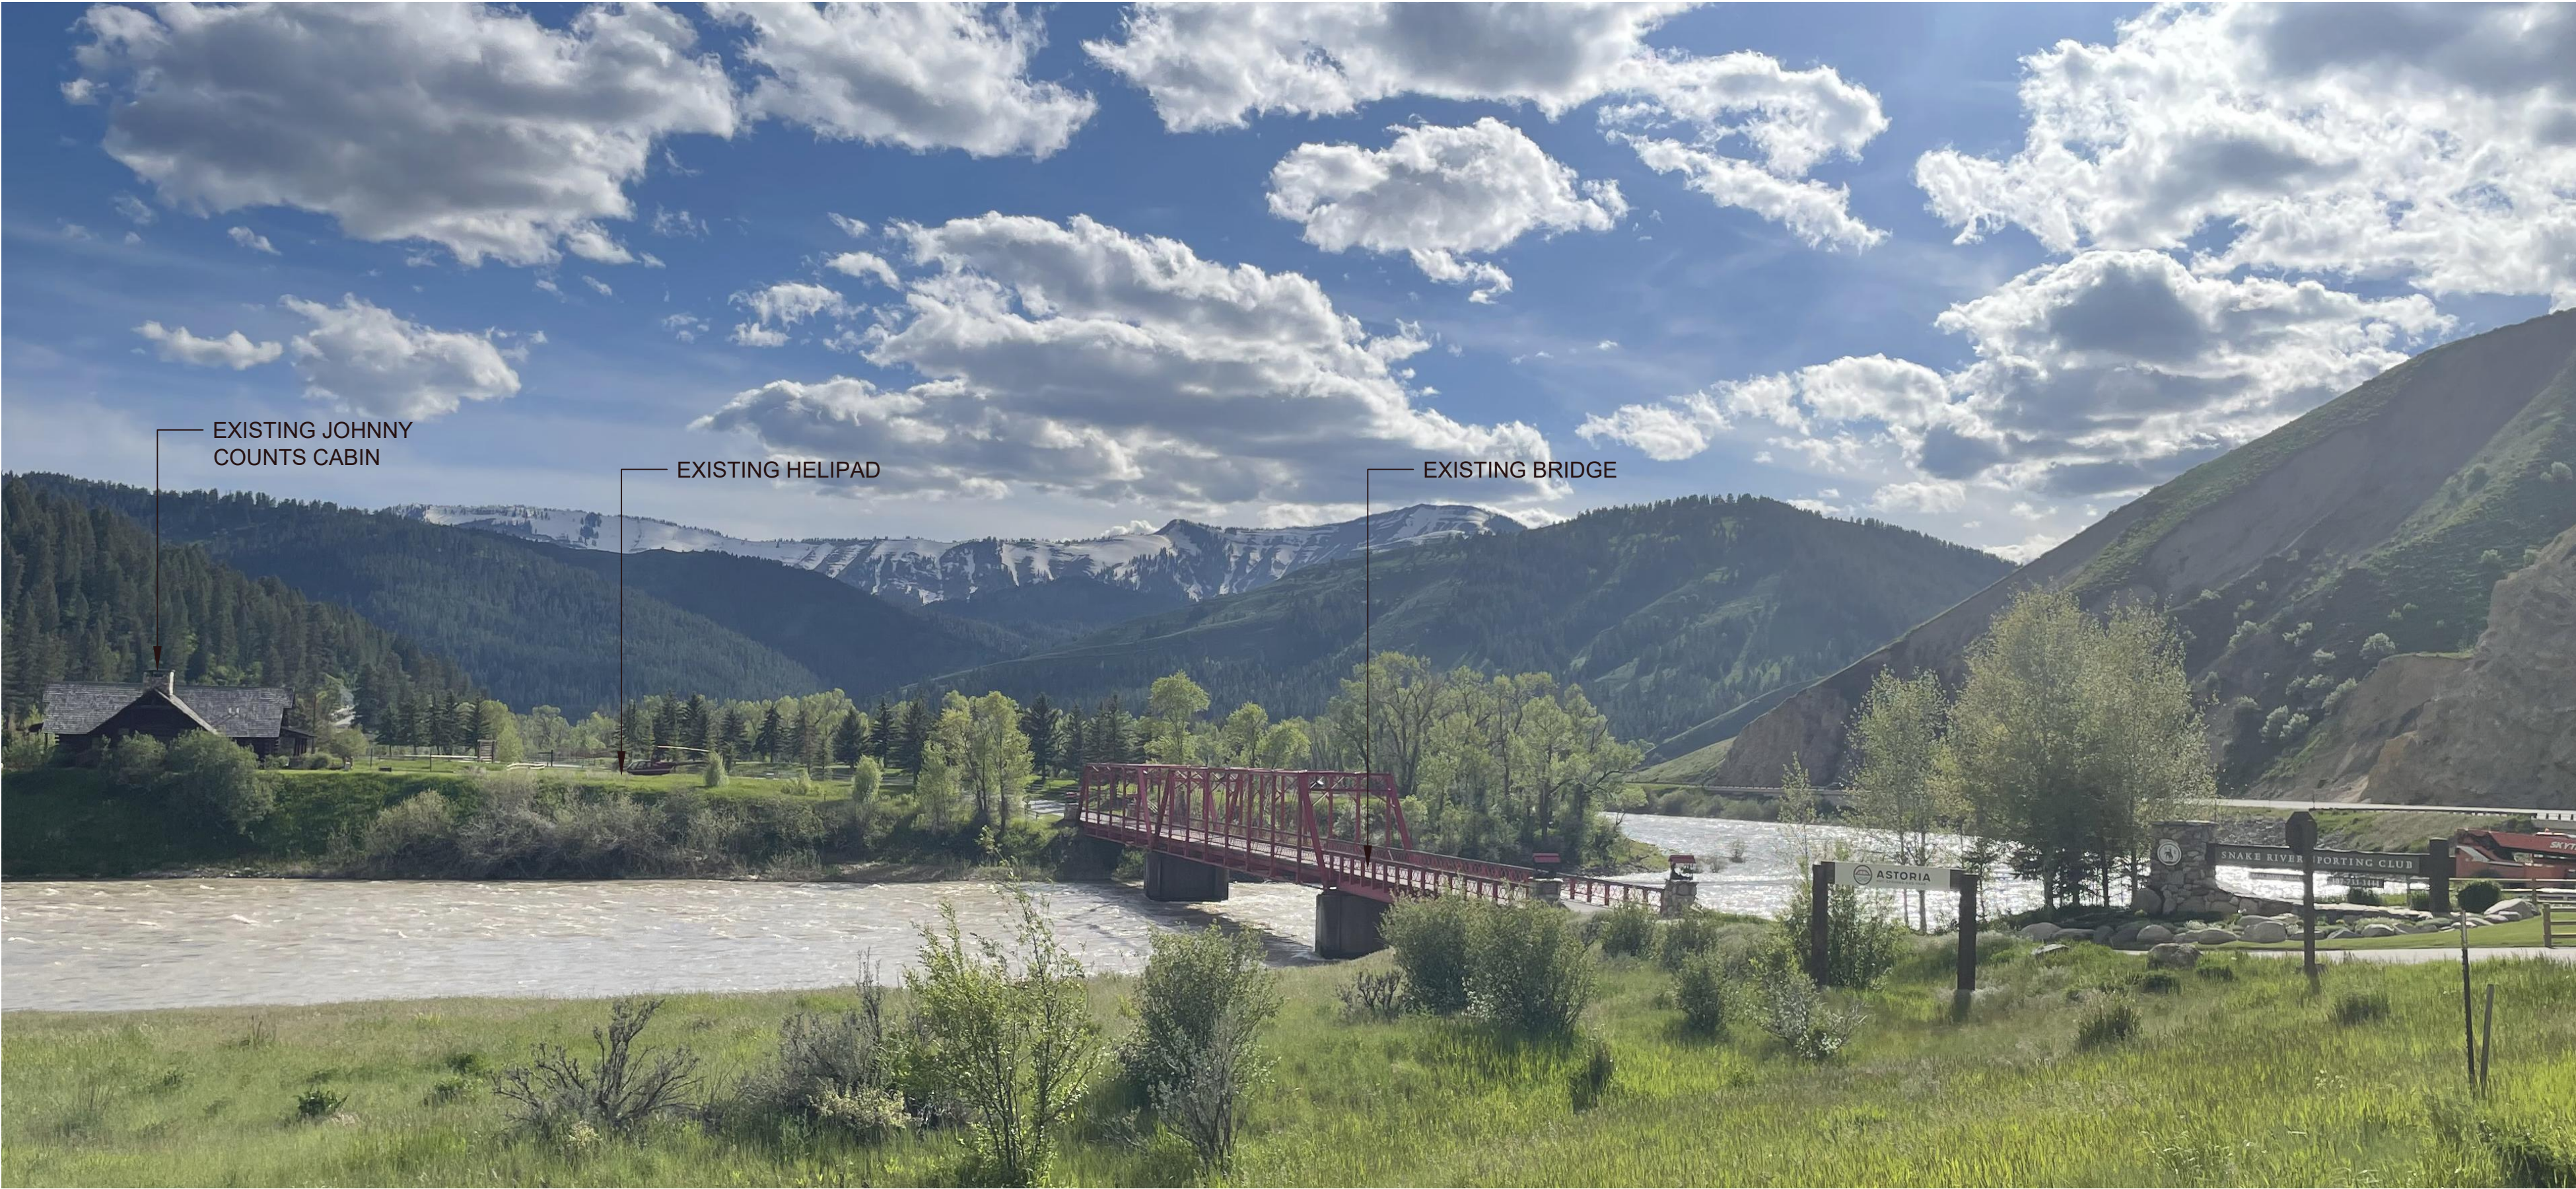
VIEW 1: EXISTING LANDSCAPE VIEW LOOKING SOUTHWEST

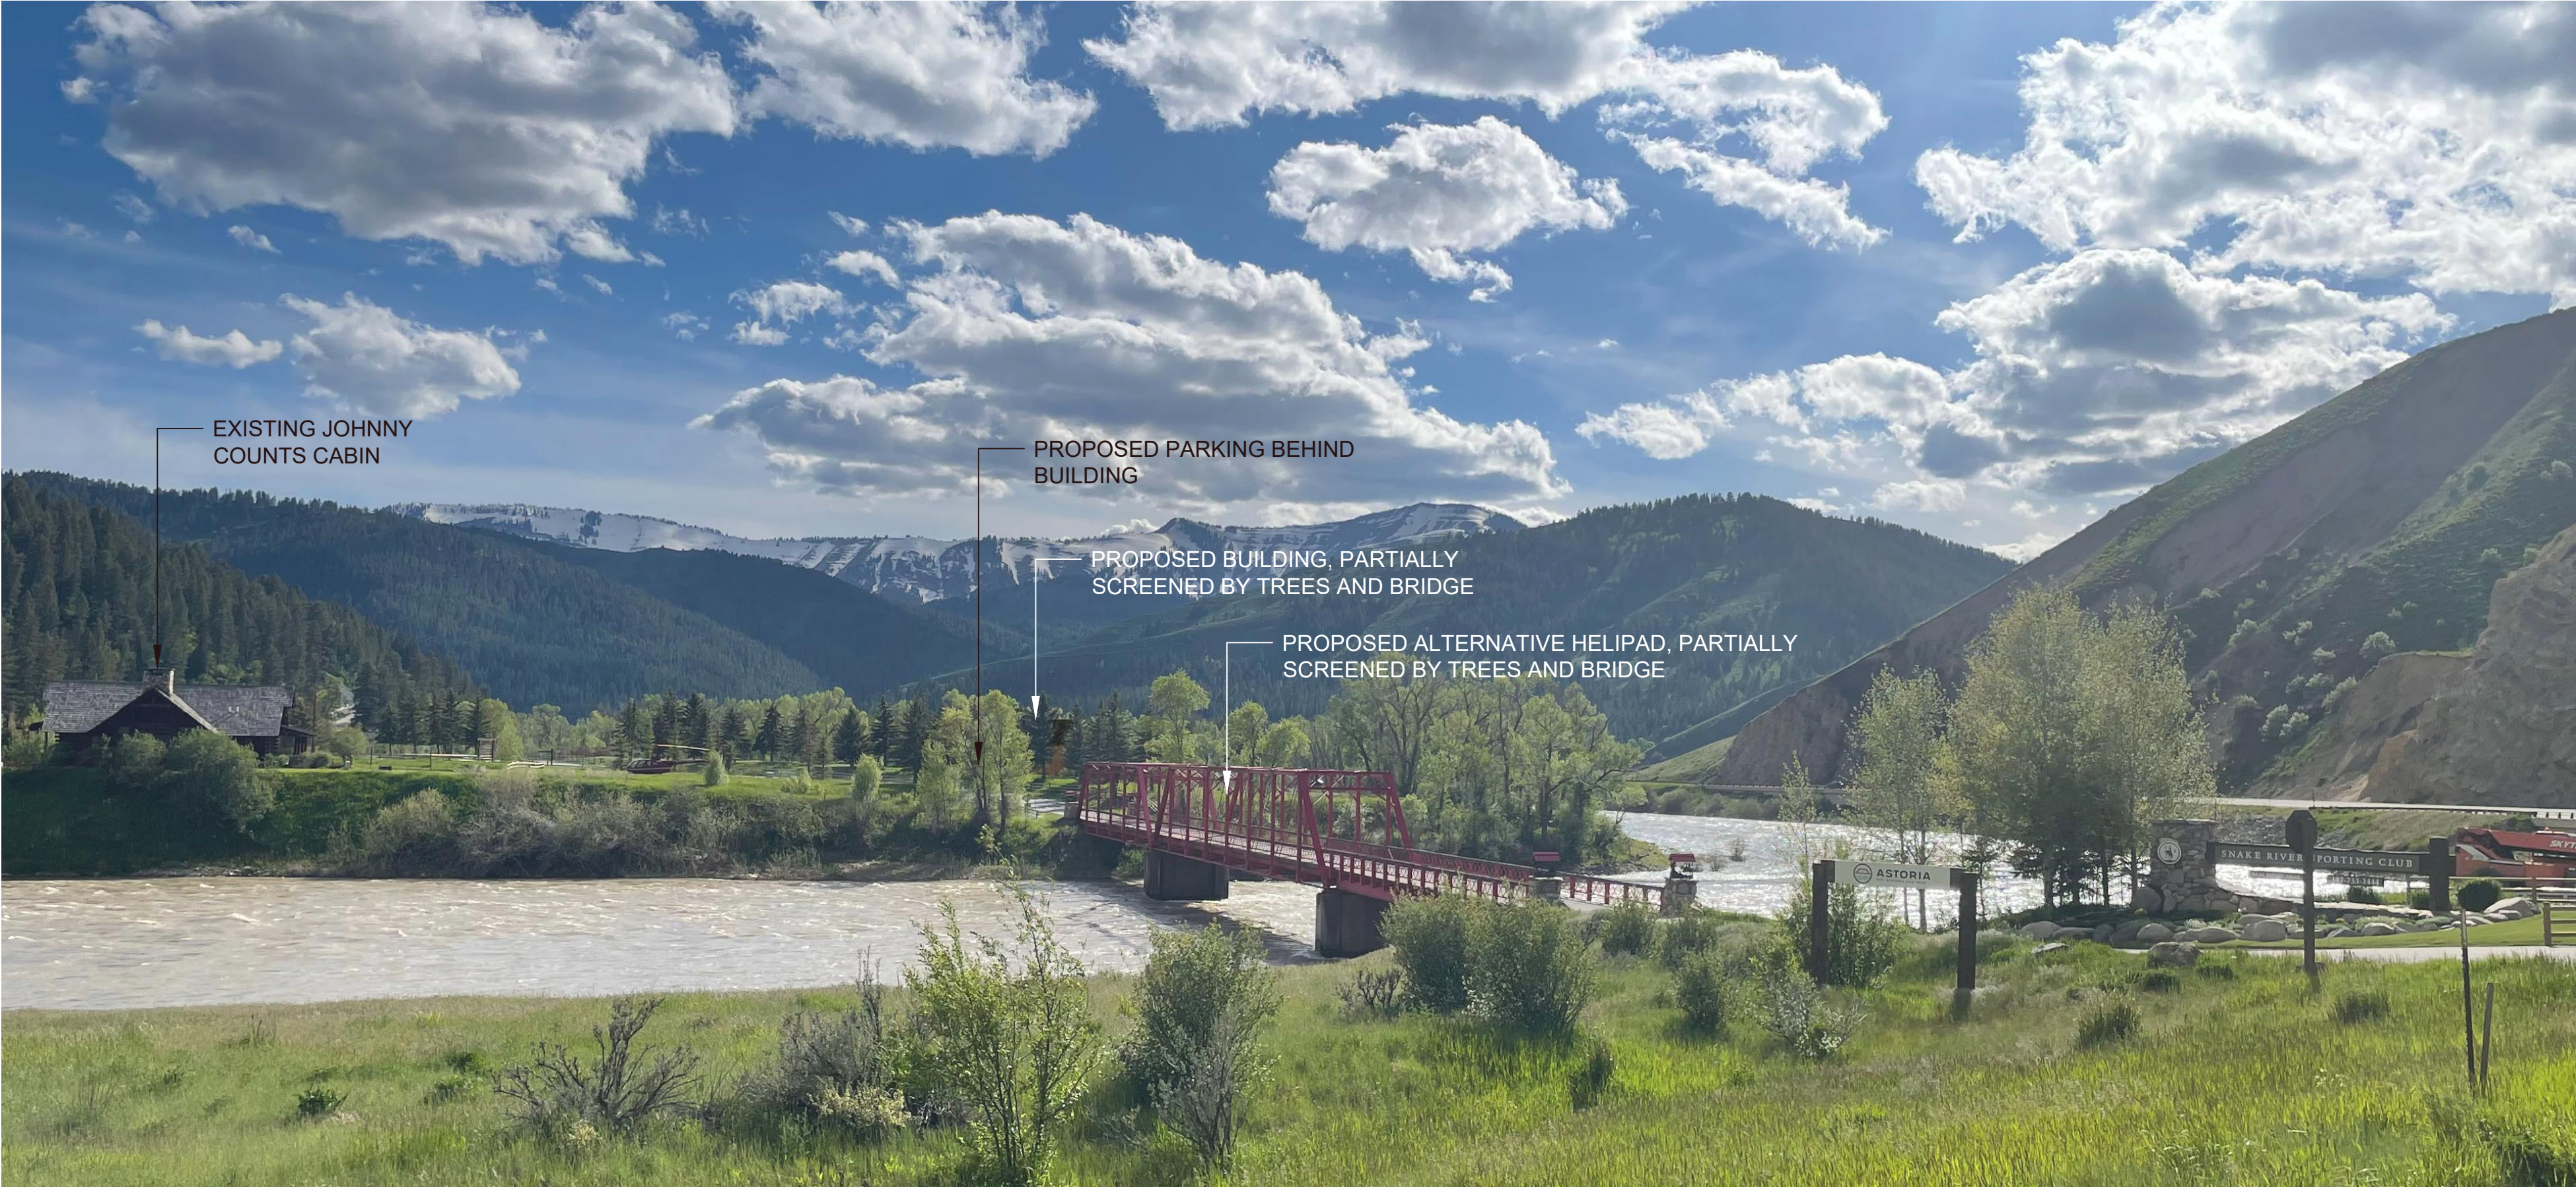
THE PROPOSED DEVELOPMENT PLAN FOR ASTORIA - SRSC EMPLOYEE HOUSING INCLUDES THE CONSTRUCTION OF PARKING LOT, CONNECTING ROAD, AND AN ALTERNATIVE HELICOPTER LANDING SITE ON A PREVIOUSLY DISTURBED AREA OF THE SITE (CURRENTLY GRAVEL MIXED INTO NATURALIZED GRASS). THE PARKING LOT, EXCLUSIVE TO SRSC EMPLOYEES, WILL CONTAIN ENOUGH SPACES FOR A RESIDENTIAL EMPLOYEE DWELLING; THE PATH, EITHER CONCRETE OR CRUSHED GRAVEL, WILL CONNECT THE EMPLOYEE HOUSING TO RIVERBEND ROAD; AND THE ADJACENT ALTERNATIVE HELICOPTER LANDING SITE WILL BE AVAILABLE FOR ANY NECESSARY MEDICAL EVACUATIONS, SCREENED AWAY FROM THE MAIN ROAD.

VIEW 1: PROPOSED LANDSCAPE VIEW LOOKING SOUTHWEST

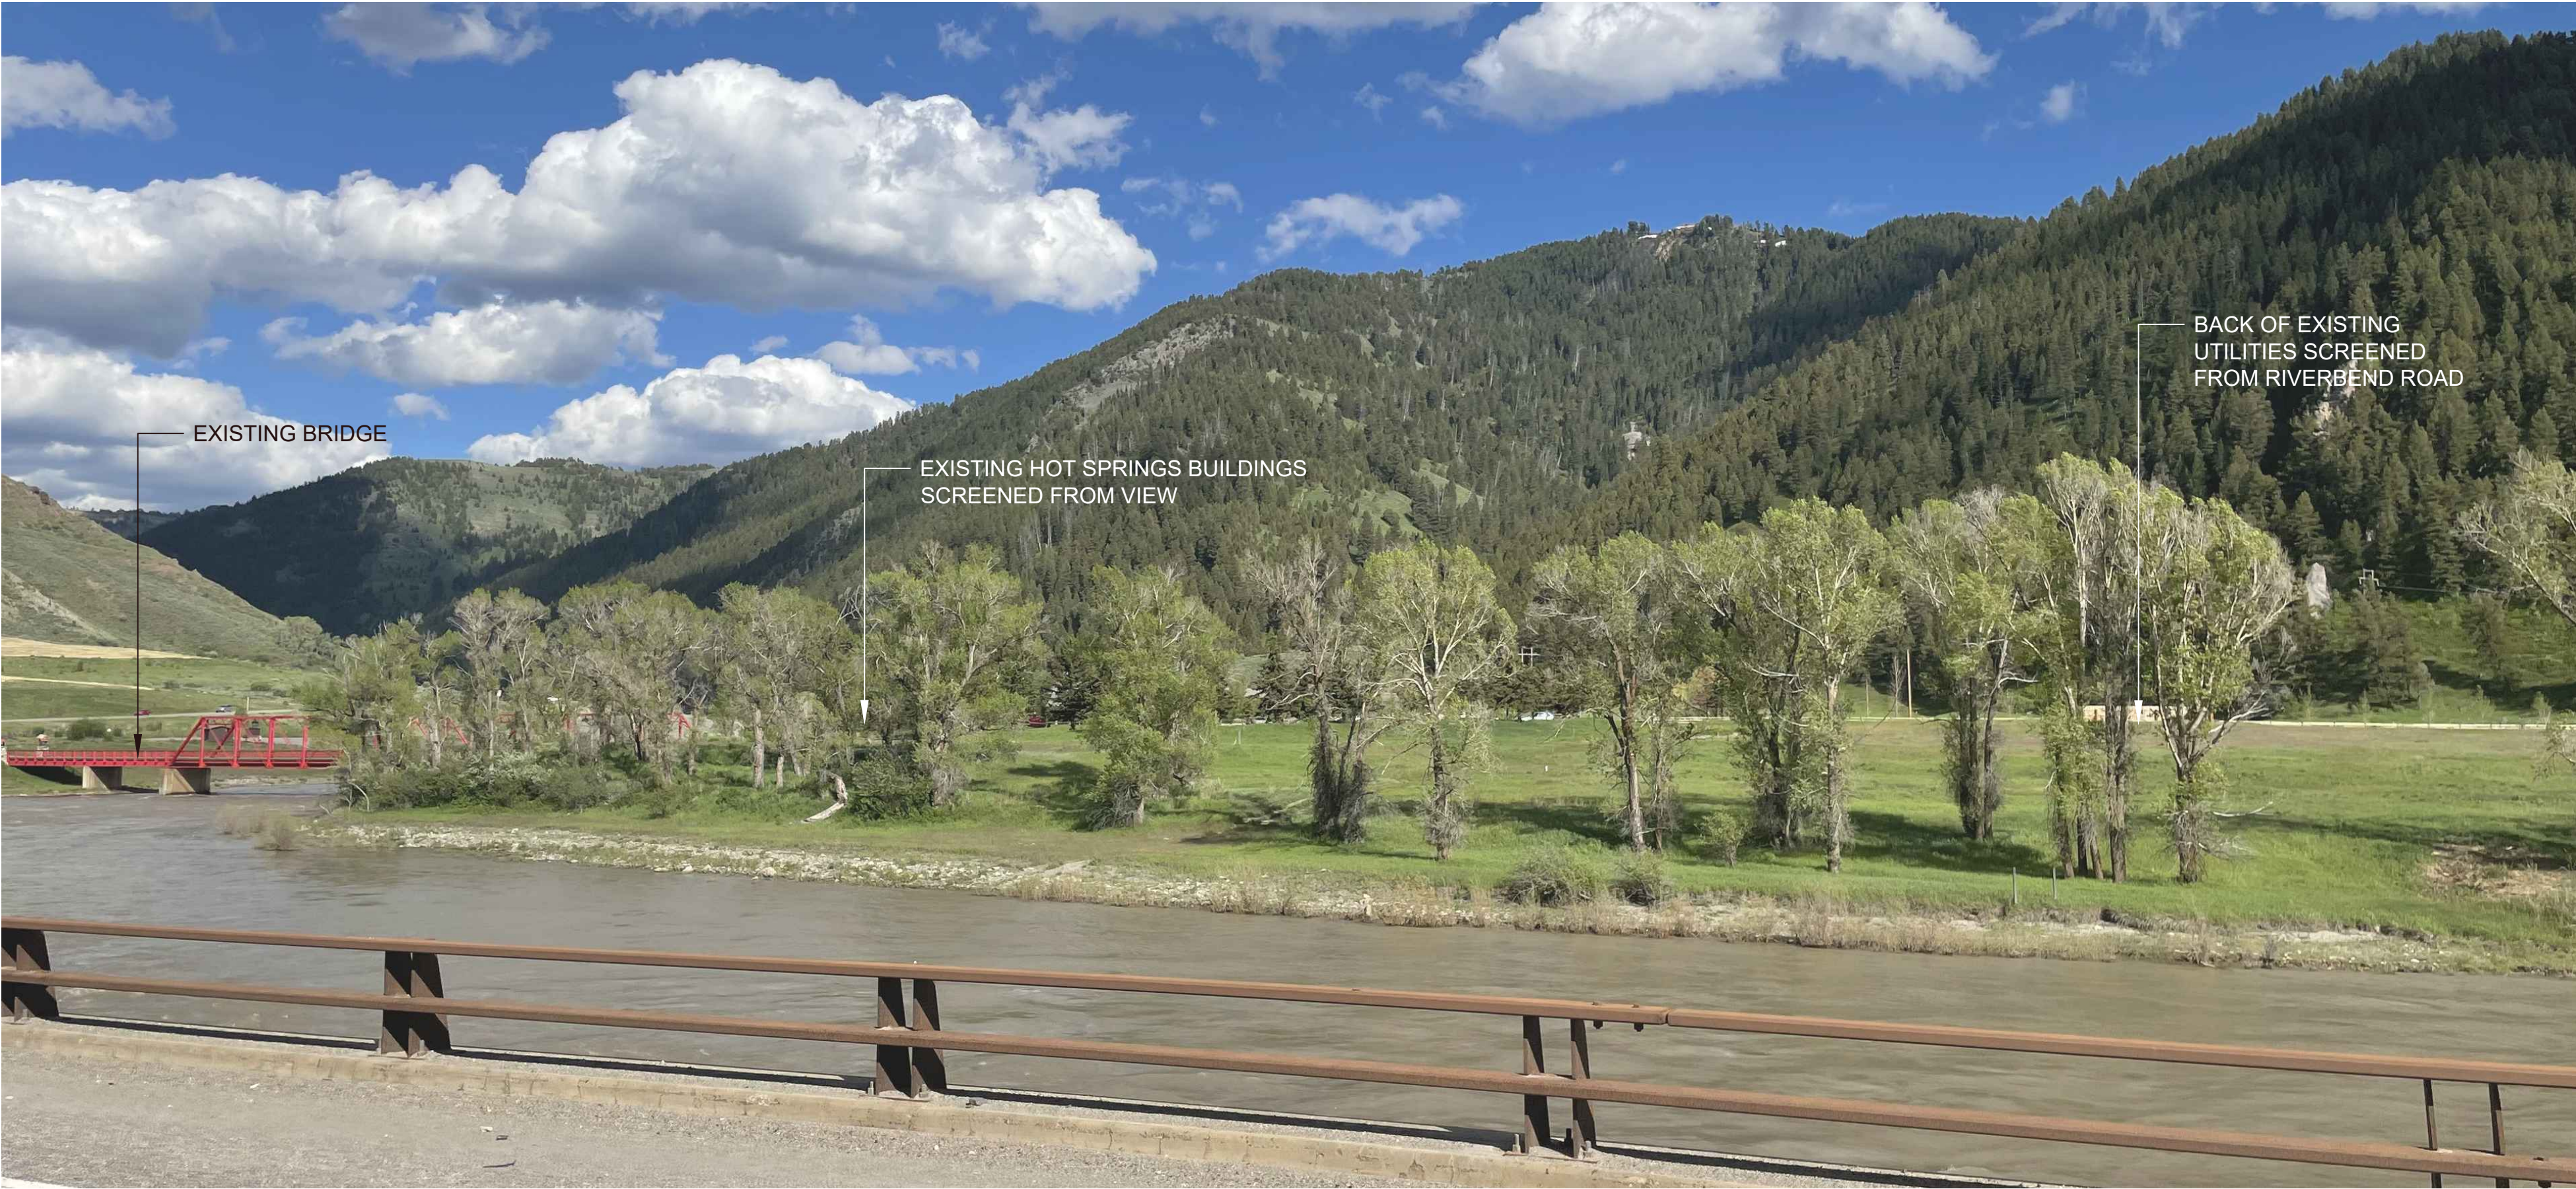
VIEW 2: EXISTING LANDSCAPE VIEW LOOKING SOUTHEAST

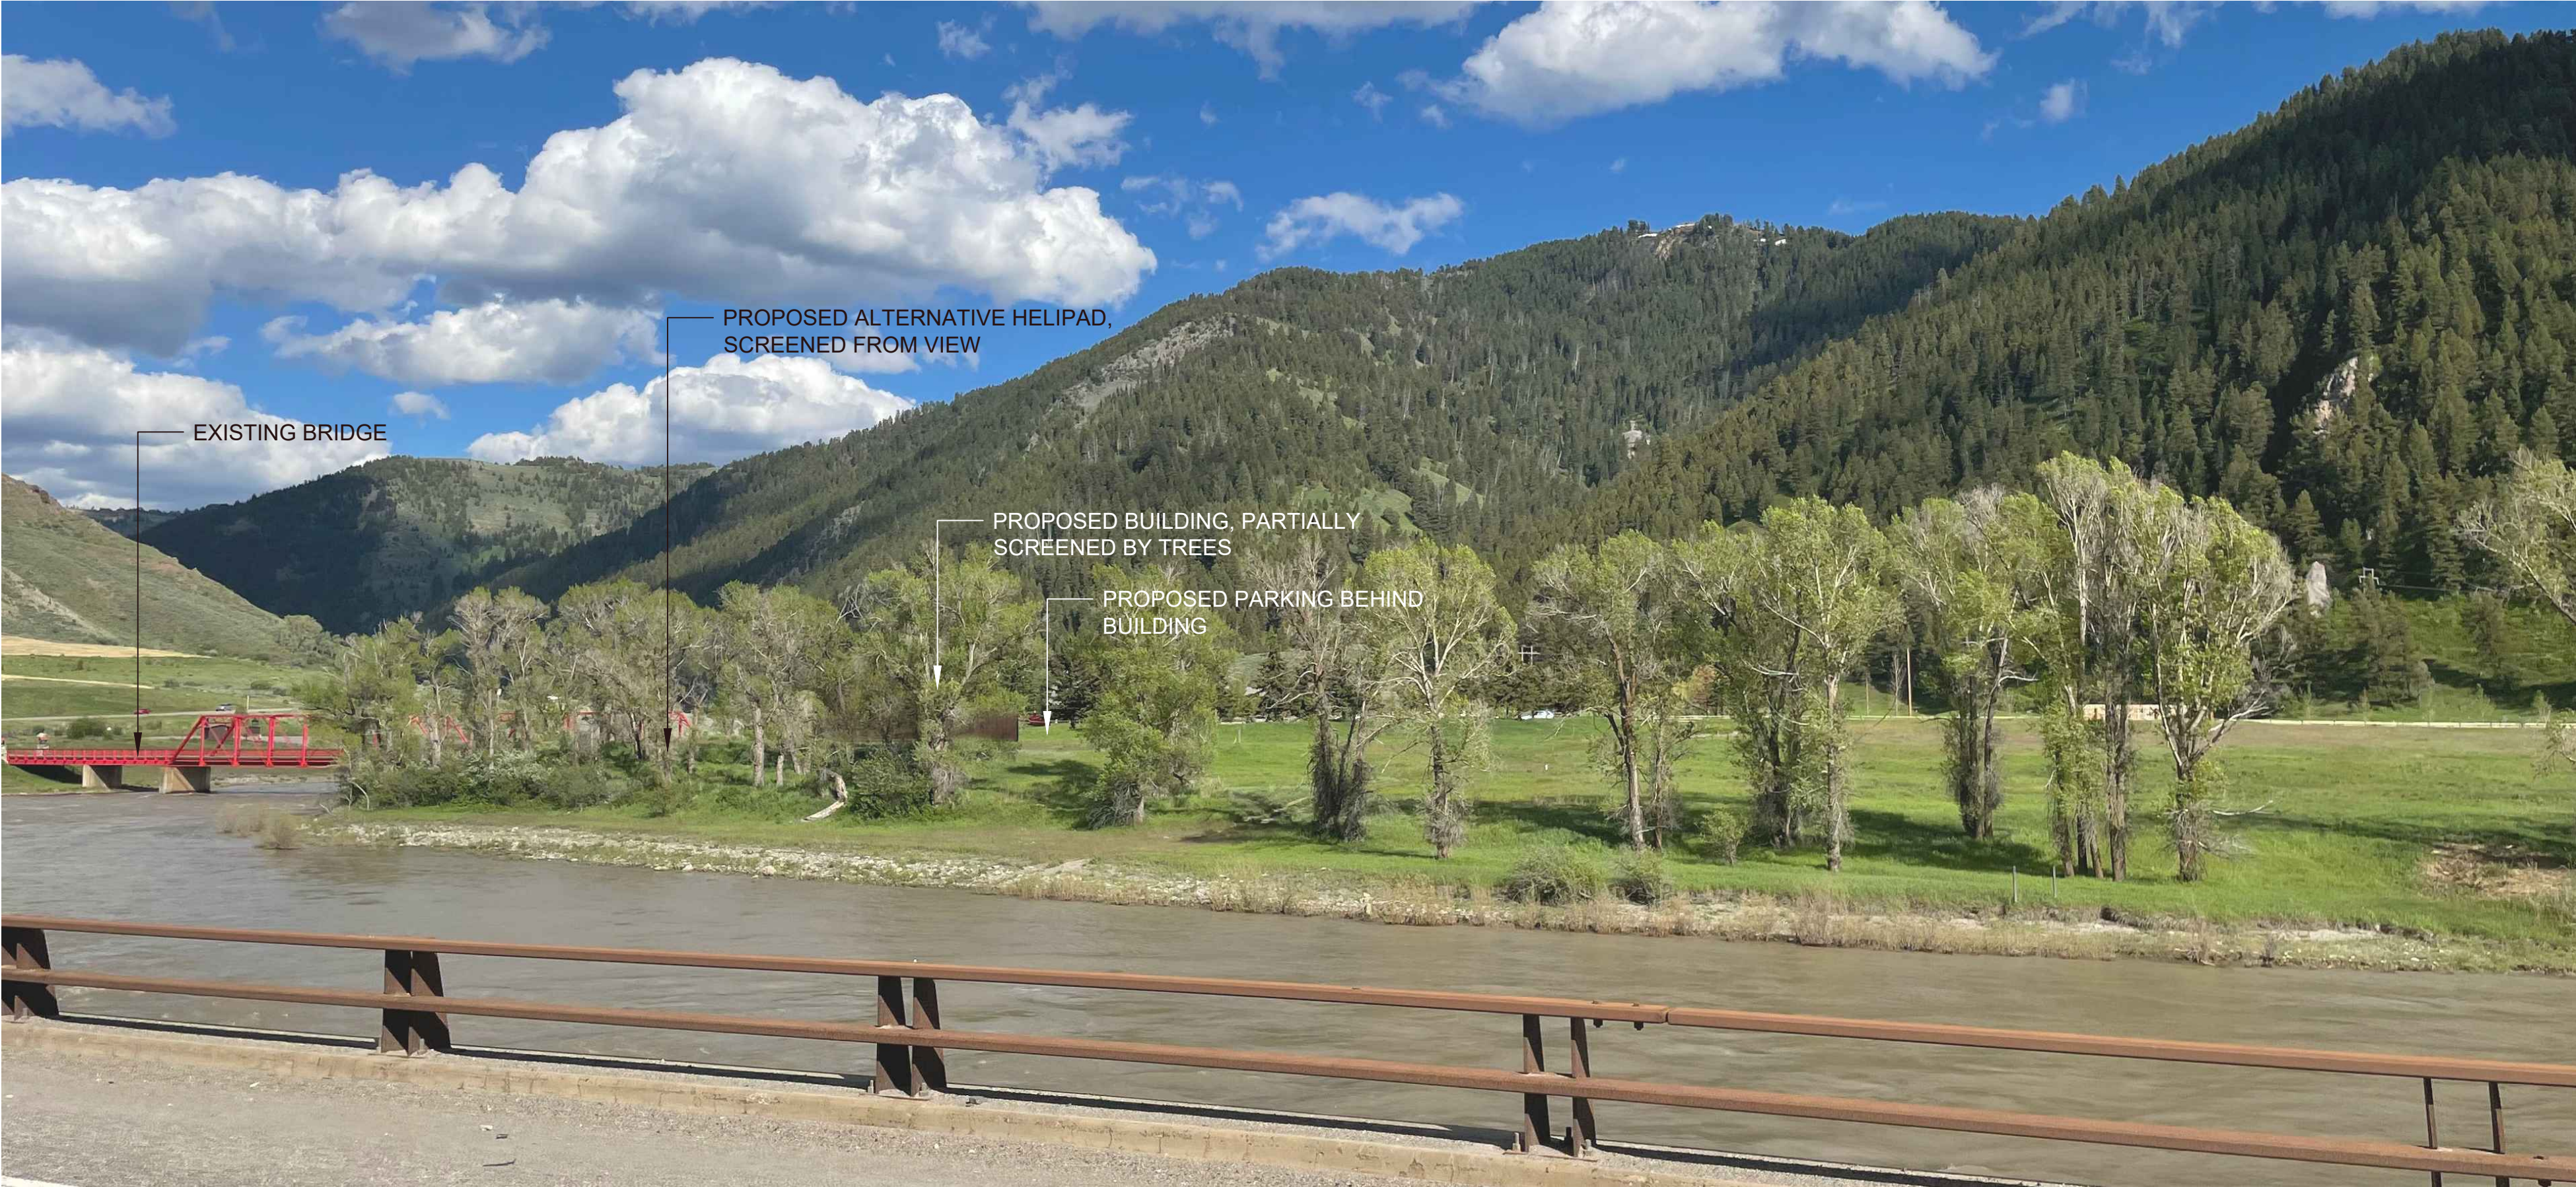
THE PROPOSED DEVELOPMENT PLAN FOR ASTORIA - SRSC EMPLOYEE HOUSING INCLUDES THE CONSTRUCTION OF PARKING LOT, CONNECTING ROAD, AND AN ALTERNATIVE HELICOPTER LANDING SITE ON A PREVIOUSLY DISTURBED AREA OF THE SITE (CURRENTLY GRAVEL MIXED INTO NATURALIZED GRASS). THE PARKING LOT, EXCLUSIVE TO SRSC EMPLOYEES, WILL CONTAIN ENOUGH SPACES FOR A RESIDENTIAL EMPLOYEE DWELLING; THE PATH, EITHER CONCRETE OR CRUSHED GRAVEL, WILL CONNECT THE EMPLOYEE HOUSING TO RIVERBEND ROAD; AND THE ADJACENT ALTERNATIVE HELICOPTER LANDING SITE WILL BE AVAILABLE FOR ANY NECESSARY MEDICAL EVACUATIONS, SCREENED AWAY FROM THE MAIN ROAD.

VIEW 2: PROPOSED LANDSCAPE VIEW LOOKING SOUTHEAST

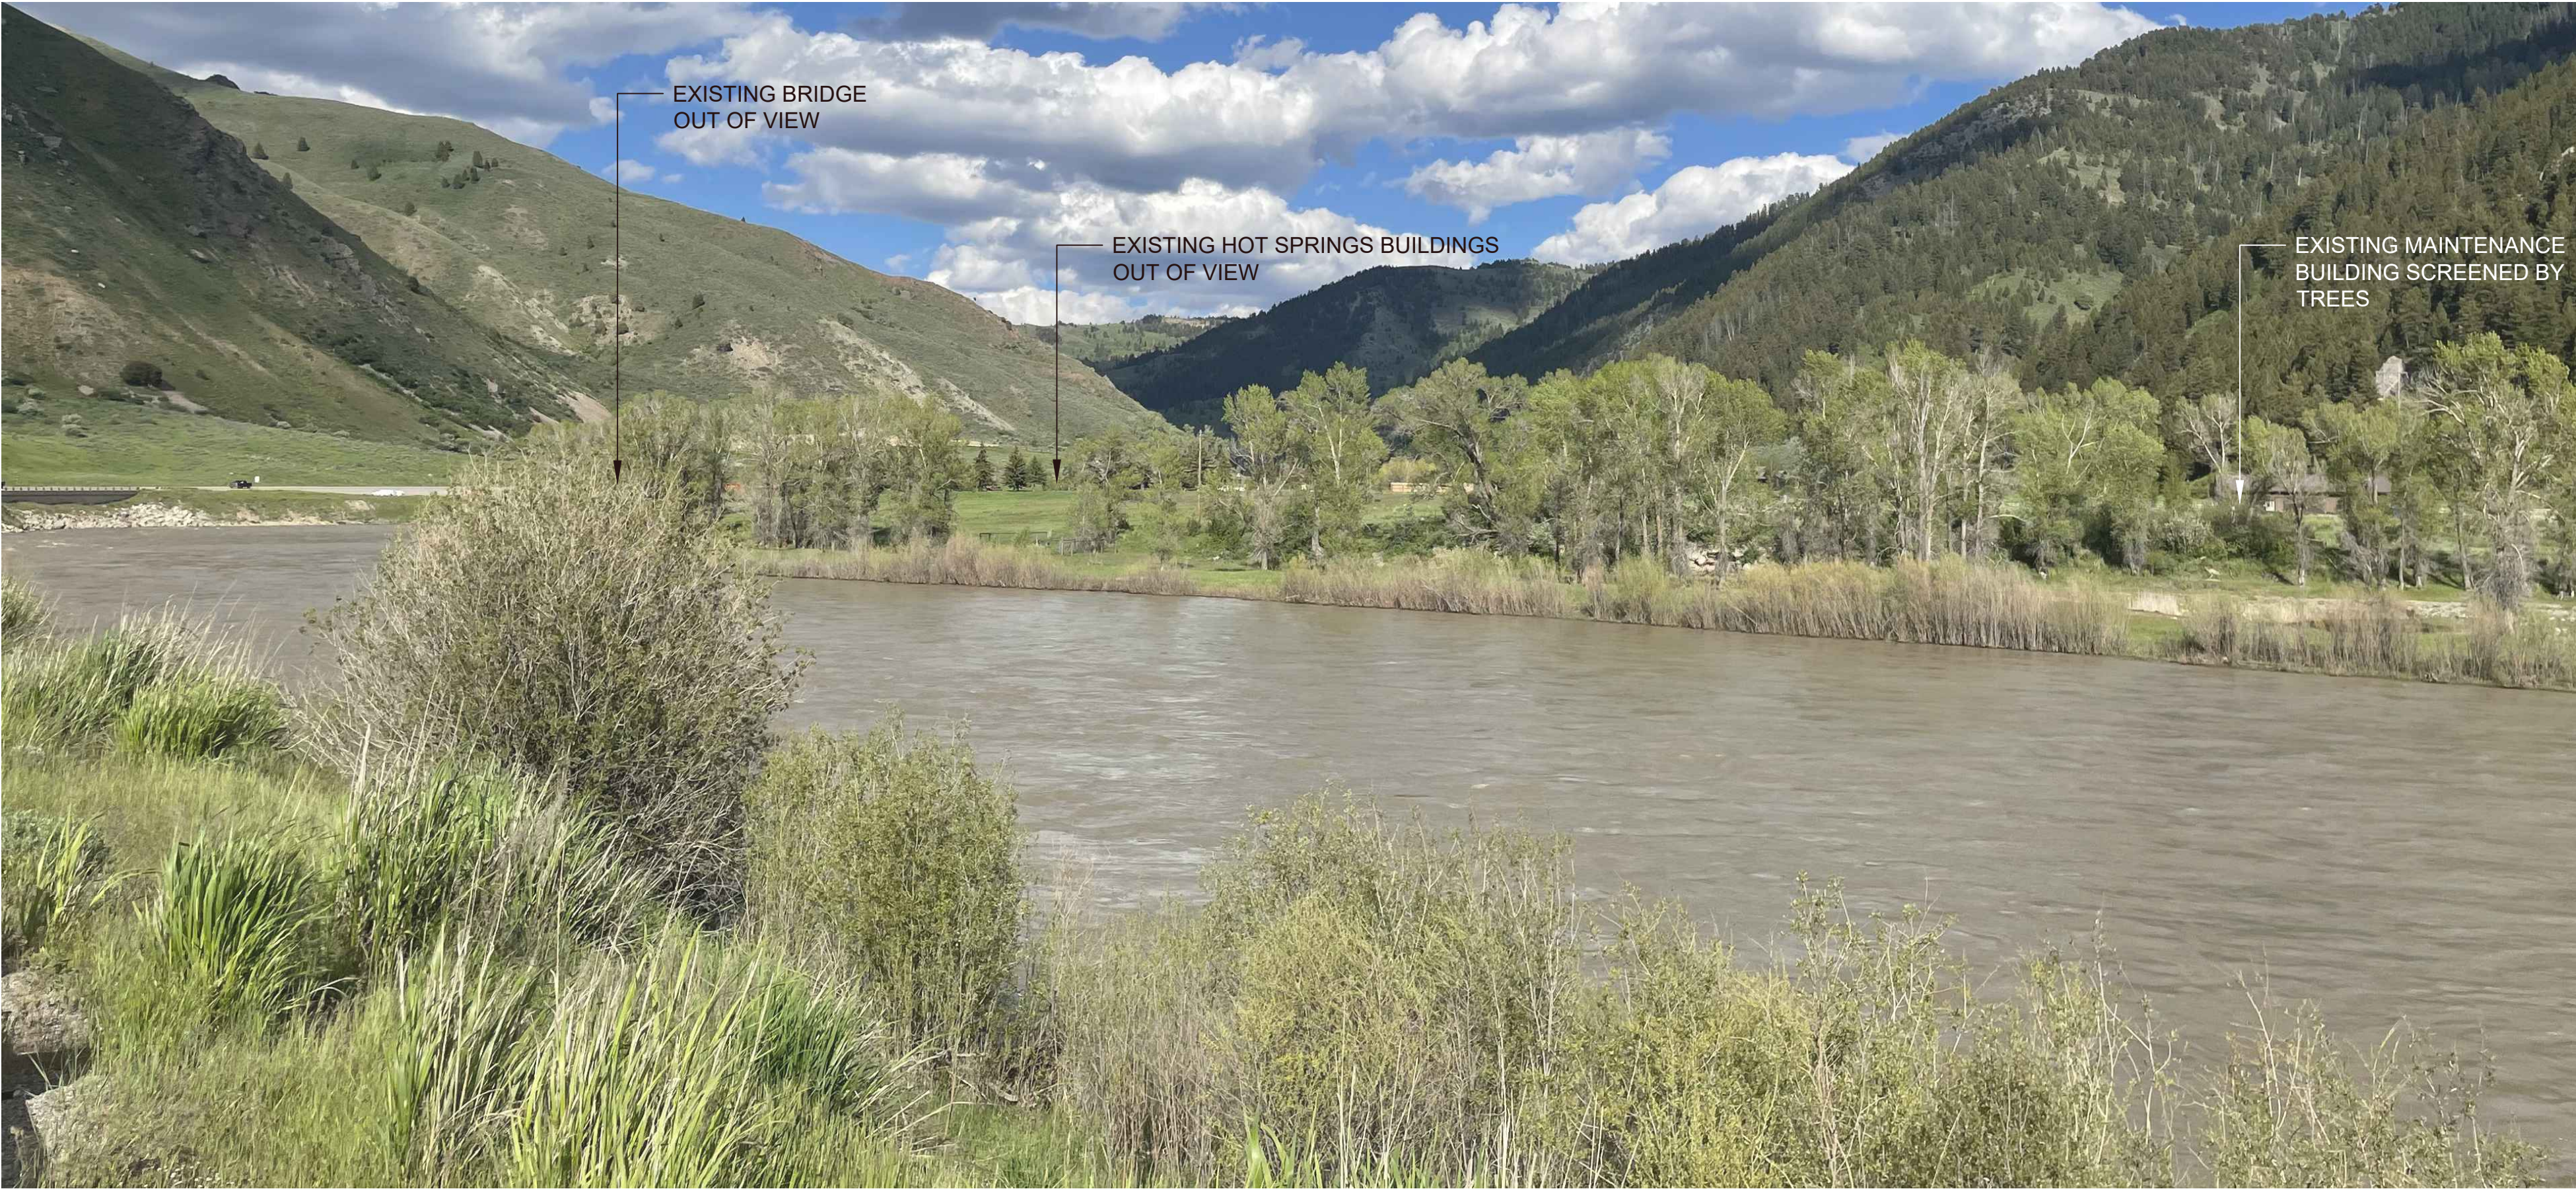
VIEW 3: EXISTING LANDSCAPE VIEW LOOKING EAST

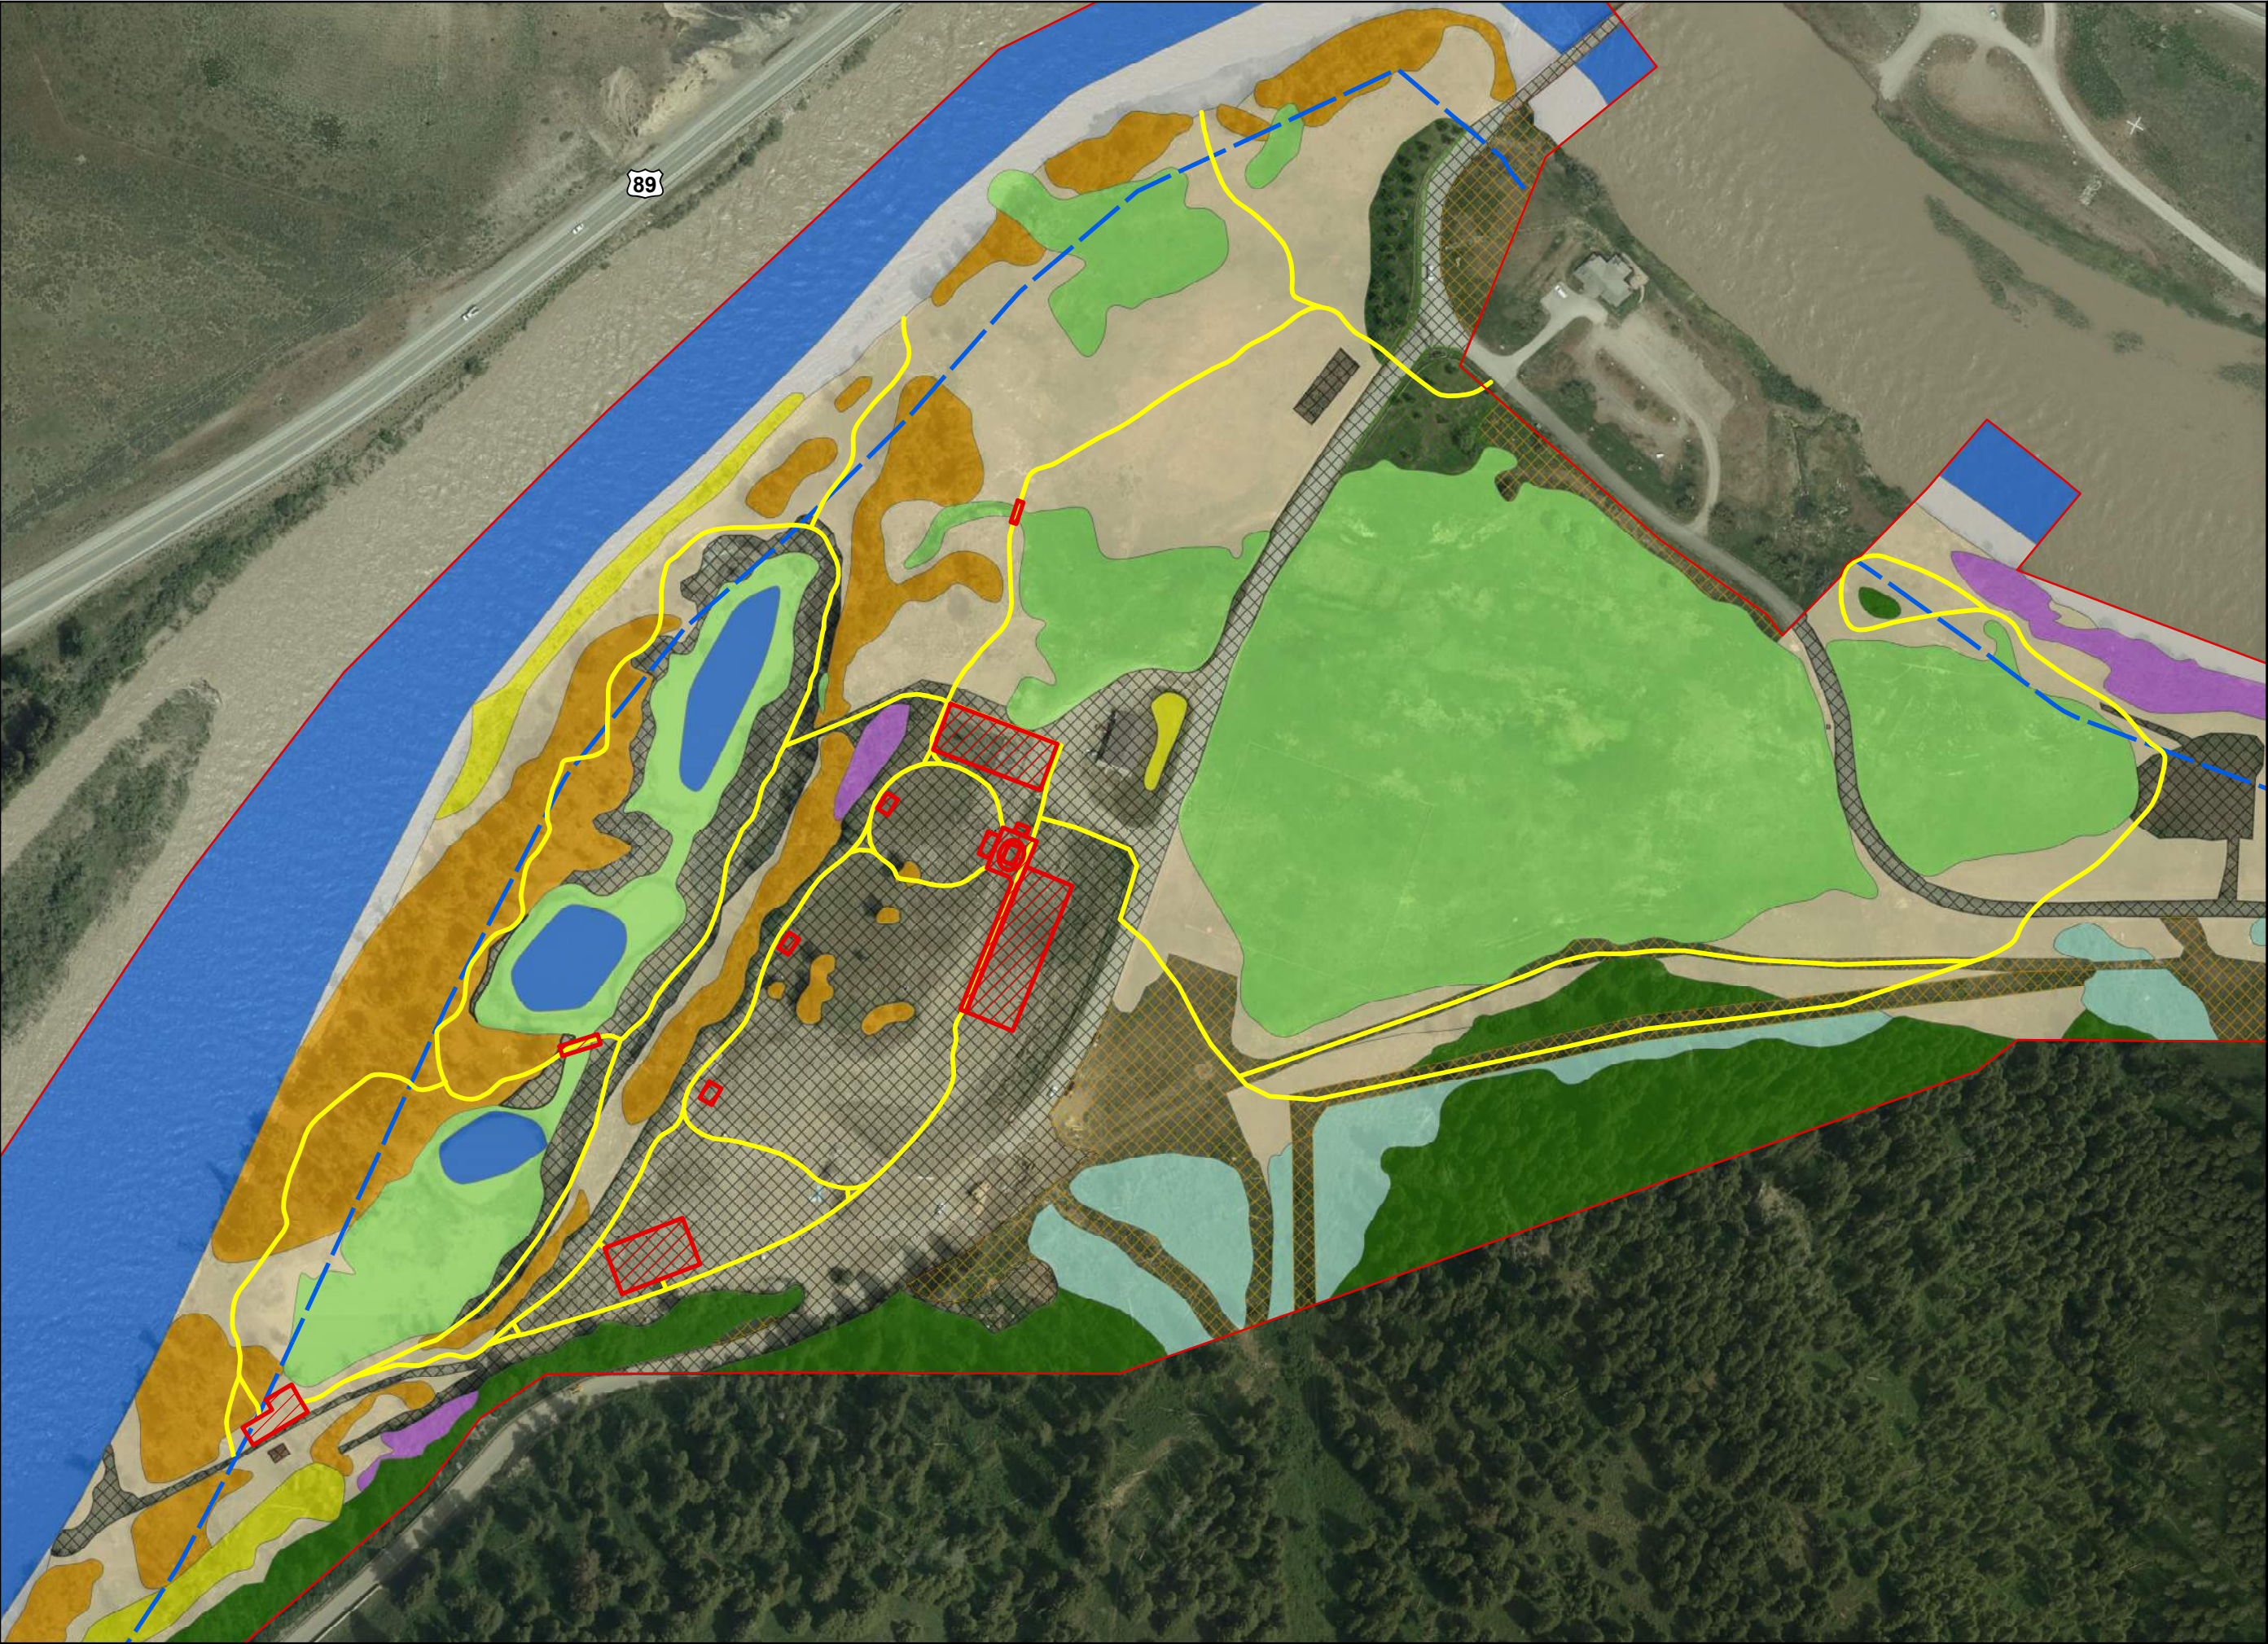
**Figure 7:**  
Proposed Phase II  
Development and  
Vegetative Cover

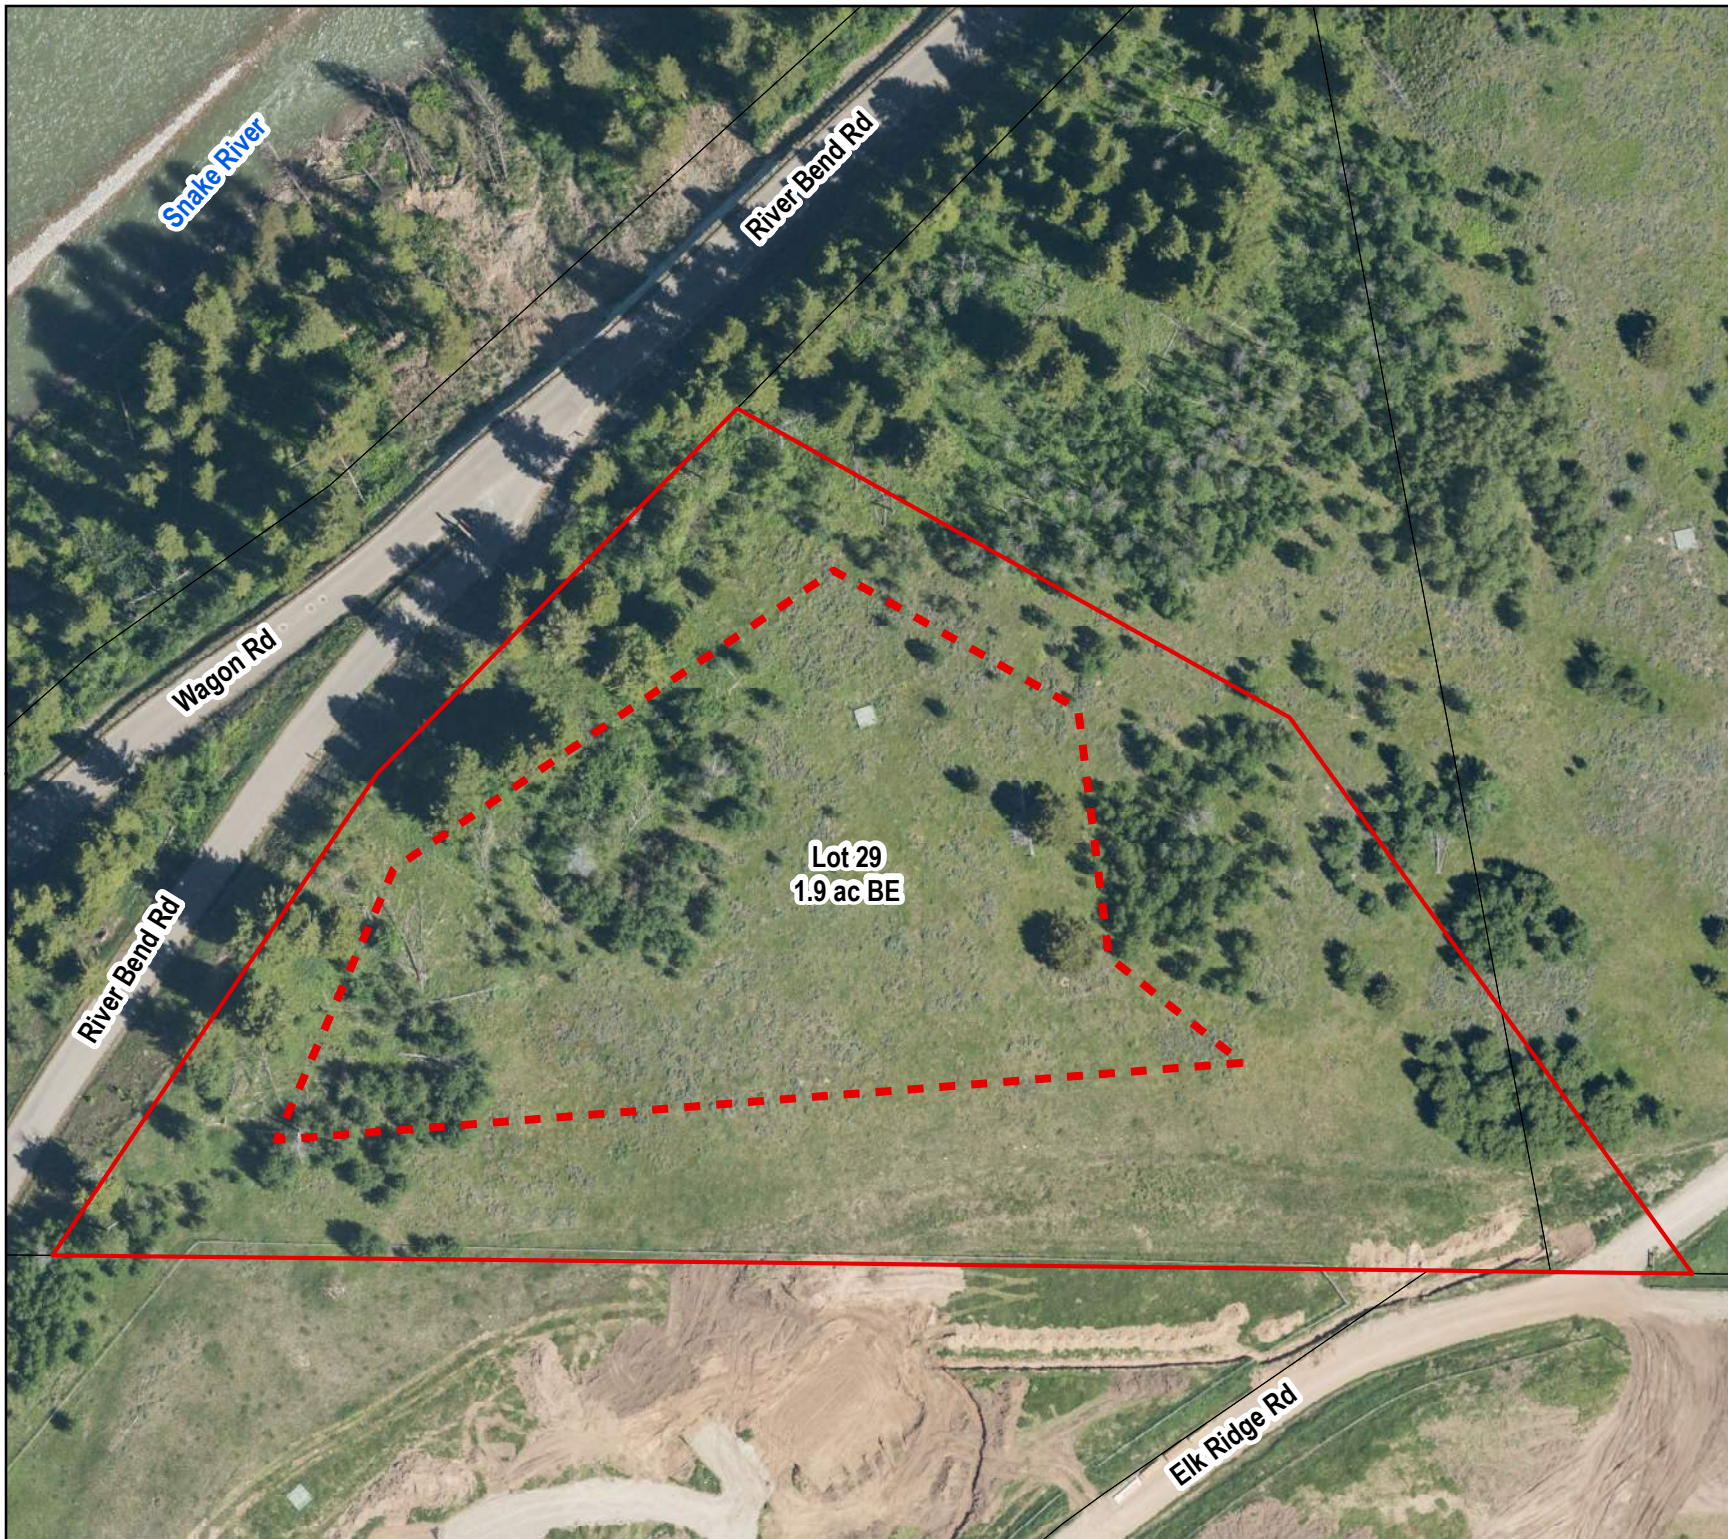
**Figure 5:**  
Proposed Building  
Envelope and Lot
