### **Planning and Zoning Commission**

**March 15, 2023 – REGULAR MEETING**

# STAFF REPORT

| <b>Agenda Item:</b> | P23-015: Amendment to PUD Snake River Canyon Ranch (Teton County) | <b>Public Comment:</b> | Yes |

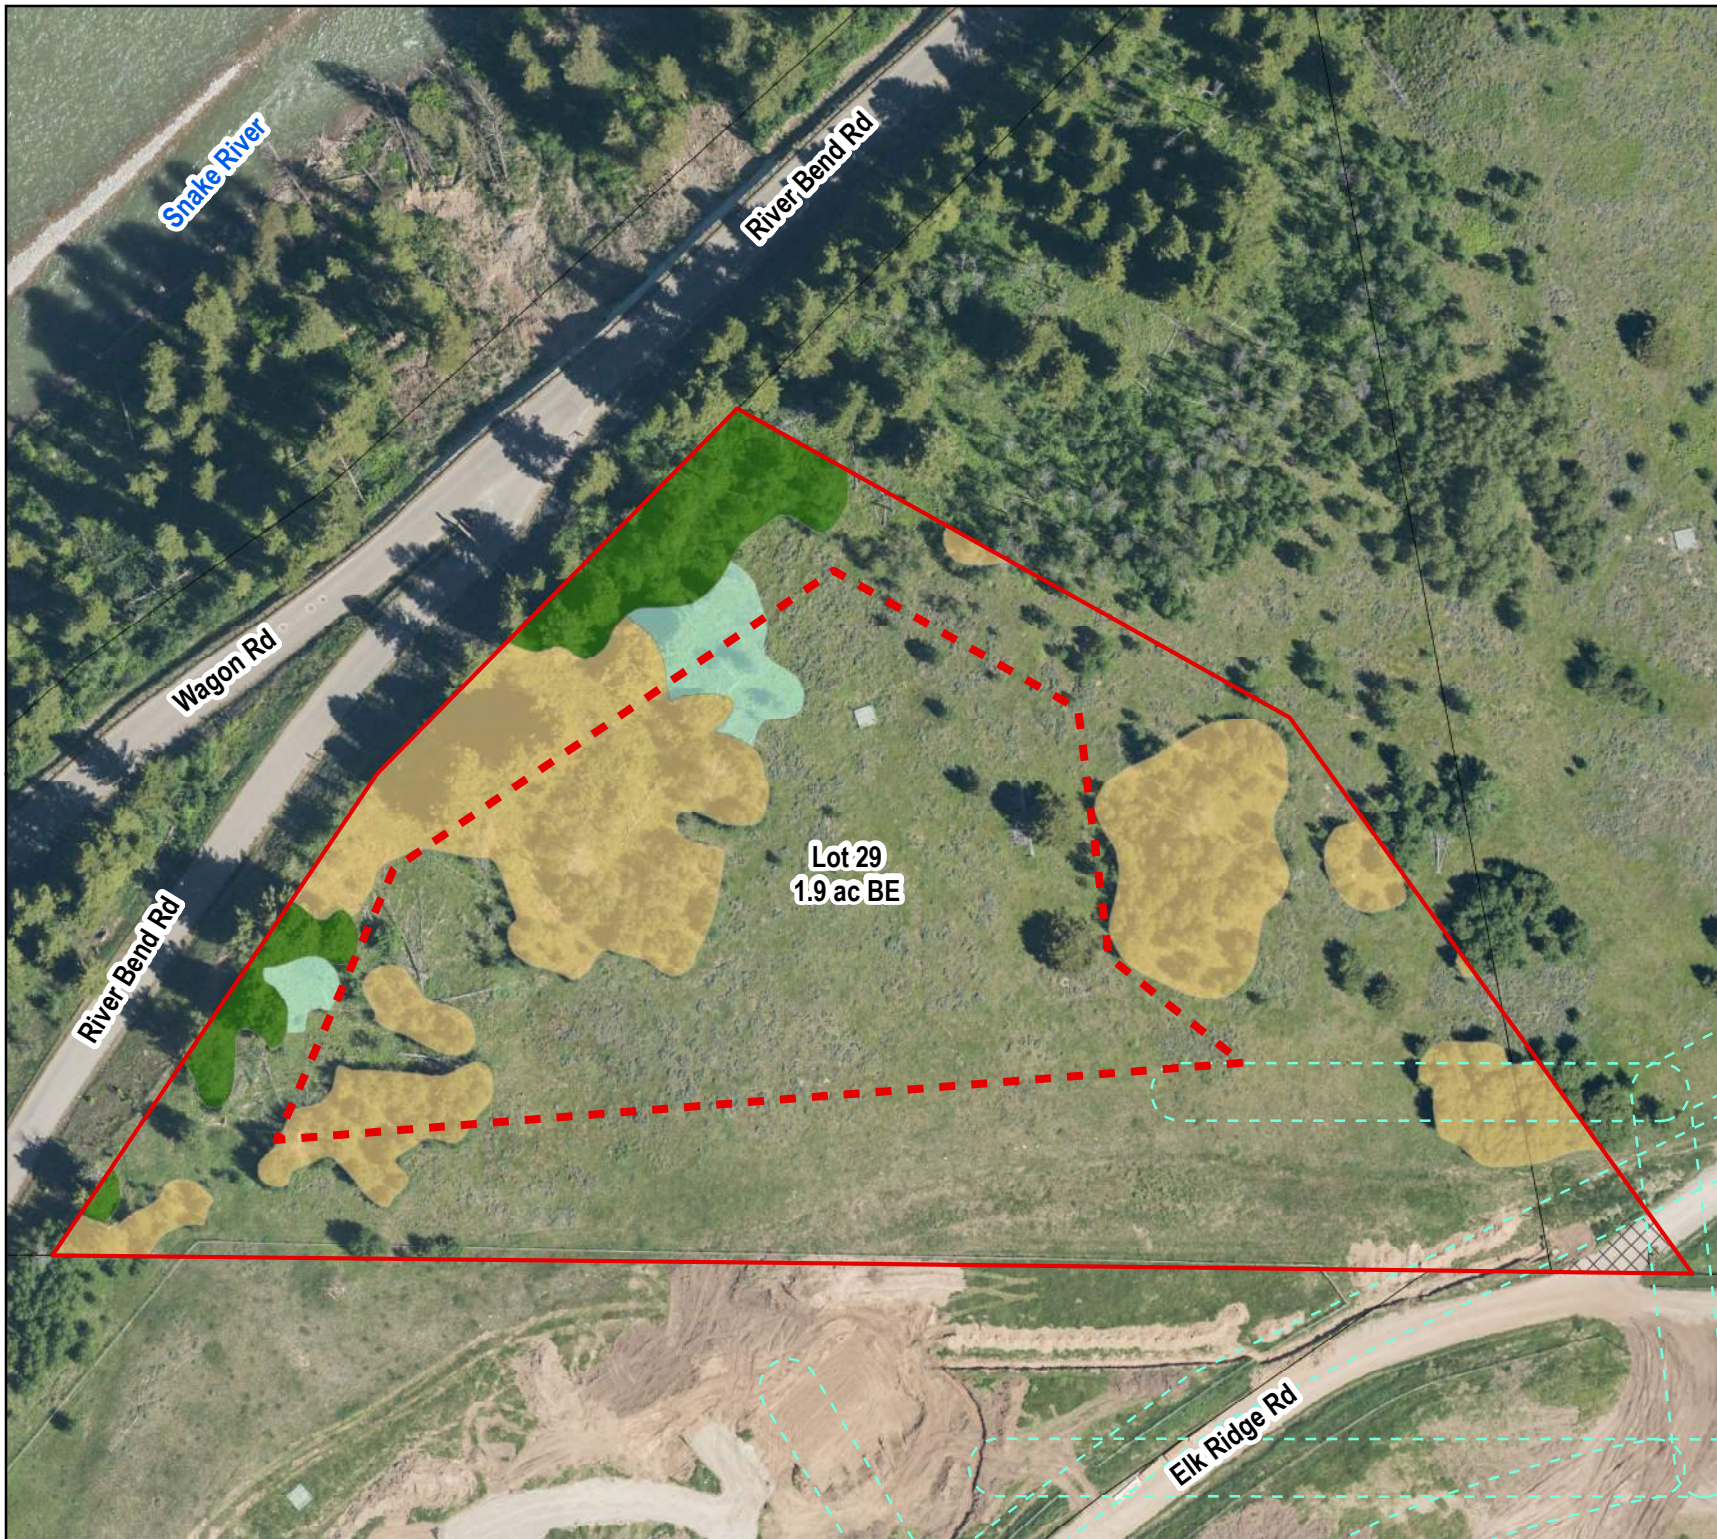
**Figure 6:**  
Proposed Building  
Envelope and Vegetative  
Cover Types

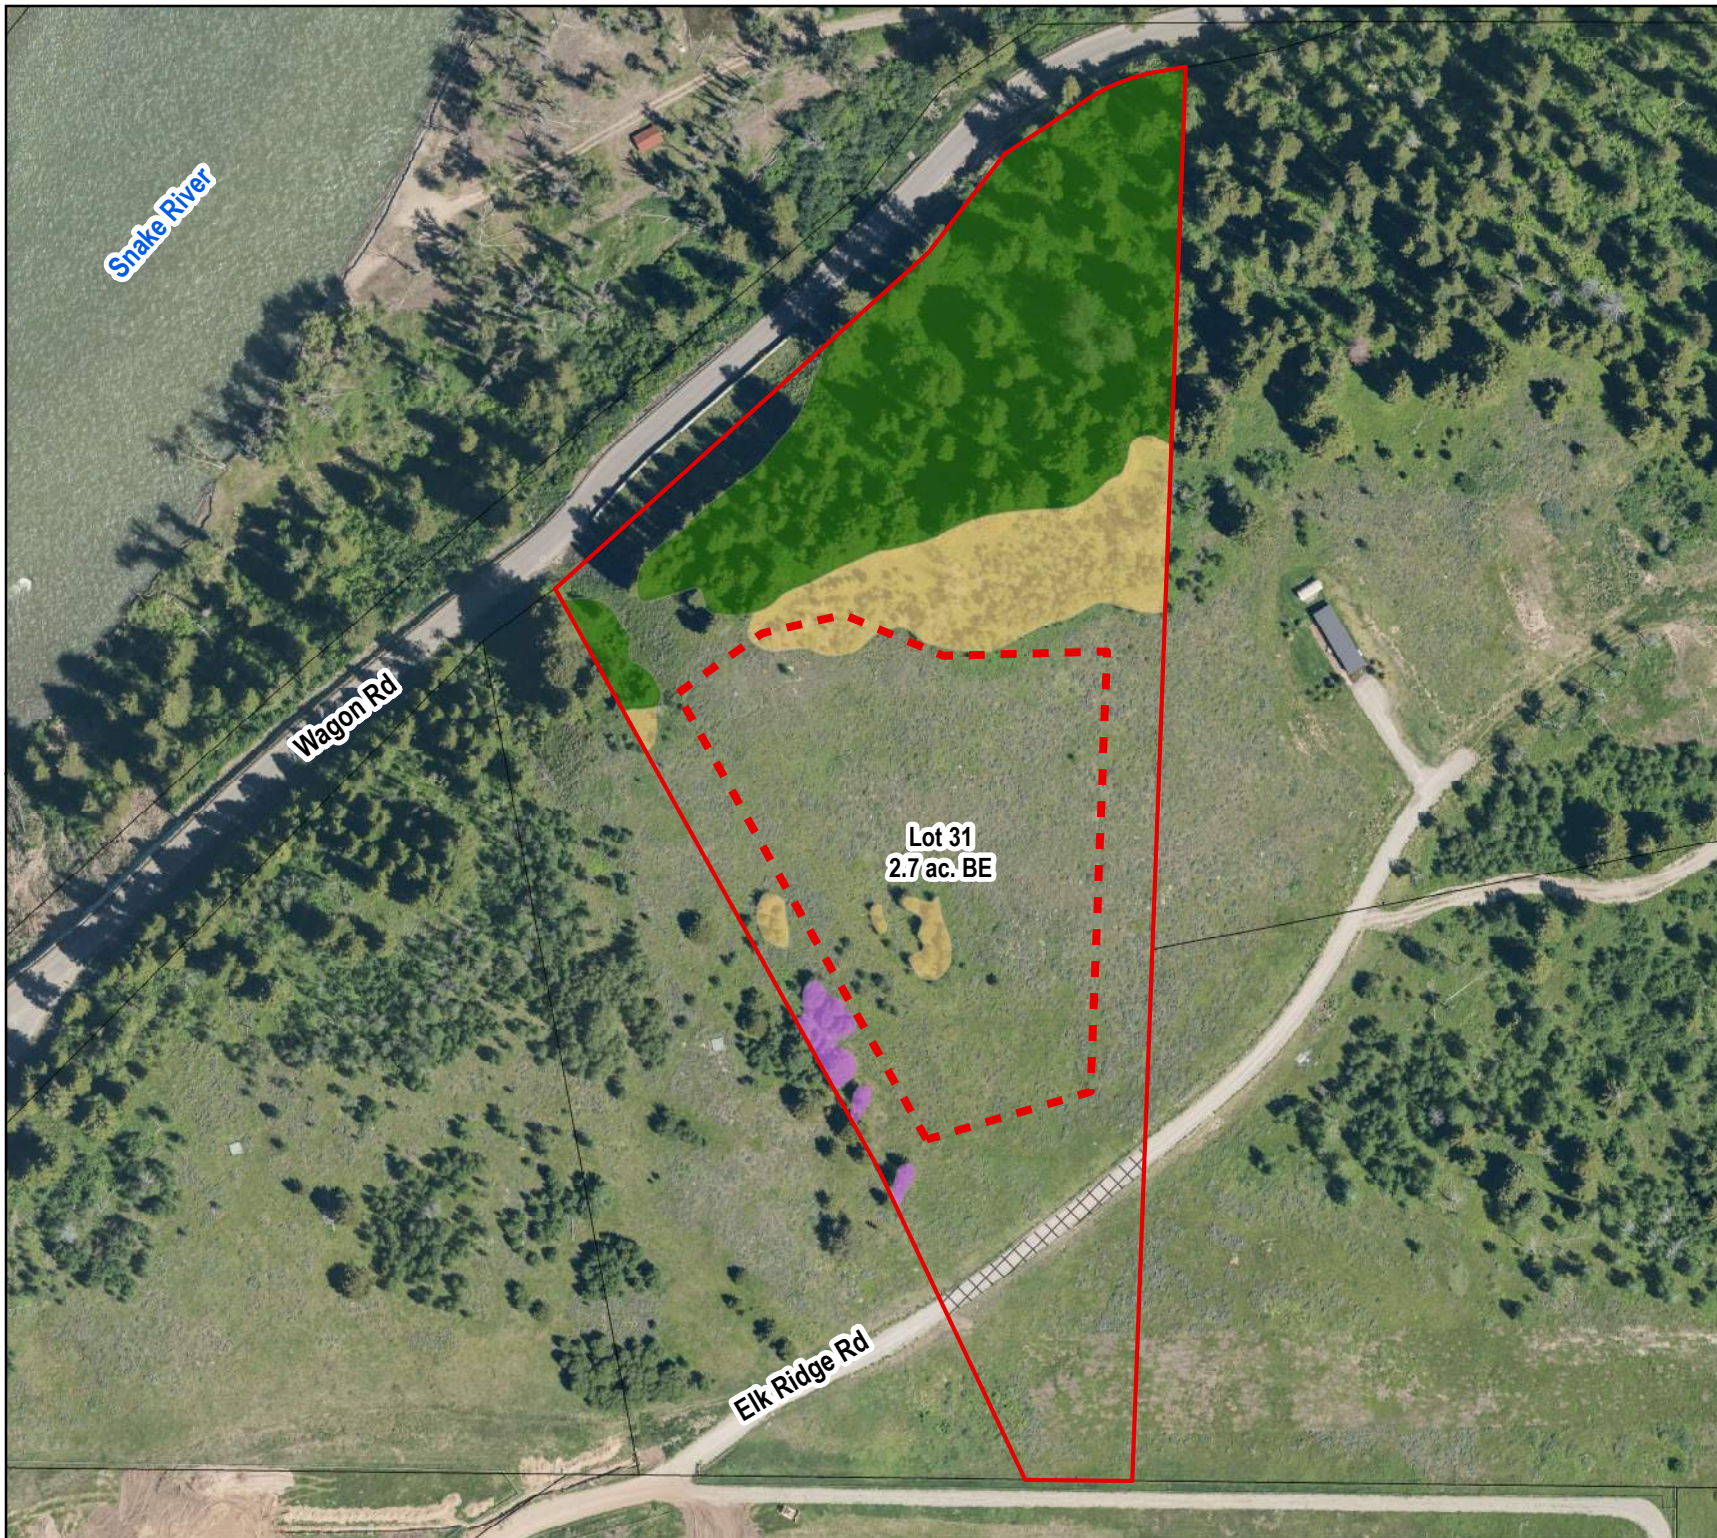
**Figure 6:**  
Proposed Building  
Envelope and Vegetative  
Cover Types

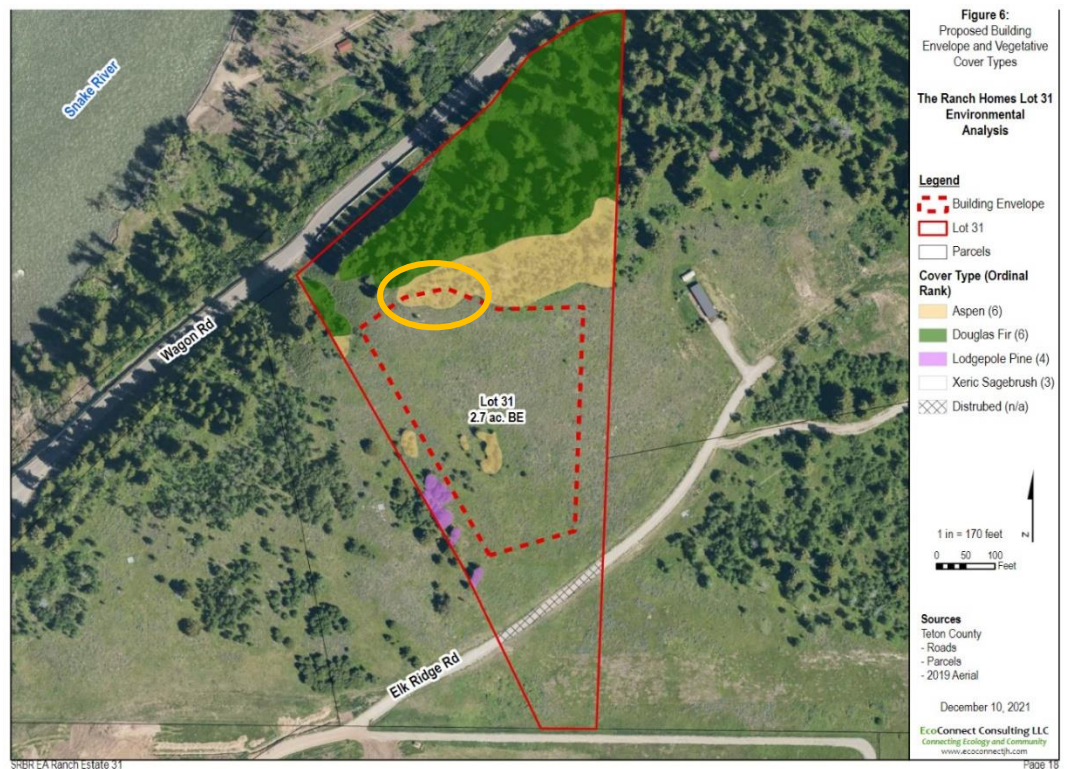
Development impacts are primarily xeric sagebrush with some minor impacts to aspen. There is a small aspen stand in the center of the property that would be impracticable to avoid, and the impacts are minimal. However, the impacts to the larger aspen stand on the north side of the development area would be easy to avoid and do not minimize impacts, and therefore it is recommended that aspen stand be left undisturbed during construction. The figure to the right identifies those aspen trees that are recommended to be left undisturbed.

Figure 1: Identifying "Northern Aspen Stand" within Recommended Building Envelope
