The purpose of this workshop is to present the findings of the Counsilman-Hunsaker (CH) Aquatics Commissioning Report, review the condition and remaining service life of the Teton County / Jackson Recreation Center aquatic facilities, discuss current maintenance efforts, and obtain policy direction regarding future aquatics planning.

CH was retained to perform an independent assessment of the Recreation Center aquatic facilities, associated mechanical systems, and long-term capital needs. The assessment documents existing conditions, identifies code and operational deficiencies, estimates short-term investments necessary to maintain operations, and outlines long-term replacement considerations.

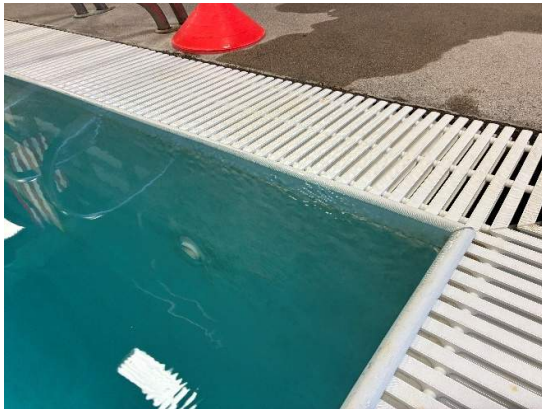
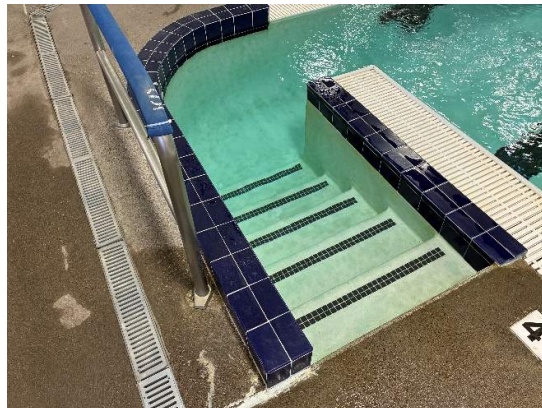
The lap pool is constructed of concrete and utilizes a proprietary aggregate plaster finish. Waterline tile is not present beneath the handhold. The pool utilizes tile for floor lane lines, wall targets, and a contrasting band at the transition point where the 5' depth begins.

A larger surge tank must be installed if a full pool replacement occurs, and the tank must have proper open area and water conveyance as required by modern codes.

A tiled concrete gutter should be considered in lieu of a plastic handhold. The levelness of a tiled gutter can be adjusted via mud bed / setting material if settlement ever occurs. For a new design, geotechnical engineers should be informed of a max differential settlement requirement of  $\frac{1}{2}$ " for gutter pools, and soil improvements should be considered during a replacement if this cannot be met with typical construction/backfill practices.

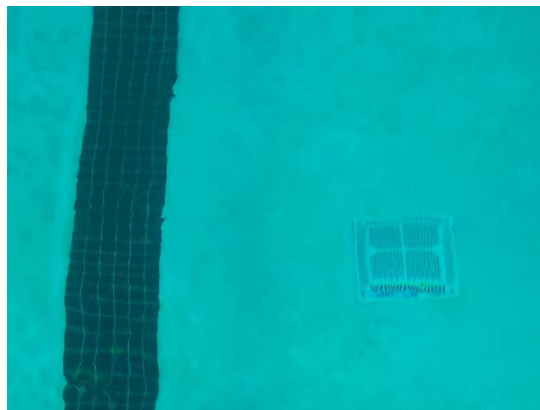
The lap pool has two (2) main drains. The main drain grates were observed from the pool deck and appeared to be the 12"x12" main drain cover, part number WG1032BHF2 by Hayward – operations team to confirm.

Unfortunately, VGB is a national-level requirement for all pools that cannot be grandfathered. Due to undersized grates, sumps, and piping, C-H recommends that the main drain grates, concrete sumps, and associated undersized piping should be replaced. A temporary fix would be to reconfigure piping within the surge tank to make sure the main drains cannot flow to the surge tank via gravity and install a safety vacuum release system (SVRS) on the recirculation pump.

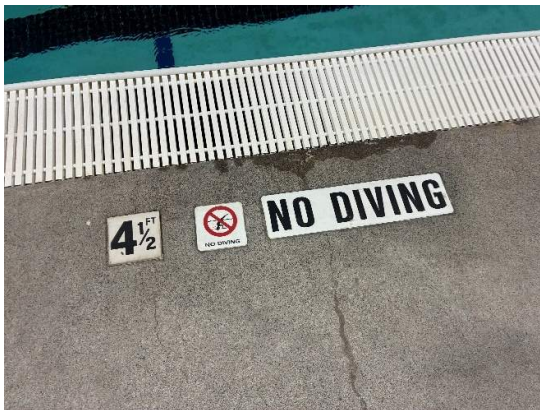
The lap pool currently features tile horizontal depth markers and vinyl adhesive horizontal "NO DIVING" warning markers. However, no vertical depth markers were observed on the vertical wall of the pool, which is a requirement of both the Teton Health District Code and the MAHC.

Additionally, C-H recommends implementing vertical depth markers in accordance with Teton Health District code if a new stainless steel gutter is installed.

For a new pool, ensure that all depth markers and warning signs are descriptive, placed on both vertical and horizontal surfaces, have text at least 4" tall, and include the international "NO DIVING" symbol.

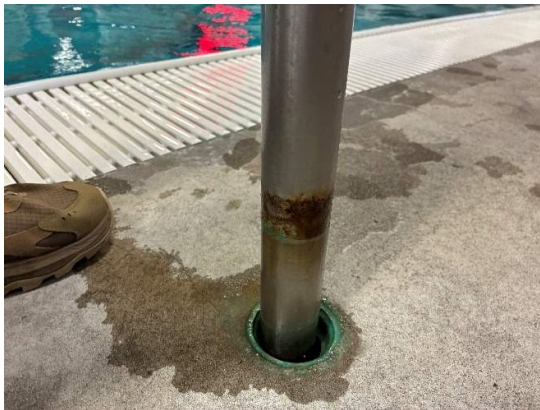
The lap pool is equipped with seven (7) floating lane lines secured by deck-anchored eyebolts and extensions. The lane lines themselves were observed to be in good condition, showing no discoloration or damage to the rotating discs.

C-H recommends cleaning and passivating the stanchion posts and anchors on a regular basis to mitigate further corrosion and extend service life.

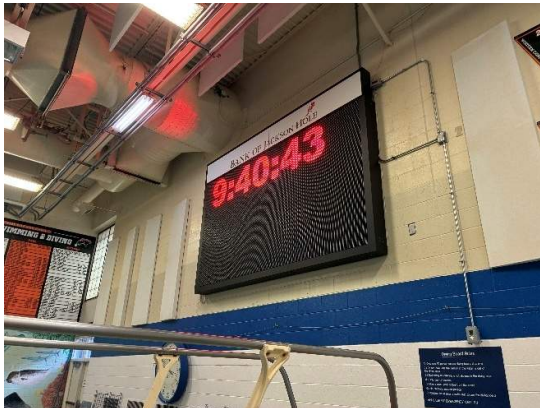
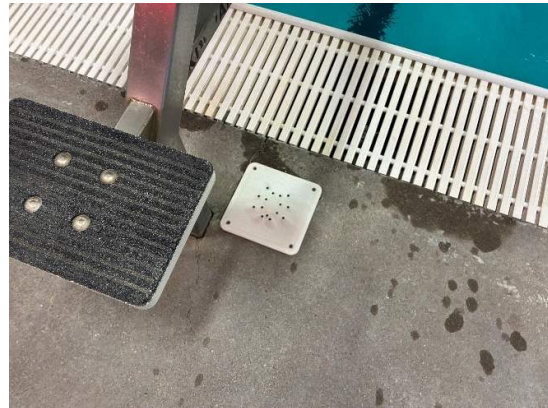
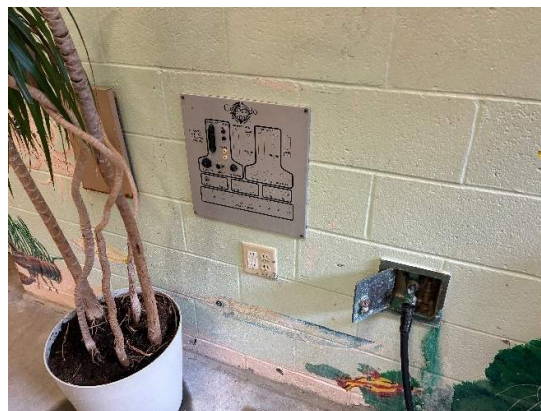
The facility utilizes a Colorado Timing System for swim meets and training. The wall plate and new Gen7 Legacy deck plates were observed to be correctly located and appeared to be in good physical condition. A timing board display mounted on the north wall was also observed and reported to be functioning properly.

If touchpads being pushed off the wall are a concern to ownership, C-H recommends contacting Colorado Timing Systems (CTS) to determine if a different touchpad or mounting mechanism would be better suited for the lap pool. Refer to Appendix A for contact information

With a new pool design, provide a new serial Gen 7 timing system with deck plates. Plan for a dedicated meet management room where the scoreboard and timing system can be operated from in a controlled, non-humid environment.

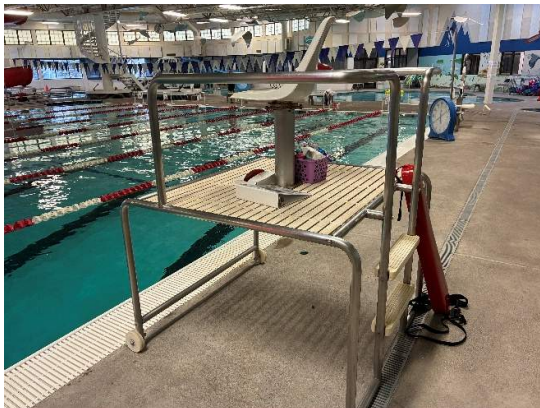
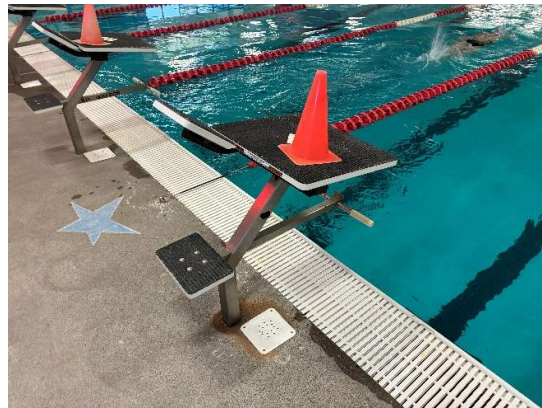
The lap pool's surrounding deck is equipped with several items necessary for competition and safety. Two (2) stainless steel lifeguard stations were observed on either side of the pool in good condition, with some slight staining under the seat.

If ownership desires more secure starting blocks, C-H recommends replacing the existing starting block anchors with dual-wedge anchors with tightening knobs in conjunction with a lap pool renovation.

Verify the proper bonding per NEC680 with the corroding anchor. If bonding is not present, replace the anchor. If bonding is present, thoroughly clean and passivate the anchor sleeve.

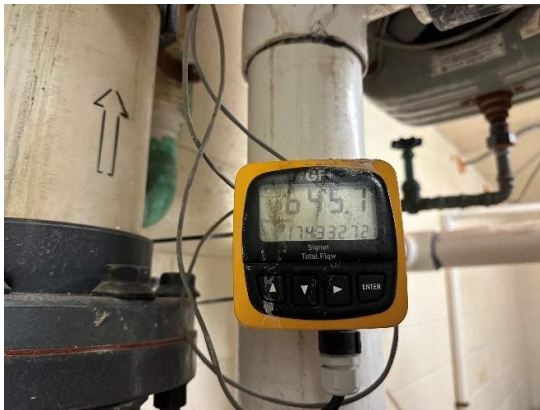
The bulk of the visible recirculation system piping uses Schedule 40 PVC piping, which is less robust than the Schedule 80 PVC typically recommended by modern aquatic industry standards for all exposed pool piping. This includes the influent and effluent heat exchanger piping (which was observed to be copper) whereas modern industry standards recommend Schedule 80 CPVC due to its superior heat tolerance. The presence of some acceptable Schedule 80 PVC fittings elsewhere in the system suggests recent, post-original-construction repairs by diligent staff. Furthermore, the piping supports were observed to be corroded and rusted, indicating a need for maintenance or replacement to ensure the long-term integrity and proper alignment of the plumbing runs.

No immediate recommendations.

During a full pool mechanical room replacement, ensure a 4-20mA signal Signet MagMeter is included to allow for feedback control with recirculation pump VFDs. This leads to significant energy savings following filter tank backwashing.

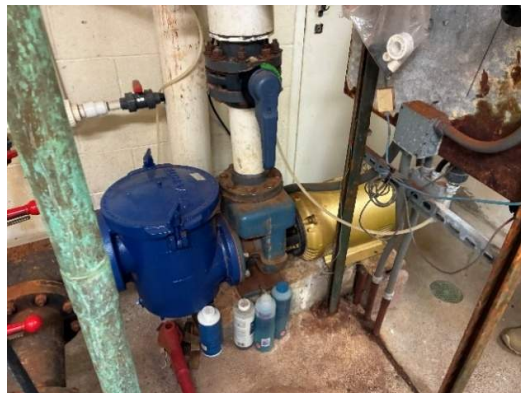
The lap pool recirculation system is driven by a Sta-Rite CSP pump paired with a 20 HP, 460V Baldor Reliance motor, and a newly replaced Sta-Rite strainer. The performance of this system is notably compromised, with staff reporting that maintaining the required 6-hour turnover rate is difficult. This difficulty is directly related to the pump's current operational state: the pump is cavitating (suggesting air intrusion or insufficient supply-side pressure) which causes the impeller to degrade prematurely, requiring replacement as often as once per year according to staff.

Given that the mechanical room likely lacks the necessary space for a dedicated pump pit, C-H recommends replacing the existing pump with two (2) self-priming 10 HP EQK(T)-1000 pumps from Pentair, a supplier that is more easily accessed in the area. Implementing two pumps not only allows for self-priming with off-the-shelf pumps but also offers partial redundancy for staff if one goes down.

Upon installation of the pumps, pressure and vacuum gauges should be installed to meet the MAHC requirements for system monitoring. Furthermore, VFDs should be implemented on the pumps to allow the system to run more efficiently, save energy, and extend the lifespan of the new pump motors.

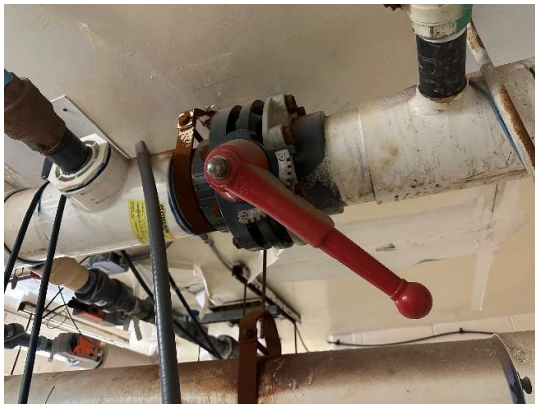
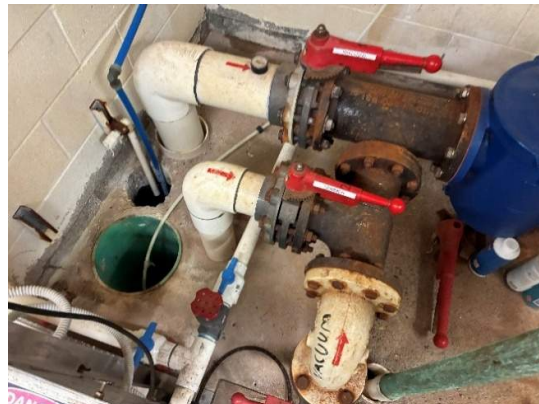
The valves and flanges throughout the mechanical room were observed to be in fair to poor condition. Specifically, those on the suction side of the recirculation pump were noted to be in particularly poor condition, characterized by significant rusting on the bolts. This corrosion compromises the long-term integrity of the plumbing connections and could lead to leaks or potential failures.

C-H recommends installing valve tags on all valves within the recirculation system and providing a corresponding detailed valve chart to assist staff in diagnosing and remedying future maintenance issues easier.

C-H recommends replacing all SCH 40 valves and flanges with SCH 80 components to adhere to modern industry standards for increased durability and pressure resistance. All valves and flanges on the influent and effluent heater lines should be replaced with SCH 80 CPVC.

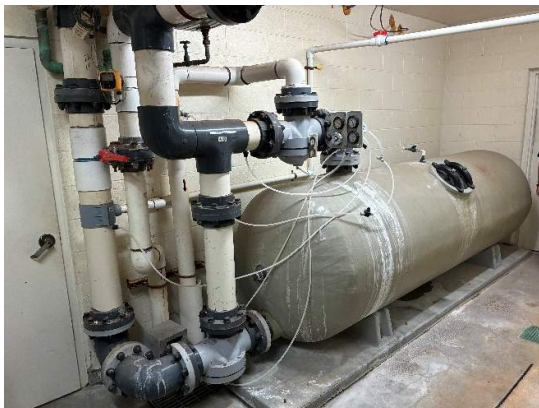
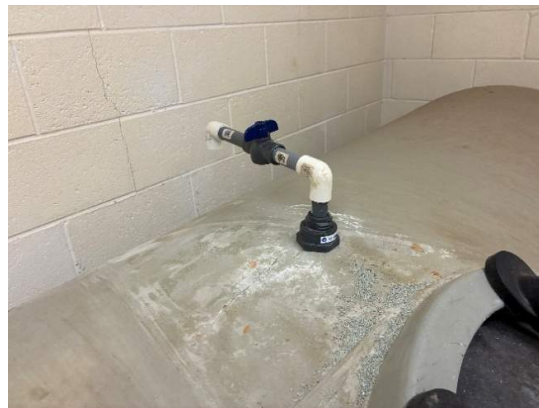
The lap pool utilizes one (1) Stark SA144 filter system with a semi-automatic backwash functionality. The filter system was observed to have a manual air relief system present, which satisfies the requirement set forth by MAHC for safe operation.

The dual tank system should not only assist with filtration at the pool, but will also ease the backwash flow rates routed to the existing sanitary connection.

Utilization of glass filter media and an electronic flocculant (such as Clear-Flow) would further increase the quality of the sand filtration at the lap pool. Alternatively, a regenerative media filtration system could also be explored for additional cost.

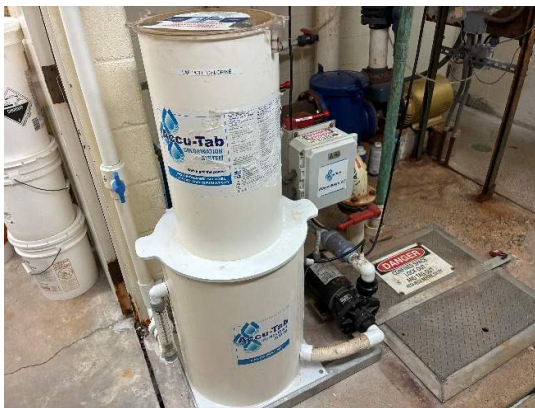
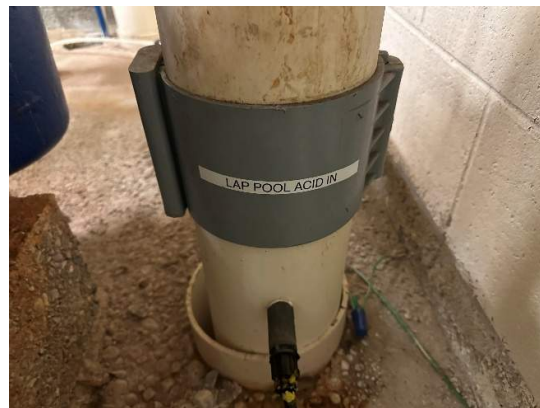
The lap pool utilizes an Accu-Tab 3070AT sanitizer system and booster pump for primary water treatment, which was observed to be in fair condition. The feed lines were observed to be clear and properly feeding the system, with no signs of excessive clogging or degradation.

If water chemistry management has been an ongoing concern for Ownership, which may be the case based upon observed amounts of sodium bicarbonate on-hand, C-H recommends a comprehensive domestic water analysis be performed to evaluate the facility's potable source water. The results of this analysis are critical for understanding the baseline alkalinity and mineral content, which directly influence the stability of the lap pool's pH. Depending on these findings, the integration of a carbon dioxide or sodium bisulfate system could be utilized to supplement the existing muriatic acid system, providing superior water quality to the facility.

**With a full facility replacement, provide a centralized pool mechanical room for all bodies of water. This will reduce the amount of muriatic acid lines traveling throughout the facility, which will therefore reduce the risk of harmful chemical leaks.**

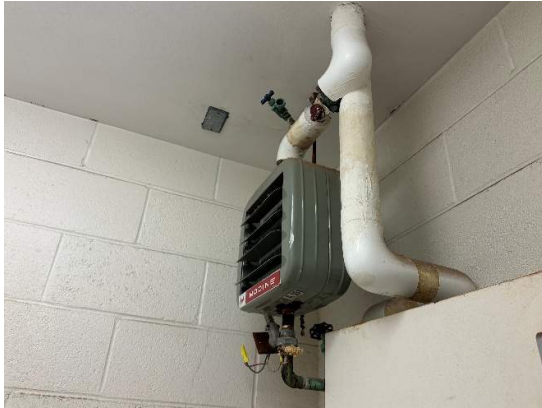
The dedicated chemical room houses several dry chemicals, including granular and tablet calcium hypochlorite, Potassium Monopersulfate, Sodium Bicarbonate, and soda ash. C-H did not confirm if these chemicals service only the lap pool or are used across other bodies of water in the facility. A ventilation system was observed in the room, but its current condition and functionality could not be verified.

NFPA diamond signage on the chemical room door and an emergency eyewash station within the room must be provided.

During a future full mechanical room renovation, C-H recommends that separate, properly fire-rated rooms be constructed to house chemicals and their respective feed systems, ensuring adequate segregation for safety.

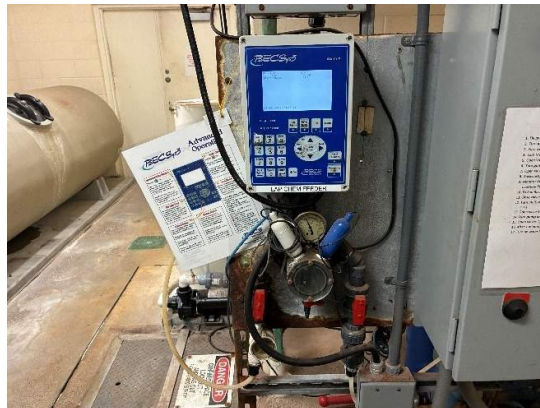
The lap pool's water chemistry is monitored and controlled by one (1) BECSys5 Water chemistry controller. This unit was observed to be in good condition and reported to be working properly.

If recirculation pump interlocks are not already in place for calcium hypochlorite and muriatic acid, consult with an electrical contractor to ensure that these interlocks are installed.

With a new pool, provide a more complex controller that can integrate with UV systems, dual- pH Buffer, and VFDs, such as the BECSys7.

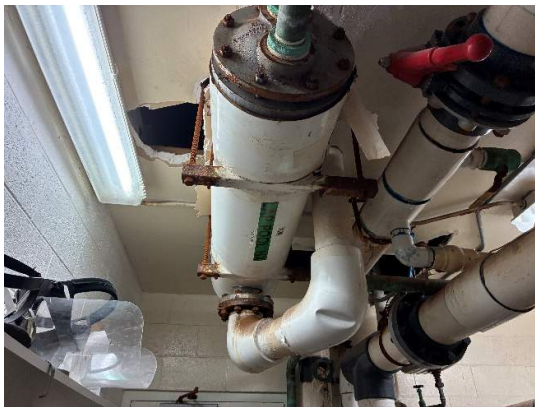
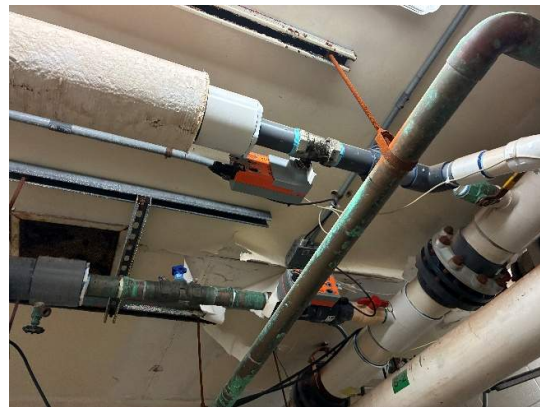
The lap pool system is currently heated indirectly via a central building boiler/heater that supplies hot water to a dedicated heat exchanger within the pool's recirculation system. The copper influent and effluent piping shows signs of aging and corrosion.

All aging influent/effluent heater lines should be replaced with SCH 80 CPVC during the next significant amount of pool mechanical room work.

Unless the pool chemical room is completely repurposed, there is not enough room for a standalone lap pool heater during a renovation. Therefore, during a future facility replacement, C-H recommends providing each pool recirculation system with its own dedicated heater. Standalone systems provide a level of redundancy for facilities with multiple bodies of water.

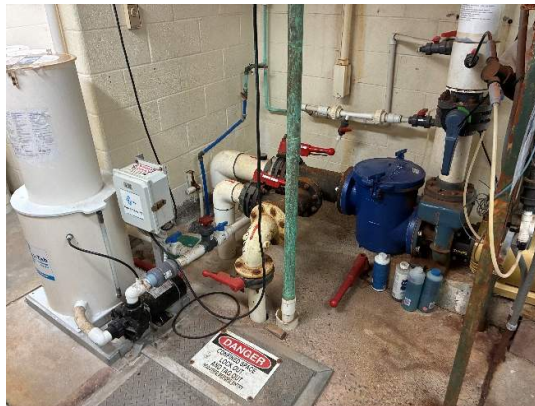
The lap pool currently utilizes a manual fill system for make-up water, which C-H observed inside the mechanical room leading into the surge tank lid. The pool originally featured an automatic fill system, but this system has since been decommissioned.

With an existing surge tank within the pool mechanical room space, an automatic water level control system is an easy addition during a renovation of any size. C-H recommends that an automatic fill system (with normal level and overflow protection) be integrated to meet MAHC requirements and ensure proper perimeter overflow into the gutter system.

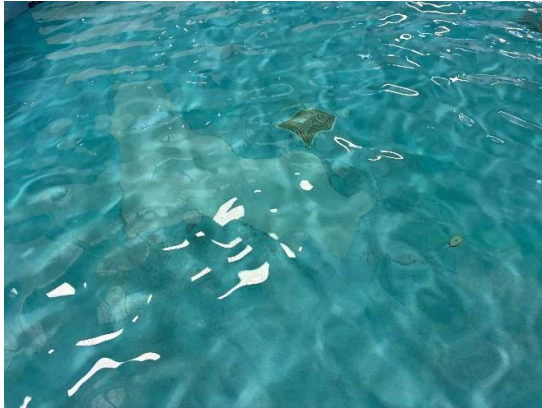
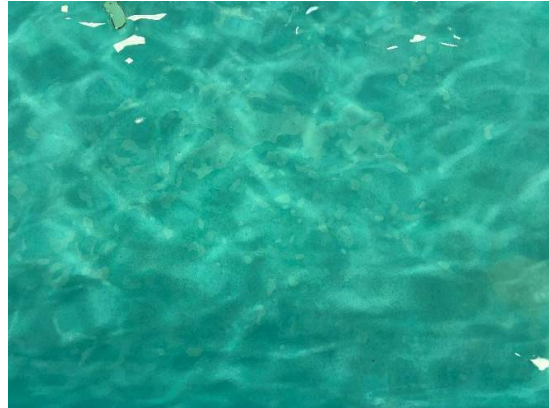
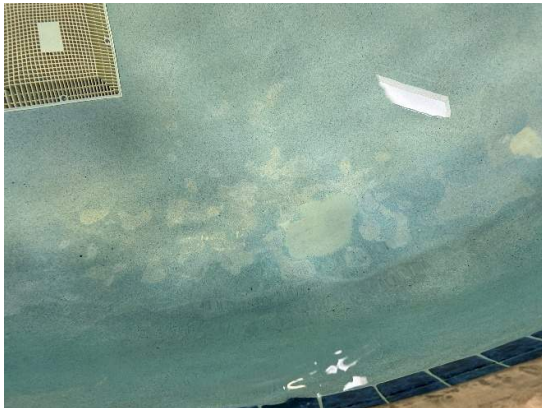
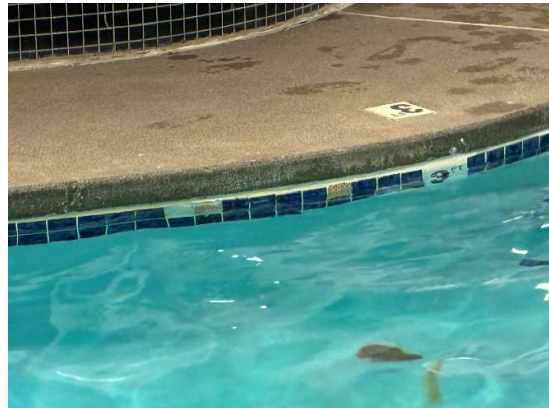
The leisure pool is constructed of concrete, and has not had significant renovation since original construction. The pool surface features an aggregate plaster finish and a 6" waterline tile. The age of the plaster is estimated by ownership to be approximately ten (10) years old.

Considering the source of the water loss has not been determined in piping, it is recommended that a water tightness test is conducted at the leisure pool to confirm the integrity of the structure itself. Refer to Appendix B for the water tightness test procedure. However, all lines and outlets should be capped for this water tightness test iteration.

**If water loss sources cannot be determined and repaired at the leisure pool as described above, C-H recommends that the pool be replaced in its entirety in the near future.**

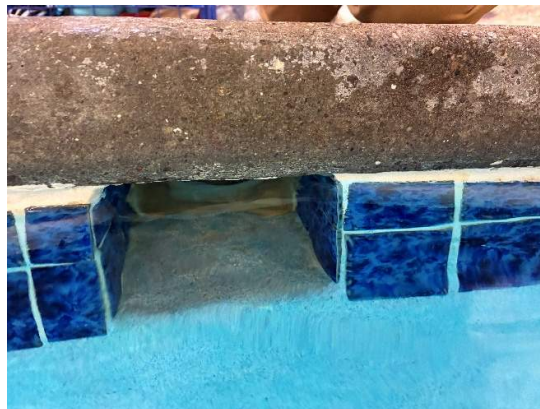
While a basket was present in each skimmer unit, no weir or deck access lid was observed on any of the skimmers. A weir is required per MAHC to ensure proper surface skimming and flow adjustment. A lifeguard reported that to clean out the skimmer baskets, staff must reach into the skimmer opening. This is an atypical operational practice stemming from the missing access lids, which are standard on commercial grade skimmers. Additionally, the skimmers are not listed with NSF-50, which violates Teton Health District Code.

The pool was observed to be overfilled, with the waterline exceeding the centerline of the skimmer opening. This condition violates both Teton Health Code and MAHC, which require the water level be maintained at the midpoint (centerline) of the skimmer opening for optimal skimming and water quality management.

Furthermore, the skimmers were observed to be out of level with each other. This hydraulic imbalance becomes critical when one of the skimmers runs dry. The skimmer closest to the entry ramp was noted to dry up occasionally, rendering it non-functional. MAHC requires each skimmer to be level with all other skimmers in the pool within a tolerance of  $\frac{1}{4}$ ", a standard which this system does not meet.

The pool deck and skimmers must be cut out and replaced in order to meet more modern codes.

**C-H recommends removing and replacing the entire pool to ensure proper perimeter overflow and gutter system code compliance.**

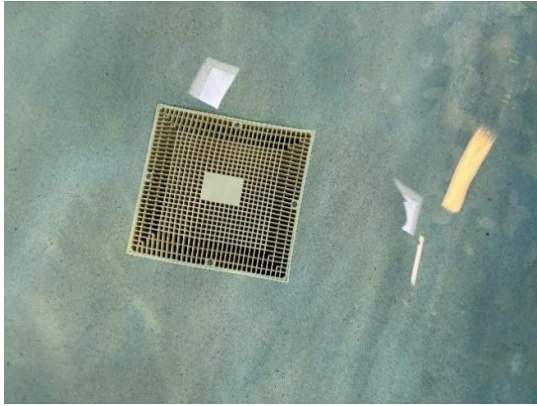
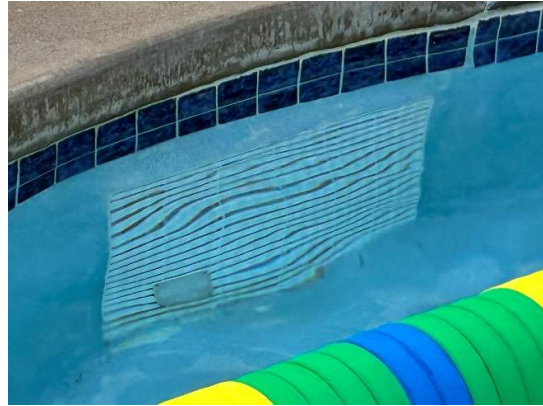
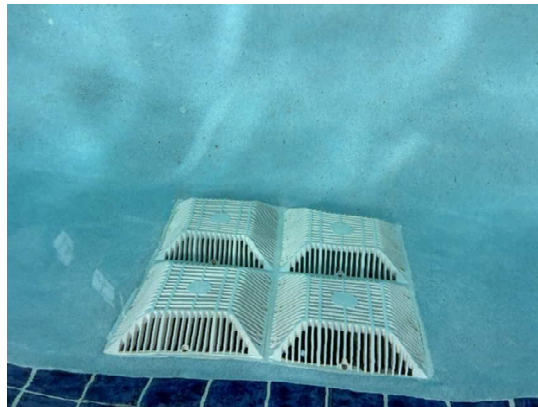
## MAIN DRAINS

The leisure pool includes five (5) 12"x12" recirculation main drains located in the pool floor. The drain grates appear to be 12"x12" MLD-FG-1212-WT by Neptune-Benson. Operations team to confirm.

The pool also has four (4) 9"x9" grates dedicated to the waterslide suction. All grates were observed to be in good condition. However, the sizing of the total grate area does not meet the "unblockable" size described by VGB. Therefore, this grating does not meet VGB without a Safety Vacuum Release System. The waterslide wall sump depth could not be confirmed from existing drawings for VGB compliance. However, the 4" line shown is undersized per Teton Health District Code requirements for pipe velocity.

Verify the lifespan of all grates at the pool and ensure they are replaced at the intervals recommended by the manufacturers described above.

Nearly all pool suction piping is undersized per current codes, and should be upsized during a full pool replacement to accommodate high flow-rate features.

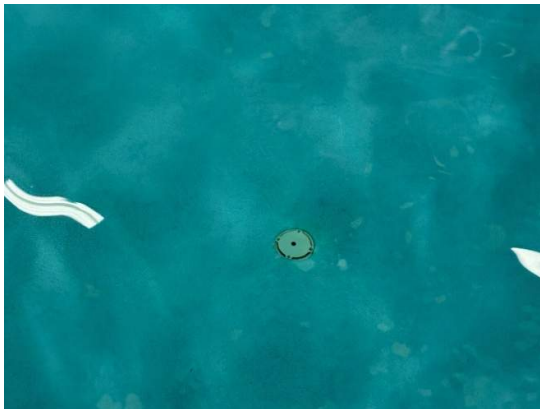
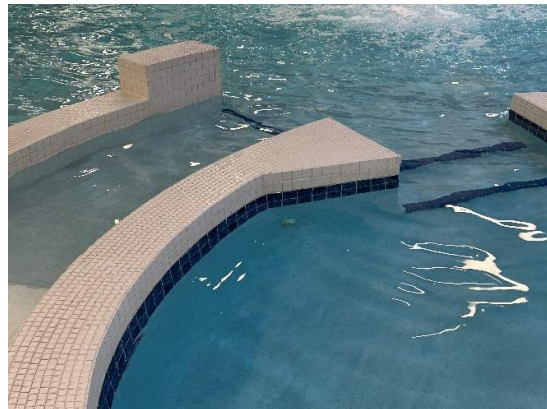
## INLETS

The leisure pool's recirculation system utilizes a combination of ten (10) floor inlets and one (1) wall inlet located in the wading area. C-H observed that the floor inlet nozzles featured various makes and models.

Areas where floor inlets used to be located have been patched in an attempt to remedy water loss that was traced to the return lines. Existing drawings indicate that the floor inlet supply pipes are not encased in concrete and tied to the bottom of the pool structure. This configuration, combined with large amounts settlement of the pool structure (indicated by the out-of-level skimmers) can lead to repeatedly broken pipes.

The differing types of inlet nozzles also suggest a lack of standardization in replacement parts, which can negatively affect the hydraulic balance and overall efficiency of the recirculation system.

Cap the inlets and perform a water tightness test on the pool to determine if the leaks are coming from the structure itself, or the floor inlet supply lines. If the floor inlet supply lines are determined to be the issue, further demolition, repair, and concrete encasement of the lines should take place.

During a pool replacement, ensure that all floor inlet lines are encased in concrete and tied to the underside of the pool structure. This ensures that the structure and all associated piping move as a unit, reducing the chance of breakage.

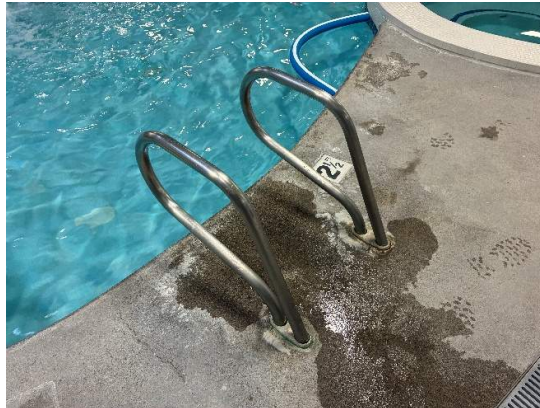
## LADDERS

The leisure pool features two (2) pairs of stainless steel grab rails that were generally observed to be in fair condition. The stainless steel material of the rails themselves appears sound. However, the associated escutcheons (decorative covers where the rail meets the deck) were observed to have visible surface-level corrosion. The grab rails remain secure in their anchors, as they exhibit only a slight, acceptable amount of rocking.

It is important to note that if skimmers are selectively replaced in lieu of a whole pool replacement, these grab rails may also require reconfiguration and replacement.

If rails are not replaced, C-H recommends cleaning and passivating all stainless-steel grab rails and escutcheons to inhibit future corrosion and extend the life of this equipment.

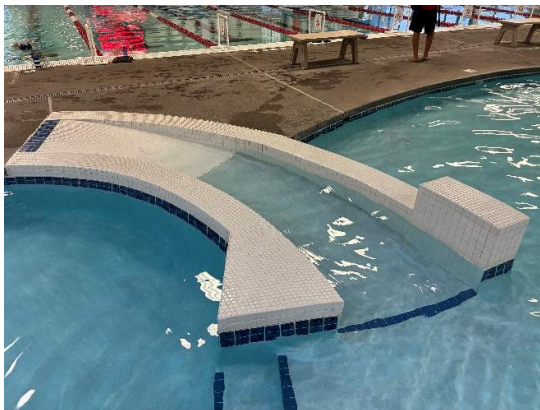
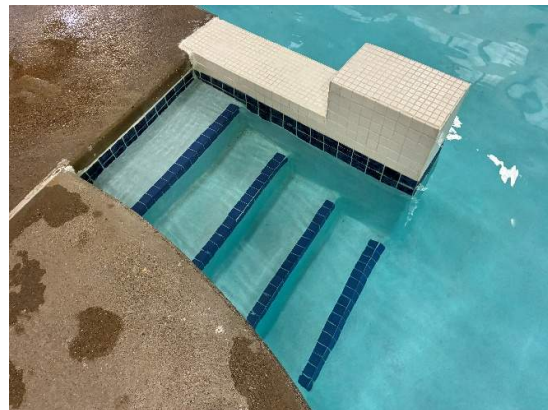
## INGRESS AND EGRESS

The leisure pool's means of entry and exit do not meet current ADA compliance requirements. Since the pool perimeter is under 300', one primary means of accessible entry/exit must be provided (a ramp or a pool lift). While a ramp is an acceptable means of primary access, the existing one is missing required handrails, and it has a cross slope which is not allowed for ADA access. Due to the short set of stairs into the wading area, the ramp does not serve as the primary ADA "beach entry" access for the wading area either.

One traditional stair entry into the leisure pool is present and appears to be in fair condition, but it does not have handrails. Both the Teton Health Code and MAHC require stairs to be equipped with at least one handrail for safe use.

Handrails should be installed at the stair-entry during the next repair/renovation.

Upon pool replacement, ensure that the requirements for ADA access are met, and intermediate stairs are excluded from the pool design to comply with the MAHC.

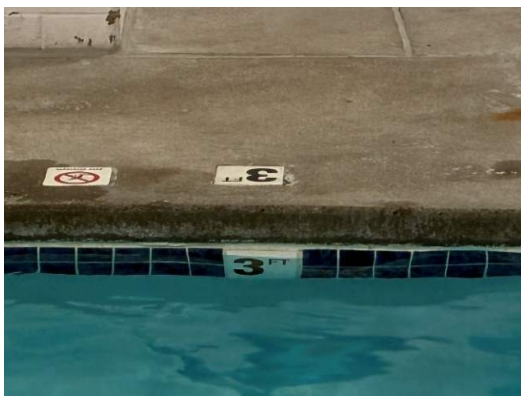
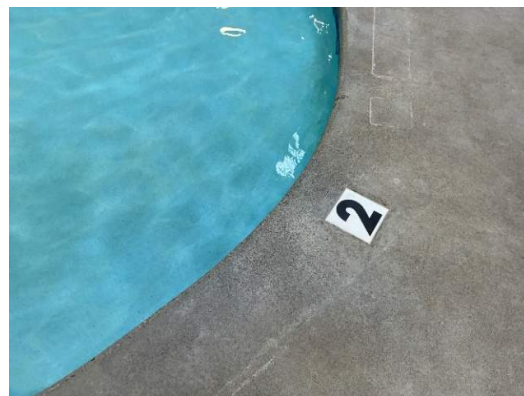
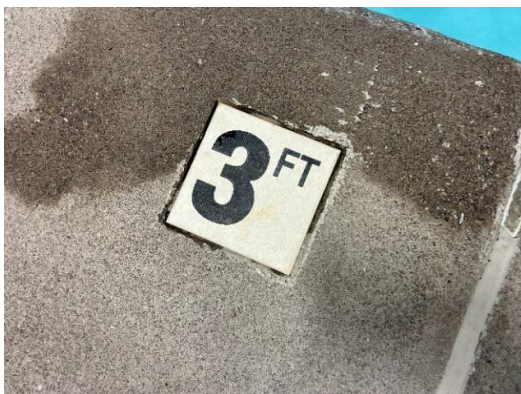
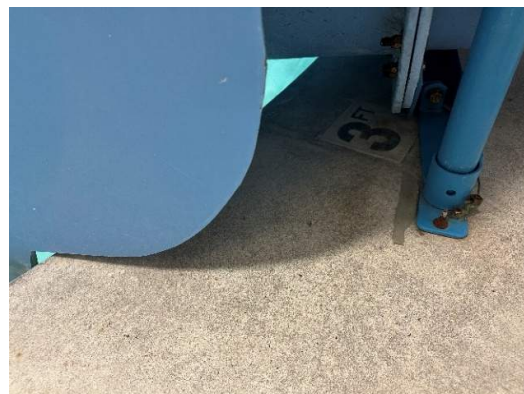
## WARNING SIGNS AND DEPTH MARKERS

The leisure pool currently features tile horizontal and vertical depth markers and vinyl "NO DIVING" warning markers. While the depth markers and warning signs were generally observed to be properly spaced within 25' along the pool perimeter, one marker was hidden beneath the slide flume.

C-H also observed near the wading area that some depth markers are not descriptive, lacking any units to specify what the numeral represents. The vinyl "NO DIVING" markers affixed to the pool deck were observed to be peeling off in certain areas, compromising their visibility and function. All non-compliant and damaged markings must be corrected or replaced to ensure patron safety and adherence to all applicable codes.

C-H recommends replacing all non-descriptive depth markers with markers that display both a number and units to patrons. Any peeling "NO DIVING" should be replaced as needed or permanently replaced with tile.

For a new pool, ensure that all depth markers and warning signs are descriptive, placed on both vertical and horizontal surfaces, have text at least 4" tall, and include the international "NO DIVING" symbol.

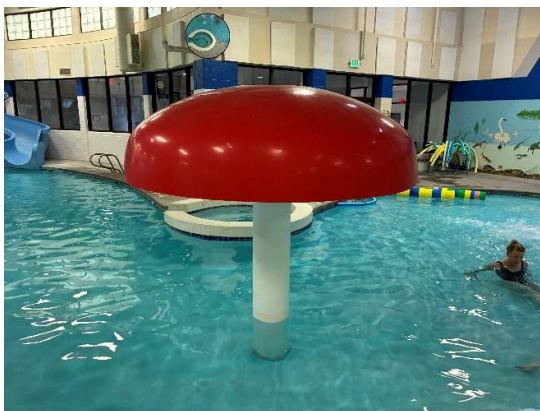
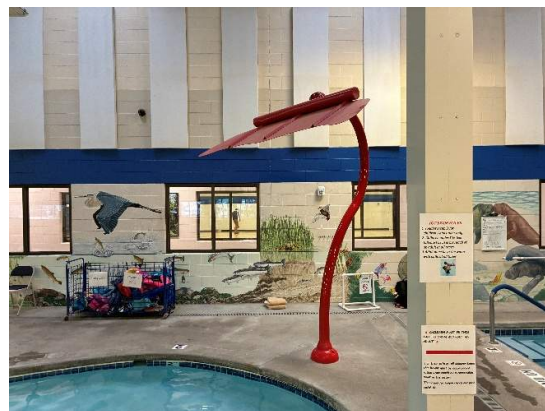
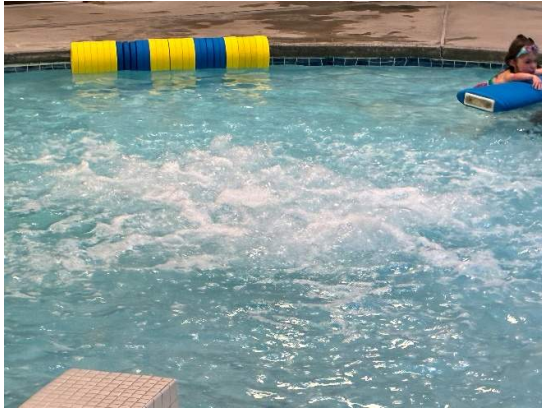
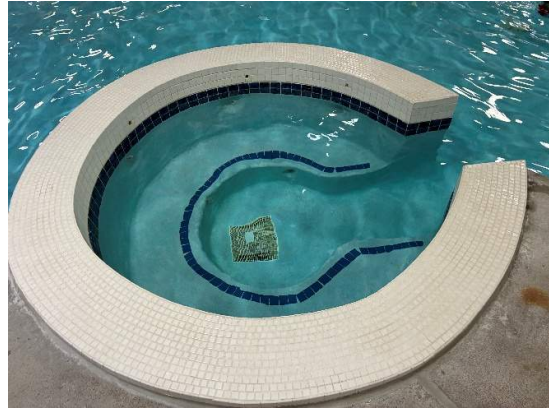
## FEATURES

1. Vortex: A small vortex pool feature is present but has not been functioning within the recent memory of staff. This feature has multiple inlets above the water level that are currently not operational. The piping in the mechanical room was observed to be disconnected.
2. Whale Tail Feature: This feature, which replaced a previous rockwork waterfall feature, is in similar condition to the umbrella feature; the coating is in good shape, but the feature does not work due to operational issues. The piping in the mechanical room was observed to be disconnected.

3. Bubbler Feature: A bubbler feature is present and was observed to be working during the site visit. An air blower is present for this feature in the mechanical room.
4. Mushroom Waterfall Feature: This feature was observed to be in fair condition, with the coating showing little discoloration or deterioration. Ownership did not note any issues with this feature, though C-H did not confirm the functionality on site. The piping was observed to be properly connected in the mechanical room.

C-H recommends repairing the pump for the whale tail and vortex bench, and resuming operation. Ensure that all pumps within the leisure pool are tied to a functioning and operational SVRS system.

**All feature pumps implemented in a new pool should have their own dedicated suction line. Ensure that pipes and sumps are adequately sized for modern codes such as VGB and MAHC.**

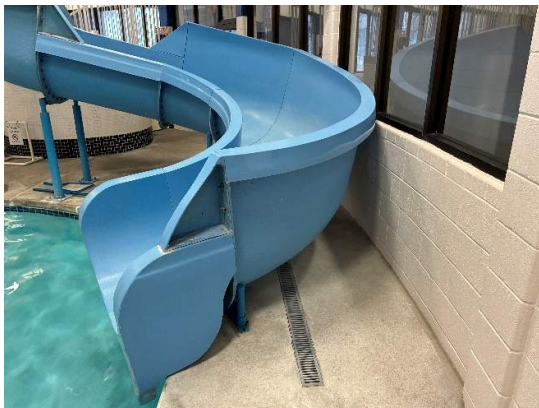
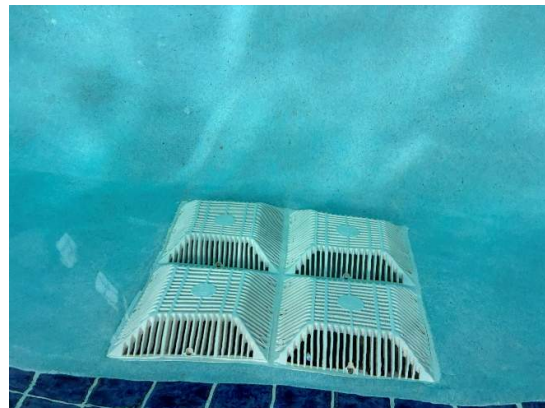
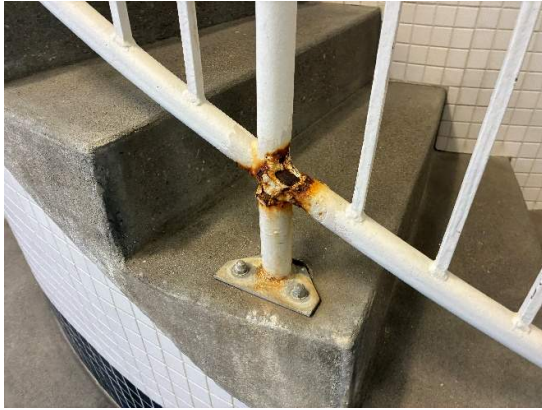
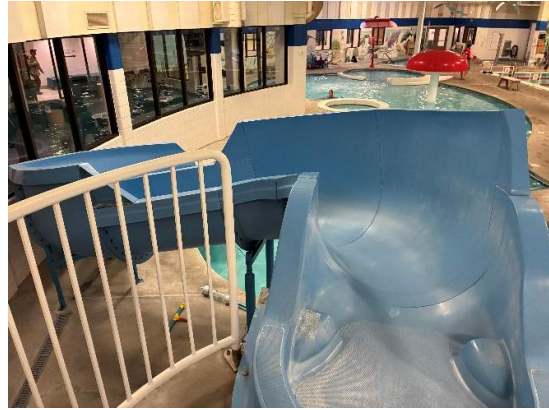
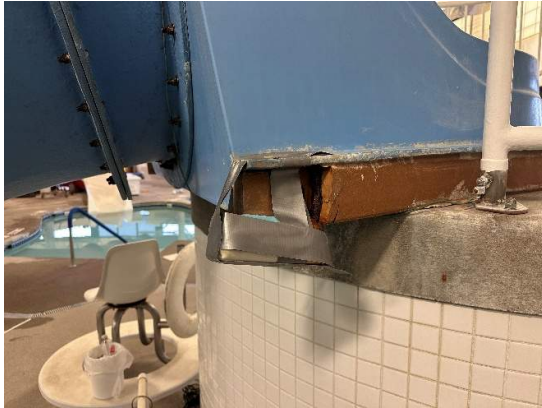
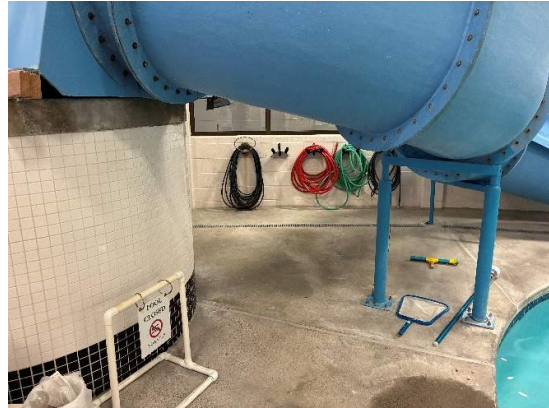
## SMALL WATERSLIDE

The leisure pool is equipped with one small blue waterslide that was observed to be in fair to poor overall condition. While the coating on the fiberglass flume was in fair condition—only showing discoloration and surface staining since the renovation in the 2010s—the slide presents numerous structural and safety deficiencies. A primary structural concern noted was that the slide start tub was placed over a wood plank and was overhanging the concrete support structure.

The support structure itself was in poor condition, featuring visibly rusted railings and areas where the protective coating was completely removed. Furthermore, the structure presents a safety hazard as children are able to walk underneath it and hit their heads on fiberglass and support. C-H observed that padding was duct-taped onto the slide in these low-clearance areas, suggesting that previous incidents may have occurred.

If the waterslide is to remain, C-H recommends contacting a waterslide restoration company, such as SafeSlide or SlideRenu for renovation services. Contact information for these companies will be provided in Appendix A.

Future facility plans should accommodate code-required deck widths for waterslide ride paths around the pool. An E-stop should be designed at the top of the slide tower in future facility plans.

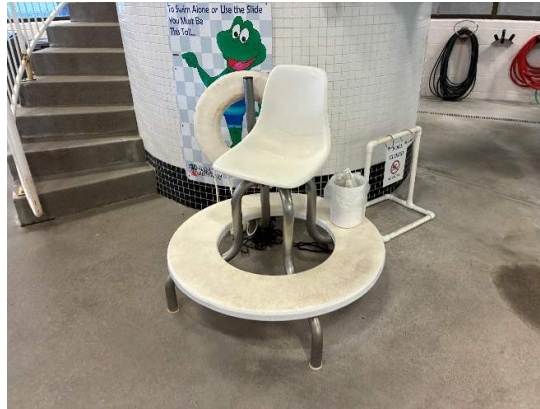
## DECK EQUIPMENT

C-H observed one (1) lifeguard chair that serves the leisure pool, spa, and splash pool. It was observed to be in good condition.

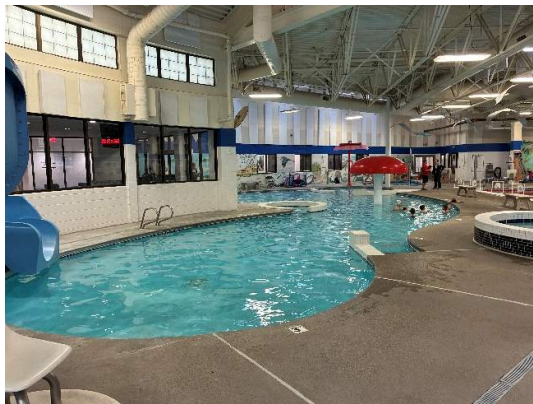
## POOL DECK

As a "general use" pool in a public facility, the leisure pool is subject to the Teton Health District Code requirement mandating a minimum of 8' of unobstructed deck clearance around the entire perimeter of the pool vessel. C-H observed that the leisure pool is in violation of this requirement. C-H observed numerous areas where the available deck clearance was far less than the required 8'.

Nothing can be done immediately to completely correct this code-compliance issue.

In future pool renovations, deck clearances must be considered to adhere to all applicable code requirements.

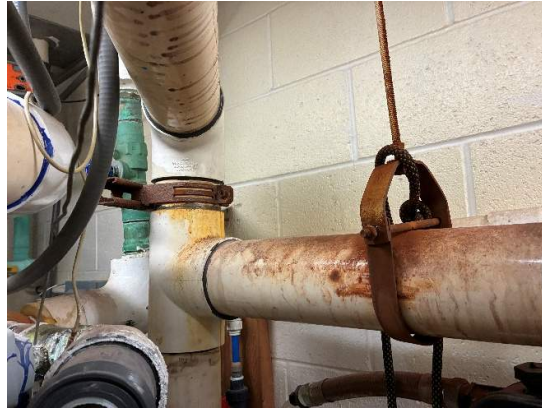
## PIPING

The bulk of the visible recirculation system piping uses Schedule 40 PVC piping, which is less robust than the Schedule 80 PVC typically recommended by modern aquatic industry standards for all exposed pool piping. This includes the influent and effluent heat exchanger piping (which was observed to be copper) whereas modern industry standards recommend Schedule 80 CPVC due to its superior heat tolerance. The presence of some acceptable Schedule 80 PVC fittings/piping in the UV bypass and elsewhere throughout the system suggests recent, post-original-construction repairs by diligent staff. Furthermore, the piping supports were observed to be corroded and rusted, indicating a need for maintenance or replacement to ensure long-term integrity and proper alignment of the plumbing runs.

The piping system lacks essential identifiers: no color-coded arrows were observed indicating the direction of flow, which violates both Teton Health District code (requiring arrows) and MAHC (requiring colored arrows). Additionally, no posted piping and system schematic was observed in the mechanical room, which does not adhere to both Teton Health District Code and MAHC.

C-H observed that the water chemistry controller sample cell effluent line was upstream of the filter. This should be located downstream of the filter to prevent clogging.

C-H recommends color-coded arrows be applied on all recirculation pipes per the interval listed in the MAHC. A detailed system schematic (flow diagram) must be posted in the mechanical room to adhere to both the Teton District Health Code and the MAHC.

C-H recommends replacing all existing SCH 40 piping with SCH 80 piping throughout the mechanical room for improved longevity. The influent and effluent piping running from the heat exchanger should be replaced with SCH 80 CPVC piping to adhere to modern industry standards. In conjunction with the piping replacement, all existing pipe supports should also be replaced.

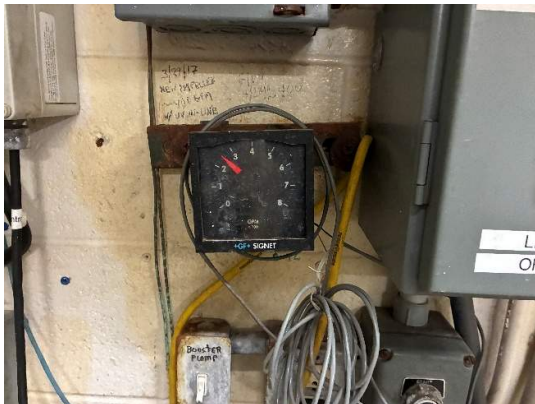
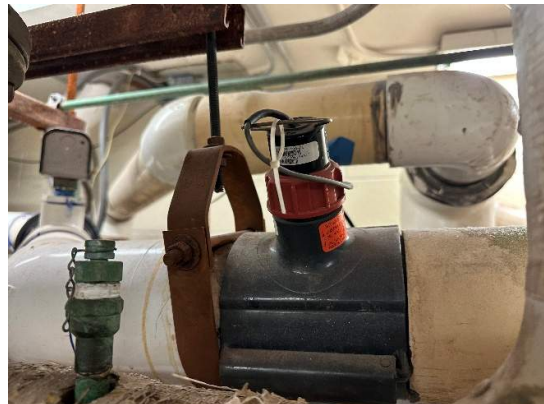
## FLOW METERS

One (1) Signet rotary flow meter was installed on the leisure pool piping, which is accurate enough, installed appropriately, and is acceptable per all code requirements.

During a full pool mechanical room replacement, ensure a 4-20mA signal Signet MagMeter is included to allow for feedback control with recirculation pump VFDs. This leads to significant energy savings following filter tank backwashing.

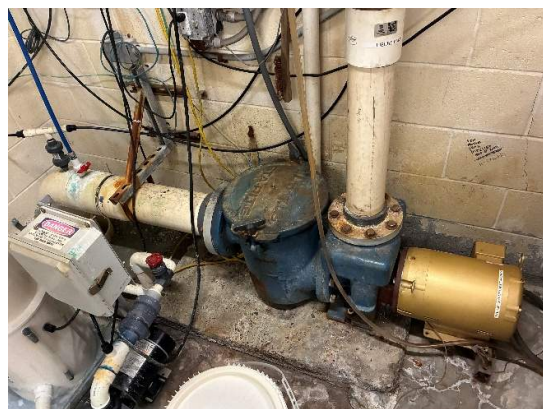
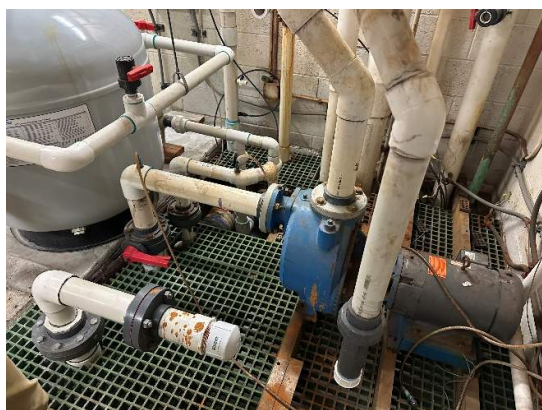
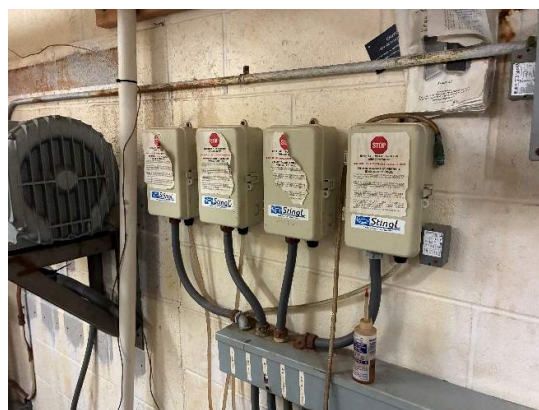
## PUMPS

The leisure pool recirculation system is driven by a Sta-Rite CSP pump paired with a 15 HP, 460V Baldor Reliance motor, and an aging Sta-Rite strainer. The pump was replaced in 2023. The flow rate varies widely on this system according to staff, from 250gpm to 500gpm based on how recently the filter has been backwashed. The lowest level, 250gpm is acceptable for an activity pool turnover, roughly equating to 2 hours. Operation staff noted that the pump is cavitating (suggesting air intrusion or insufficient supply-side pressure) which causes the impeller to degrade prematurely, requiring frequent replacement.

The recirculation pump is not located within a pump pit and therefore does not achieve the industry-preferred condition of flooded suction (where the pump intake is below the pool's water level by at least 2'). The elevation of the pump compared to the pool water level is contributing to cavitation and is straining the motor. The pump's strainer is not adequately supported by a housekeeping pad.

The pumps are missing pressure and vacuum gauges, which are required by MAHC. These measure the pressure differential across each pump, which gives the operator insights into the flow rate of the pool system, power consumption, as well as performance of each pump.

The pumps do not include VFDs, which would allow for speed adjustments to optimize flow, reduce energy consumption, and manage pressure spikes that can damage equipment.

In conjunction with a full pump replacement, C-H recommends that both pumps should be installed within the existing pump pit, or the existing balance tank should be converted to an additional pump pit vault. Leaks would need to be sourced if the pump was placed within the balance tank.

Upon installation of the pumps, pressure and vacuum gauges should be installed to meet the MAHC requirements for system monitoring. Furthermore, VFDs should be implemented on each pump, but especially the recirculation pump to allow the system to run more efficiently, save energy, and extend the lifespan of the new pump motor.

In conjunction with a pool replacement, a larger pump pit should be installed to allow each operating pump to be placed below water level. Each pump should be provide with service valves, pressure gauges, a VFD, and proper housekeeping pad support.

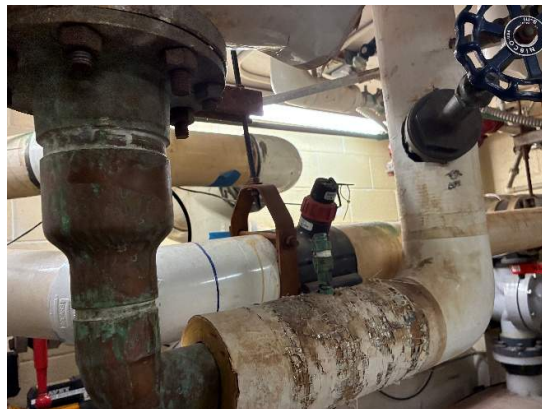
## VALVES AND FLANGES

The valves and flanges throughout the mechanical room were observed to be in fair to poor condition. Many of the installed valves are a Schedule 40 PVC material, whereas modern aquatics industry standards recommend the use of more durable Schedule 80 PVC for this critical mechanical room application.

It is important to note that an isolation valve is missing on the main drain line connecting to the leisure pool recirculation pump. This is a critical valve that allows for important servicing, leak testing, pipe pressure testing, and more.

C-H recommends installing valve tags on all valves within the leisure pool mechanical room, and providing a corresponding detailed valve chart to assist staff in diagnosing and remedying future maintenance issues easier.

C-H recommends replacing all SCH 40 valves and flanges with SCH 80 components to adhere to modern industry standards for increased durability and pressure resistance. All valves and flanges on the influent and effluent heater lines should be replaced with SCH 80 CPVC.

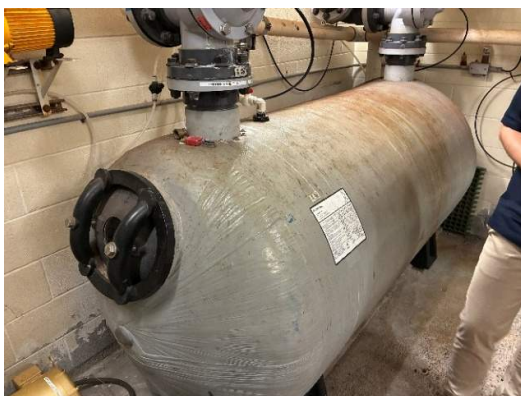
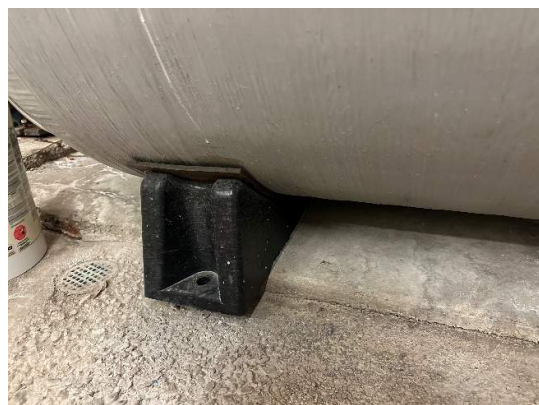
## FILTRATION EQUIPMENT

The leisure pool utilizes one (1) Stark SA96 filter system with semi-automatic backwash functionality. The filter system was observed to have a manual air relief system present, which satisfies the requirement set forth by MAHC for safe operation.

Ownership reported that when the backwash cycle is performed for an excessive duration, sanitary waste line backs up, indicating an undersized or blocked backwash waste line. It should be noted that the original design documents included three (3) filter tanks, and the original sanitary capacity may have been sized for smaller tanks. This is likely the reason that a single tank overwhelms the sanitary line during backwash if a blockage is not present.

The filter backwash system is a semi-automatic method, relying on actuated valves to operate. Staff noted that these valves break down easily and require repairs often.

C-H recommends switching to a multiple tank filter system during a pool mechanical room renovation. 30" diameter vertically oriented tanks should be used to ensure ceiling heights and door clearances can be maintained. The new face piping should include manual backwash valves which will reduce the repair frequency required by staff.

Utilization of glass filter media and an electronic flocculant (such as Clear-Flow) would further increase the quality of the sand filtration at the leisure pool.

Alternatively, a regenerative media filtration system could also be explored for additional cost.
