The purpose of this workshop is to present the findings of the Counsilman-Hunsaker (CH) Aquatics Commissioning Report, review the condition and remaining service life of the Teton County / Jackson Recreation Center aquatic facilities, discuss current maintenance efforts, and obtain policy direction regarding future aquatics planning.

CH was retained to perform an independent assessment of the Recreation Center aquatic facilities, associated mechanical systems, and long-term capital needs. The assessment documents existing conditions, identifies code and operational deficiencies, estimates short-term investments necessary to maintain operations, and outlines long-term replacement considerations.

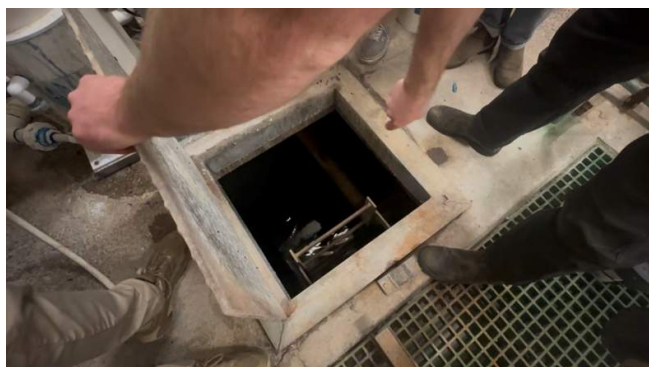
## EXISTING LEISURE POOL BALANCE TANK

C-H observed a tank below the leisure pool mechanical room floor slab, accessible through an aluminum floor hatch. Both the skimmer and main drain suction lines pass through this tank before reaching the pump, but they lack any float valves, or isolation valves that would suggest a functional interaction with the vessel. Because the leisure pool utilizes a skimmer system, the pool structure inherently provides built-in surge capacity, rendering a surge tank useless. In modern aquatic design, suction lines from skimmers and main drains are simply connected at a tee prior to the pump and are managed via throttling/isolation valves within the mechanical room, entirely bypassing the need for an intermediate tank. Facility staff reported needing to occasionally pump the water out of the tank manually with a sump pump. The source of the water within the tank is unknown. According to the existing drawings, the original design of this tank was to be a balance tank, and the skimmers were to be gravity-flow. However, the skimmers are now connected directly to the pump, as required for the use of an SVRS.

C-H recommends the specific source of the facility's ongoing water loss be determined. C-H recommends draining the water completely out and drying the tank, and then thoroughly searching for the water ingress point.

If the tank can be made watertight, C-H suggests that the top of this tank at the mechanical room grade could be removed. This modification would allow the floor of the vessel to be utilized as a dedicated pump pit, enabling the leisure pool recirculation pump to be relocated to a lower elevation where it can receive a flooded suction. Transitioning to a flooded suction configuration would eliminate current priming issues and prolong the life of the leisure pool pump motor and impeller.

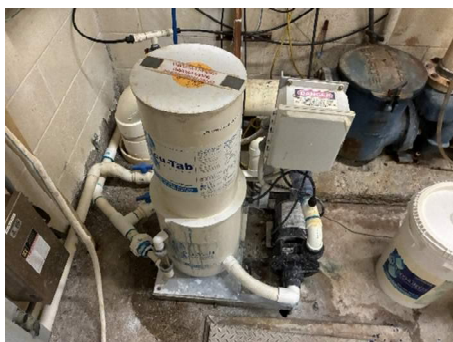
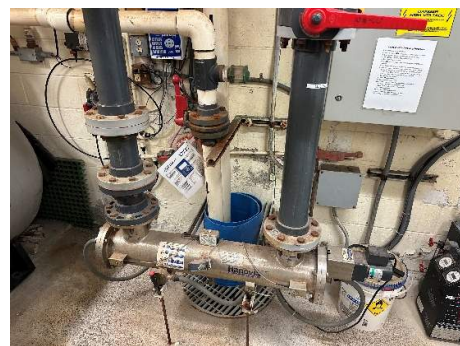
## CHEMICAL TREATMENT

The leisure pool utilizes an Accu-Tab 1030 sanitizer system and booster pump for primary water treatment, which was observed to be in fair condition. The feed lines were observed to be clear and properly feeding the system, with no signs of excessive clogging or degradation.

Using muriatic acid as the sole pH buffer is a common and effective industry practice for lowering pH in commercial pools. However, it quickly reduces the pool's total alkalinity (TA), which is the water's natural buffering capacity. Low TA can lead to unstable pH (known as pH "bounce") and corrosive water. If the fill water has a higher TA, then this standalone system is sufficient.

If water chemistry management has been an ongoing concern for Ownership, which may be the case based upon observed amounts of sodium bicarbonate on-hand, C-H recommends a comprehensive domestic water analysis be performed to evaluate the facility's potable source water. The results of this analysis are critical for understanding the baseline alkalinity and mineral content, which directly influence the stability of the pool's pH. Depending on these findings, the integration of a carbon dioxide or sodium bisulfate system could be utilized to supplement the existing muriatic acid system, providing superior water quality to the facility.

C-H recommends that the bulbs are replaced, and the Hanovia UV system is restarted. Secondary sanitation reduces the amount of chloramines produced by a pool, which can greatly improve the environment of a natatorium. In addition, the UV system kills chlorine resistant threats such as legionella and cryptosporidium.

**With a full facility replacement, provide a centralized pool mechanical room for all bodies of water. This will reduce the amount of muriatic acid lines traveling throughout the facility, which will therefore reduce the risk of harmful chemical leaks.**

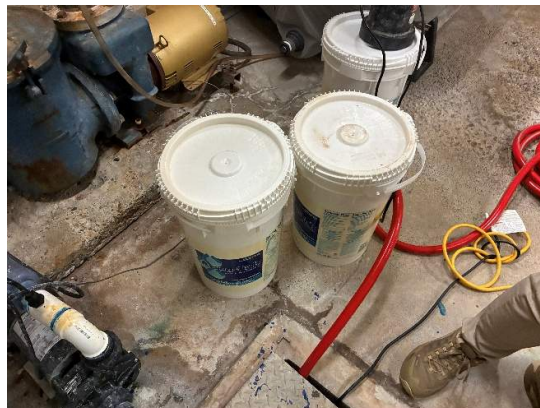
## CHEMICAL STORAGE

The leisure pool lacks a dedicated, fire-rated chemical storage space, resulting in hazardous storage practices throughout the facility. During the inspection, chemicals were observed stored within the general mechanical room. This arrangement presents a fire and explosion hazard and directly violates IFC, which mandates that pool chemicals (specifically calcium hypochlorite) be stored in a segregated, ventilated, and properly rated environment to prevent dangerous reactions or interference with electrical infrastructure.

Furthermore, the required NFPA diamond signage is not present on the mechanical room doors. While these storage conditions are substandard, the facility is in compliance with the MAHC regarding immediate first aid, as a functional emergency eyewash unit was observed and accessible within the pool mechanical room space.

Provide fire rated cabinets within the space for storage of calcium hypochlorite to mitigate fire hazards. These cabinets will double the amount that is allowed to be stored within the space without becoming a hazard classification per the IFC.

Provide NFPA diamond signage on the mechanical room door.

During a future full mechanical room renovation, C-H recommends that separate, properly fire-rated rooms be constructed to house chemicals and their respective feed systems, ensuring adequate segregation for safety.

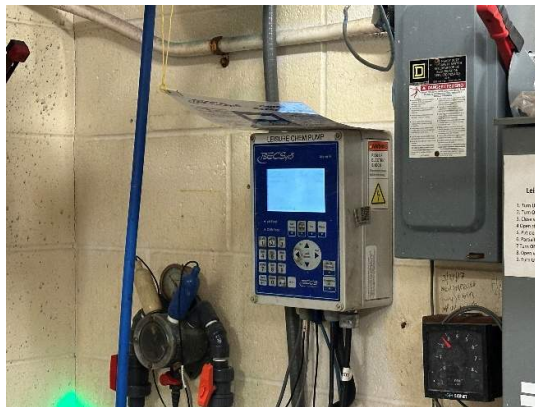
## WATER CHEMISTRY CONTROLLER

The leisure pool's water chemistry is monitored and controlled by one (1) BECSys5 water chemistry controller. This unit was observed to be in good condition and reported to be working properly.

If recirculation pump interlocks are not already in place for calcium hypochlorite and muriatic acid, consult with an electrical contractor to ensure that these interlocks are installed.

With a new pool, provide a more complex controller that can integrate with UV systems, dual- pH Buffer, and VFDs, such as the BECSys7.

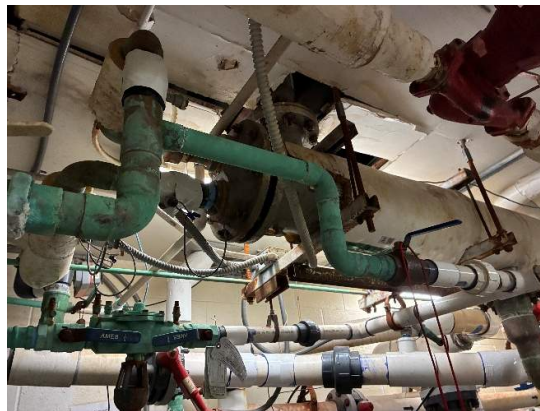
The leisure pool system is currently heated indirectly via a central building boiler/heater that supplies hot water to a dedicated heat exchanger within the pool recirculation system. The current influent and effluent piping is showing signs of aging and corrosion.

Based on past experiences, C-H does not recommend reimplementing the solar tube heating system for any of the existing pools. The system should be decommissioned and disconnected during the next significant repair/renovation.

All aging influent/effluent heater lines should be replaced with SCH 80 CPVC during the next significant amount of pool mechanical room work.

There is not enough room for a standalone leisure pool heater in the case of a renovation. Therefore, during a future facility replacement, C-H recommends providing each pool recirculation system with its own dedicated heater. Standalone systems provide a level of redundancy for facilities with multiple bodies of water.

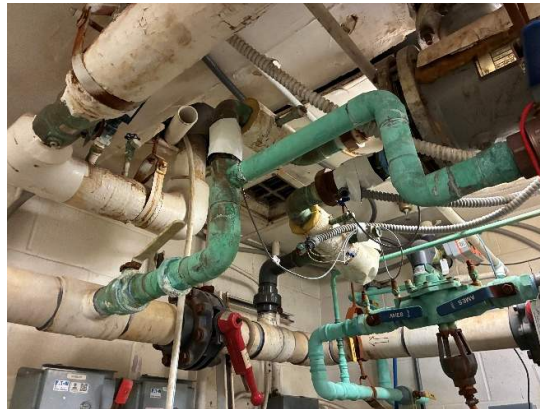
The leisure pool currently utilizes a manual fill system for make-up water, which C-H observed inside the mechanical room tee'ing into the heat exchanger piping. The domestic water valve is left cracked open to offset the constant water loss from the leisure pool structure.

While an automatic system is not required by code, a manual system introduces the risk of the water level falling too low, and the skimmers potentially drawing air into the pool's recirculation pump and causing damage.

The make-up water line should be re-routed to the main recirculation line in lieu of the piping connected to the pool's heat exchanger.

An automatic water level control system is a more complex addition to skimmer pools when compared to pools that have in-mechanical room surge tanks. An abandoned supply or suction line would need to be re-used to create a "wet-well" in the mechanical room in which sensors can be placed. Otherwise, the deck would need to be torn out in order to route pipe or conduit back to the pool mechanical room.

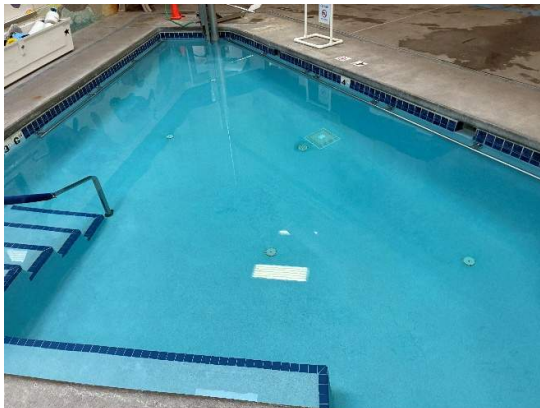
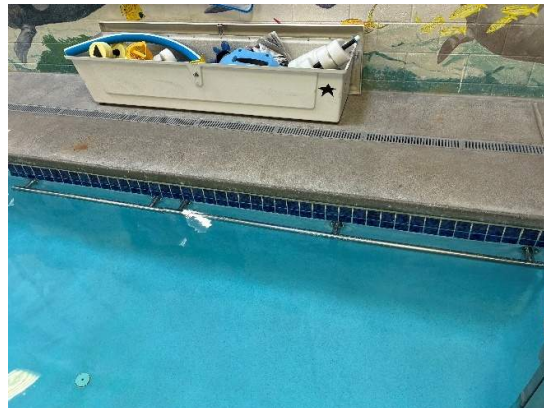
## STRUCTURE AND FINISH

It may be ideal to plan for a re-plaster of the therapy pool if any other pools within the facility are being re-plastered, to get some "economy of scale" on contractors mobilizing to do the work.

While water loss has not been a problem at the therapy pool, staff should consider performing a water tightness to assess the true condition of the structure. Refer to Appendix B for the water tightness test procedure specified by C-H during new construction projects.

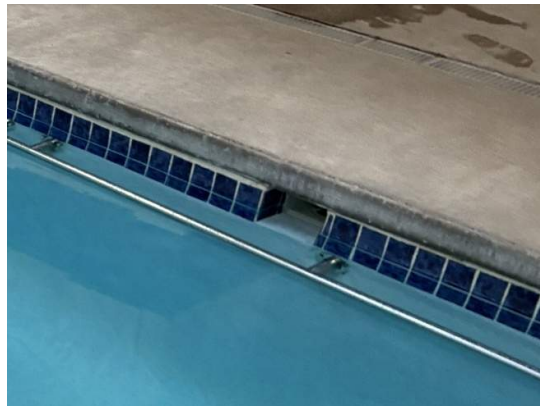
The therapy pool utilizes a skimmer system for perimeter overflow, consisting of two (2) skimmers total, which meets the quantities required by code. However, the therapy pool skimmer suction pipe size does not meet the velocity requirements per Teton Health District Code.

While a basket was present in each skimmer unit, no weir or deck access lid was observed on any of the skimmers. A weir is required per MAHC to ensure proper surface skimming and flow adjustment. A lifeguard reported that to clean out the skimmer baskets, staff must reach into the skimmer opening. This is an atypical operational practice stemming from the missing access lids, which are standard on commercial grade skimmers. Additionally, the skimmers are not listed with NSF-50, which violates Teton Health District Code.

The pool deck and skimmers must be cut out and replaced to meet more modern aquatic codes.

**C-H recommends removing and replacing the entire pool to ensure proper perimeter overflow and gutter system code compliance.**

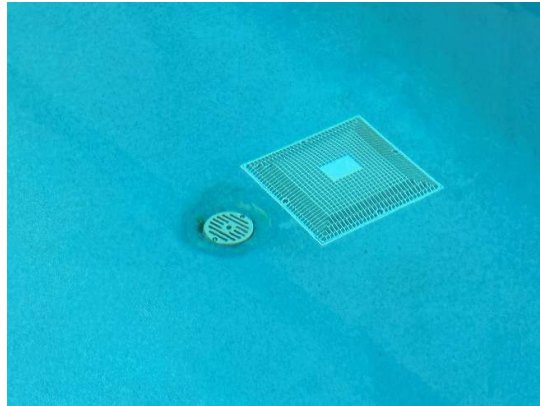
The therapy pool includes one (1) 12"x12" recirculation main drain located in the pool floor. The drain grates appear to be 12"x12" MLD-FG-1212-WT by Neptune-Benson. Operations team to confirm.

Verify the lifespan of the grate at the pool and ensure they are replaced at the intervals recommended by the manufacturers described above.

With a new pool design, provide two (2) main drain grates to adhere to VGB without relying on a SVRS at the recirculation pump.

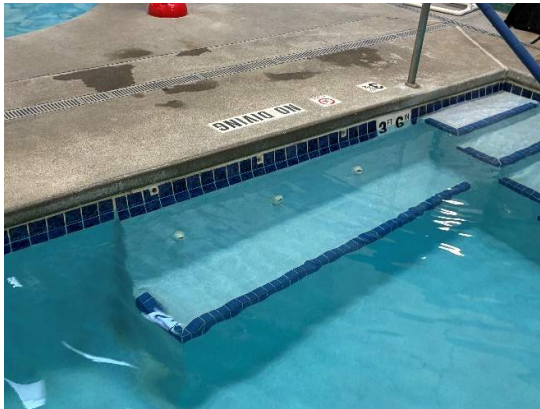
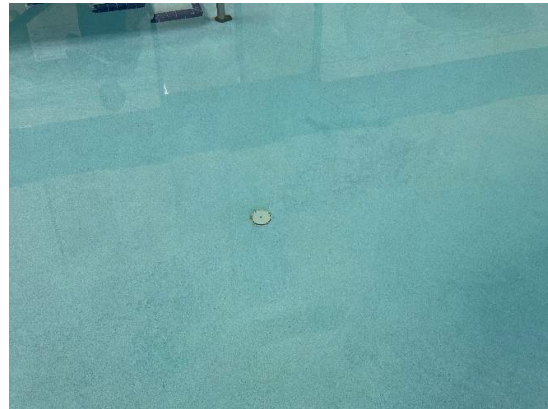
The therapy pool recirculation system utilizes five (5) floor inlets and various dysfunctional hydrotherapy inlets. It was observed that one of the floor inlet's nozzle featured a different make and model from the others.

Connect the 4" main drain suction line and the 2.5" jet pressure line to a new pump to restore functionality to the hydrotherapy jets.

With a new pool design, do not consolidate the recirculation and hydrotherapy bench onto the same pump as shown on the existing drawings. These uses have very different pressure requirements due to the filter on the recirculation line.

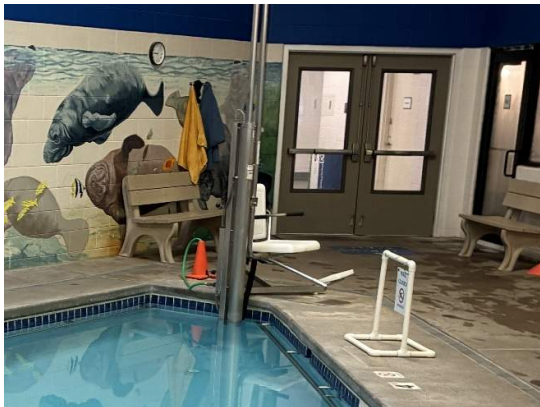
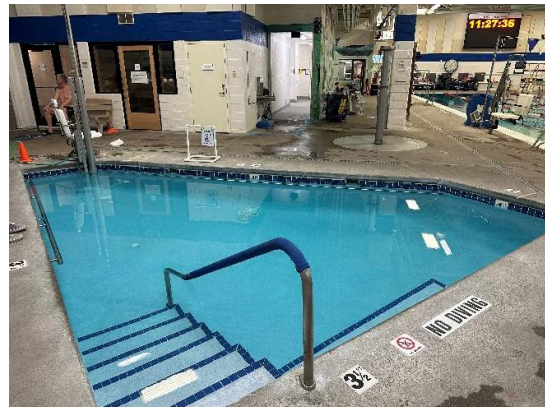
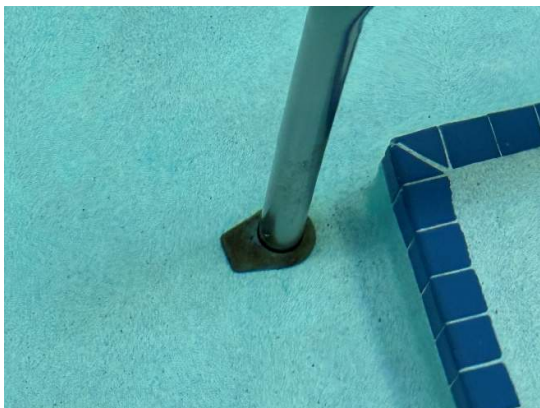
The therapy pool meets the minimum accessibility requirements set forth by ADA. A hydraulic pool lift was observed on site and is in operating condition. Since the pool perimeter is under 300', the presence of this single lift fulfills the ADA requirement for one primary means of entry.

For general ingress/egress, a stair entry with a handrail is present on the south end of the pool with a handrail, which adheres to the Teton District Health Code. The stainless steel of the stair handrail and the internal grab rails within the pool were observed to be in good condition. However, the escutcheon within the pool for the stair handrail showed visible signs of corrosion.

Therapy rails are provided for use on several sides of the pool. These rails appear to be in good condition.

C-H recommends cleaning and passivating the ADA lift, stair handrails, therapy rails, and escutcheons to mitigate further corrosion and extend service life.

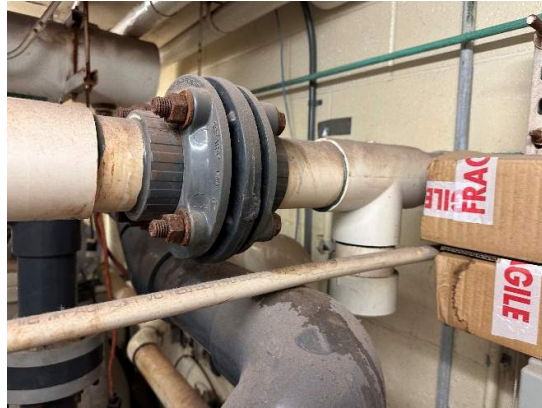
The bulk of the visible recirculation system piping uses Schedule 40 PVC piping, which is less robust than the Schedule 80 PVC typically recommended by modern aquatic industry standards for all exposed pool piping. This includes the influent and effluent heat exchanger piping (observed to be partially copper and partially Schedule 40 PVC) whereas modern industry standards recommend Schedule 80 CPVC due to its superior heat tolerance. The presence of some acceptable Schedule 80 PVC fittings/piping in the UV bypass and elsewhere throughout the system suggests recent, post-original-construction repairs by diligent staff. Furthermore, the piping supports were observed to be corroded and rusted, indicating a need for maintenance or replacement to ensure long-term integrity and proper alignment of the plumbing runs.

The piping system lacks essential identifiers: no color-coded arrows were observed indicating the direction of flow, which violates both Teton Health District Code (requiring arrows) and MAHC (requiring colored arrows). Additionally, no posted piping and system schematic was observed in the mechanical room, which does not adhere to both Teton Health District Code and MAHC.

The suction and pressure piping lines within the system are both 2", which is inadequately sized to meet the velocity requirements per Teton Health District Code at the required flow rates for the pool.

C-H observed a capped PVC tee after the heating lines. Staff were unable to confirm the function of this tee. However, since a sanitation system is not being utilized for this pool, it is CH's assumption is that this tee was used to supply water for a sanitation system that has since been removed.

C-H recommends piping for this system should be upsized from 2" SCH 40 PVC to 3" SCH 80 PVC wherever possible within the pool mechanical room space to meet code. Re-install all chemical treatment systems.

C-H recommends color-coded arrows be applied on all recirculation pipes per the interval listed in the MAHC. A detailed system schematic (flow diagram) must be posted in the mechanical room to adhere to both the Teton District Health Code and the MAHC.

C-H recommends replacing all existing SCH 40 piping with SCH 80 piping throughout the mechanical room for improved longevity. The influent and effluent piping running from the heat exchanger should be replaced with SCH 80 CPVC piping to adhere to modern industry standards. In conjunction with the piping replacement, all existing pipe supports should also be replaced.

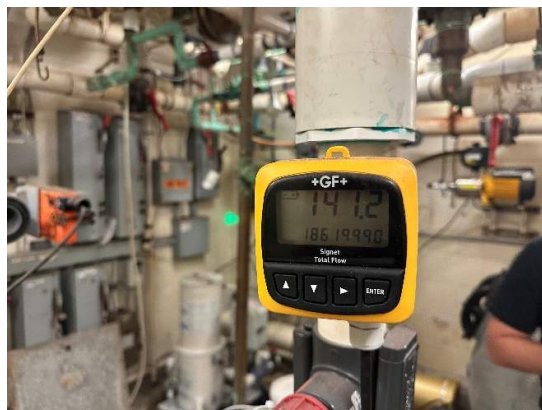
One (1) Signet rotary flow meter was installed on the therapy pool piping, which is accurate enough, installed appropriately, and is acceptable per all code requirements.

Ensure that a 1-hour minimum turnover rate is specified on any new therapy pool design.

During a full pool mechanical room replacement, ensure a 4-20mA signal Signet MagMeter is included to allow for feedback control with recirculation pump VFDs. This leads to significant energy savings following filter tank backwashing.

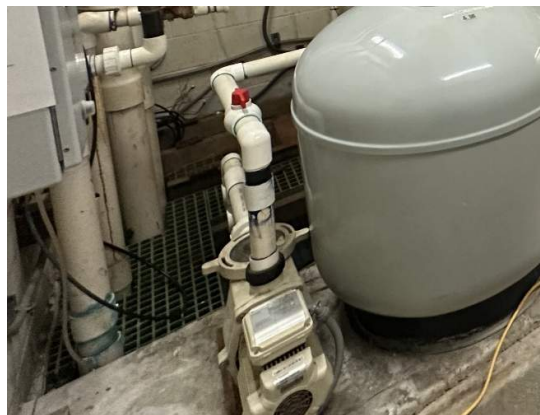
The recirculation system for the therapy pool is driven by a 2 HP Whisperflo pump, which was observed to be in good condition. This type of pump features both an integrated strainer and self-priming capabilities. The pump was observed to be missing both the suction and pressure gauges which does not meet MAHC requirements. This prevents operators from accurately monitoring the system's total dynamic head (TDH), diagnosing performance issues, and confirming the pump is operating within its anticipated flow range.

Provide pressure and vacuum gauges for all therapy pool pumps.

Install both the recirculation pump and the hydrotherapy pump within the pump pit to allow for a flooded suction condition.

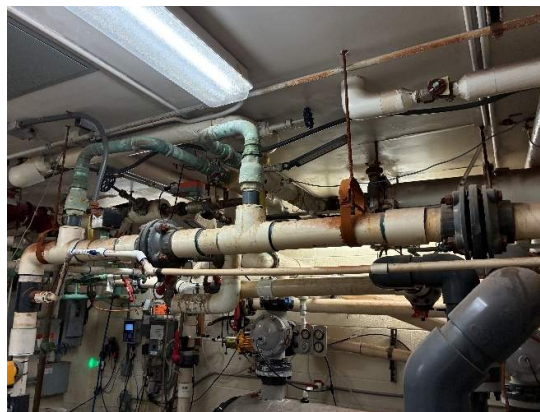
The valves and flanges throughout the mechanical room were observed to be in fair to poor condition, except for a few SCH 80 PVC valves shown in the picture below. Many of the installed valves are a Schedule 40 PVC material, whereas modern aquatics industry standards recommend the use of more durable Schedule 80 PVC for this critical mechanical room application.

C-H recommends installing valve tags on all valves within the therapy pool mechanical room, and providing a corresponding detailed valve chart to assist staff in diagnosing and remedying future maintenance issues easier.

C-H recommends replacing all SCH 40 valves and flanges with SCH 80 components to adhere to modern industry standards for increased durability and pressure resistance. All valves and flanges on the influent and effluent heater lines should be replaced with SCH 80 CPVC

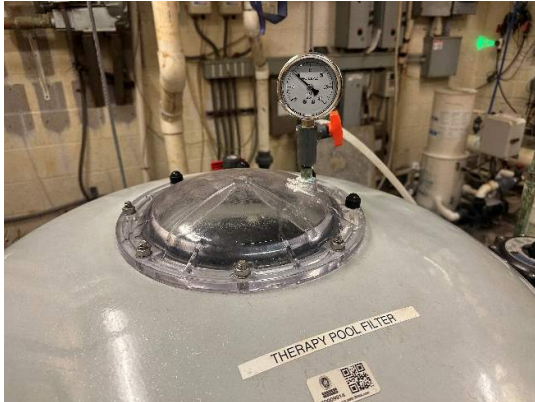
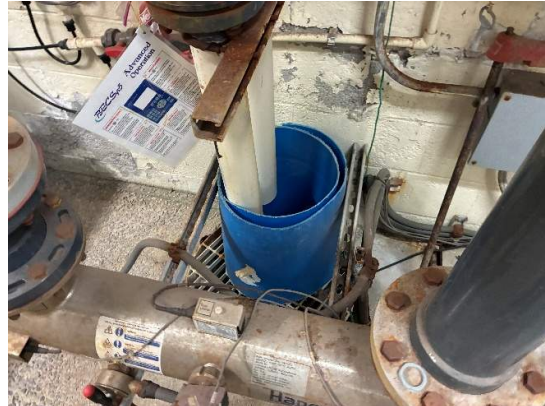
The therapy pool is serviced by a single Hayward HCF236 high-rate sand filter, which was installed within the last few years. The unit is equipped with proper gauges and air relief piping, which are essential for monitoring filter performance, determining the total dynamic head (TDH), and safely releasing accumulated air during operation or start-up.

Operationally, the system maintains adequate function. However, the facility staff noted that this filter is more difficult to service as it is the only Hayward filter at the facility.

Replace the Hayward filter with a Pentair Triton TR140. This is the same form/function as the Hayward filter, but it will be easier for staff to service based on vendors in the area.

During a facility replacement, ensure the designer understands parts and products that are readily available in the area for easier service and upkeep.

Utilization of glass filter media and an electronic flocculant (such as Clear-Flow) would further increase the quality of the sand filtration at the therapy pool.

Alternatively, a regenerative media filtration system could also be explored for additional cost.

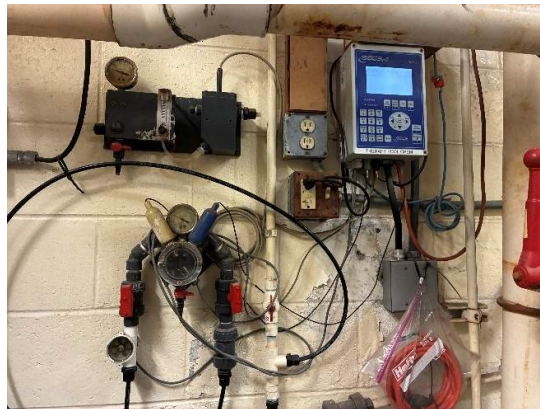
The therapy pool's water chemistry is monitored and controlled by one (1) BECSys5 Water chemistry controller. This unit was observed to be in good condition and reported to be working properly, with the exception of the missing sanitizer system.

If recirculation pump interlocks are not already in place for calcium hypochlorite and muriatic acid, consult with an electrical contractor to ensure that these interlocks are installed.

With a new pool, provide a more complex controller that can integrate with UV systems, dual-pH Buffer, and VFDs, such as the BECSys7.

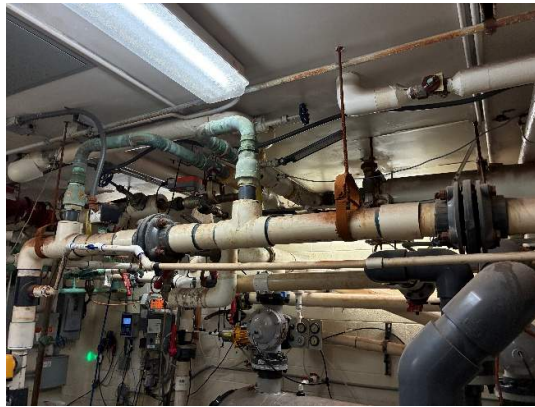
The therapy pool system is currently heated indirectly via a central building boiler/heater that supplies hot water to a dedicated heat exchanger within the pool recirculation system. The copper influent and effluent piping is showing signs of aging and corrosion.

Based on past experiences, C-H does not recommend reimplementing the solar tube heating system for any of the existing pools. The system should be decommissioned and disconnected during the next significant repair/renovation.

All aging influent/effluent heater lines should be replaced with SCH 80 CPVC during the next significant amount of pool mechanical room work.

There is not enough room for a standalone therapy pool heater in the case of a renovation. Therefore, during a future facility replacement, C-H recommends providing each pool recirculation system with its own dedicated heater. Standalone systems provide a level of redundancy for facilities with multiple bodies of water.

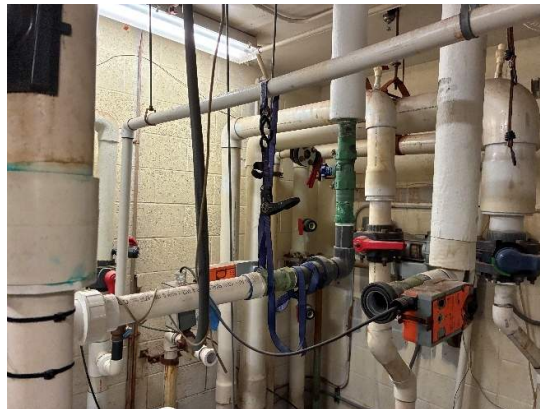
The leisure pool currently utilizes a manual fill system for make-up water, which C-H observed inside the mechanical room teeing into the recirculation piping.

While an automatic system is not required by code, a manual system introduces the risk of the water level falling too low, and the skimmers potentially drawing air into the pool's recirculation pump and causing damage.

An automatic water level control system is a more complex addition to skimmer pools when compared to pools that have in-mechanical room surge tanks. An abandoned supply or suction line would need to be re-used to create a “wet-well” in the mechanical room in which sensors can be placed. Otherwise, the deck would need to be torn out in order to route pipe or conduit back to the pool mechanical room. A consideration is re-using the hydrotherapy line, if the hydrotherapy jets are not repaired.

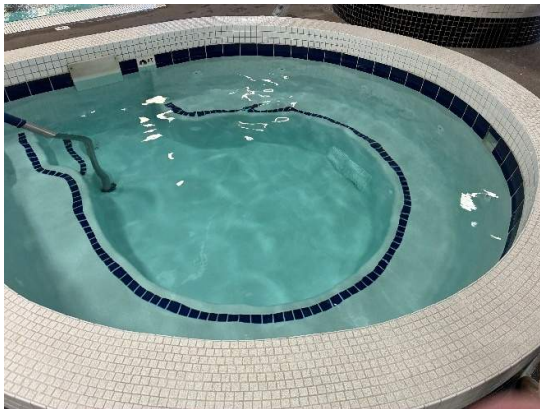
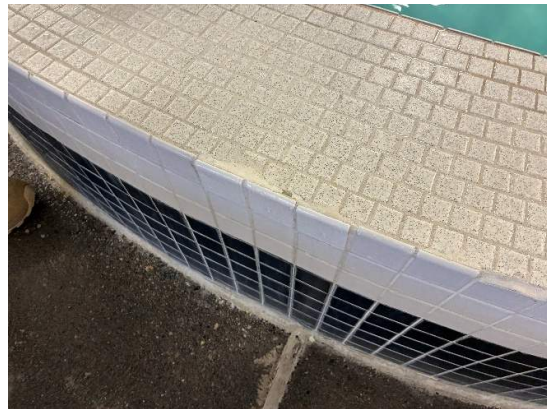
The spa pool is constructed of concrete with an aggregate plaster interior finish with a 12" waterline tile. The exterior and top faces of the spa structure are also tile. The spa finish was observed to be in fair condition, displaying staining and some delamination along the floor face. Ownership was unable to specify the date of the last plaster replacement. The tile is in fair to poor condition, with many areas of patched tile, cracked tiles, and dirty or missing/failing grout.

It may be ideal to plan for a re-plaster and re-tile of the spa if any other larger pools within the facility are being re-finished, to get some "economy of scale" on contractors mobilizing to do the work.

While water loss has not been reported as a problem at the spa, staff should consider performing a water tightness to assess the true condition of the structure leaks may be hard to detect at this pool with automated fill and a concealed float valve. Refer to Appendix B for the water tightness test procedure specified by C-H during new construction projects.

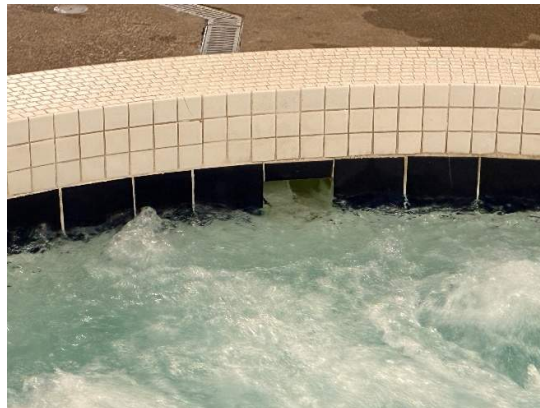
While a basket was present in the skimmer unit, no weir or deck access lid was present. A weir is required per MAHC to ensure proper surface skimming and flow adjustment. A lifeguard reported that to clean out the skimmer baskets, staff must reach into the skimmer opening. This is an atypical operational practice stemming from the missing access lids, which are standard on commercial grade skimmers. Additionally, the skimmers are not listed with NSF-50, which violates Teton Health District Code.

Nothing can be done immediately without significant spa structural changes that will cost more than replacing the spa.

C-H recommends removing and replacing the entire spa in conjunction with the rest of the pools within the facility to ensure proper perimeter overflow and gutter system code compliance.

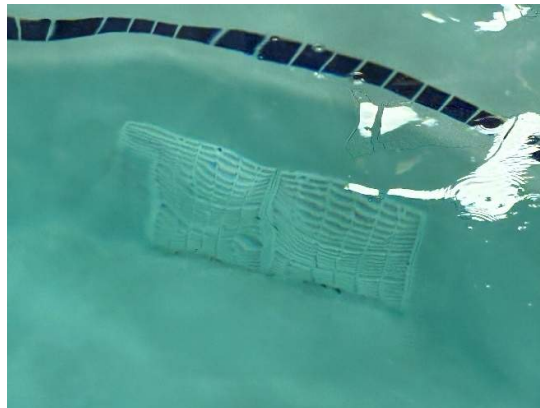
The spa includes two (2) 9"x9" recirculation main drain located in the pool floor. The drain grates appear to be 9"x9" 640-4740V by Waterway. Operations team to confirm.

Verify the lifespan of the grates at the spa and ensure they are replaced at the intervals recommended by the manufacturers described above.

With a new pool design, provide two (2) main drain grates and sumps to adhere to VGB without relying on an SVRS technology.

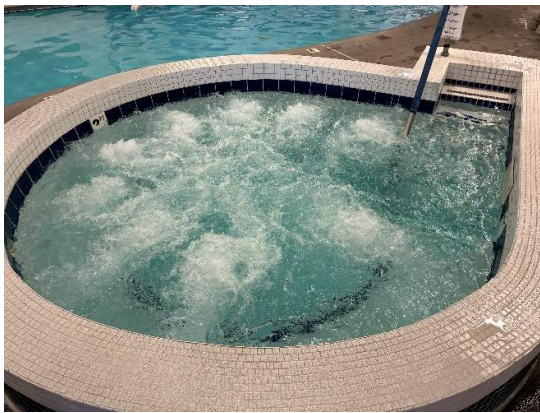
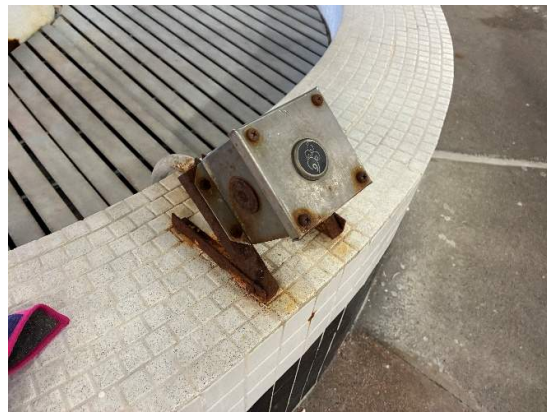
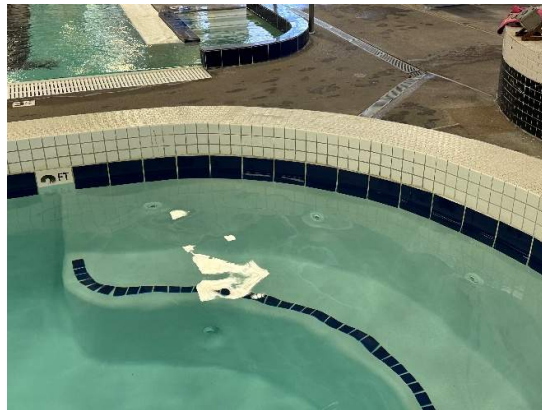
The therapy pool recirculation system utilizes four (4) wall inlets and the hydrotherapy pump is connected to ten (10) hydrotherapy jets which are operational. The hydrotherapy jets are connected to a timer switch that is mounted on the perimeter of the natatorium return air duct. The timer switch shows signs of corrosion.

Replace the hydrotherapy timer switch with a plastic or a non-ferrous metal product that can resist the corrosive environment present at the return air duct.

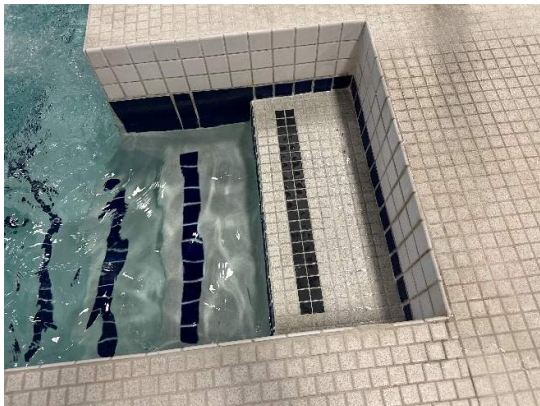
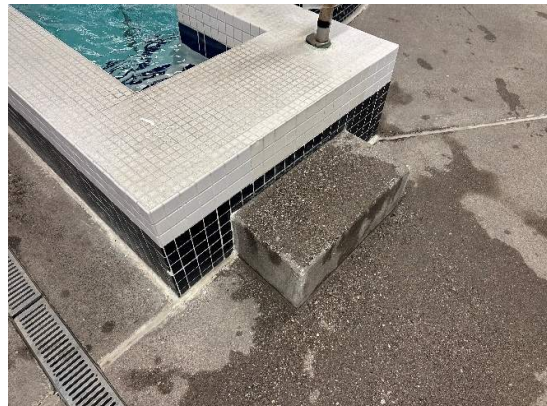
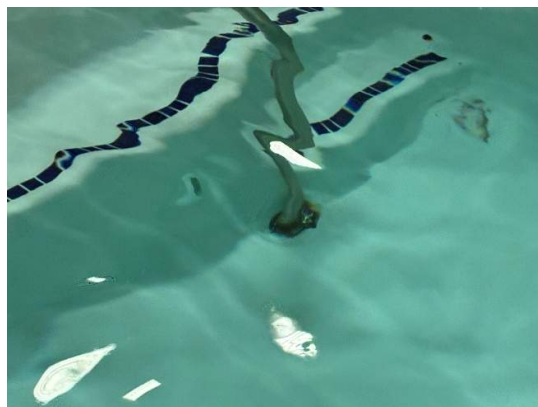
The spa includes a knee height transfer wall and a stair entry. The raised spa does not meet ADA requirements because transfer handrails are not provided along the perimeter of the spa.

One handrail is provided for the stair entry, satisfying Teton Health District Code. However, the escutcheon within the spa for the stair handrail showed visible signs of corrosion. There is an exterior curb on the outside of the stair entry leading into the spa, but it does not contain a contrasting nosing for bather visibility when using the stairs or traveling around the spa.

C-H recommends providing stainless steel transfer rails at the perimeter of the raised spa in order to meet ADA compliance.

Thoroughly clean and/or replace the escutcheon at the bottom of the stair entry handrail for the spa.

Provide a contrasting nosing at the exterior stair entry step, such as a tile band or epoxy paint.

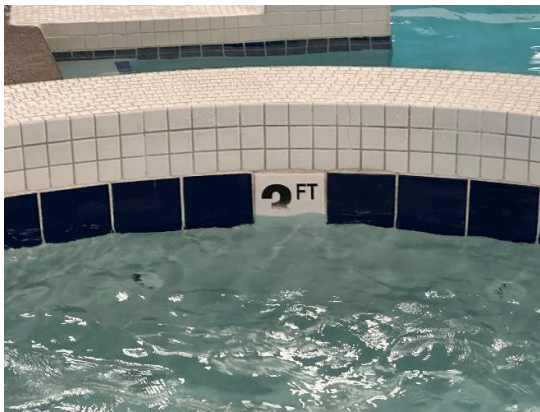
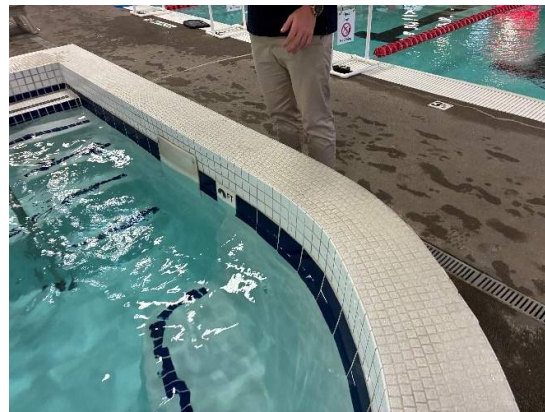
The spa currently features tile vertical tile depth markers at the spa's waterline. However, no horizontal depth markers or warning signs were observed at the top face of the spa, which is a requirement of both the Teton Health District Code and the MAHC.

C-H recommends adding horizontal depth markers and warning signs during any significant spa re-finish.

For a new pool, ensure that all depth markers and warning signs are descriptive, placed on both vertical and horizontal surfaces, have text at least 4" tall, and include the international "NO DIVING" symbol.

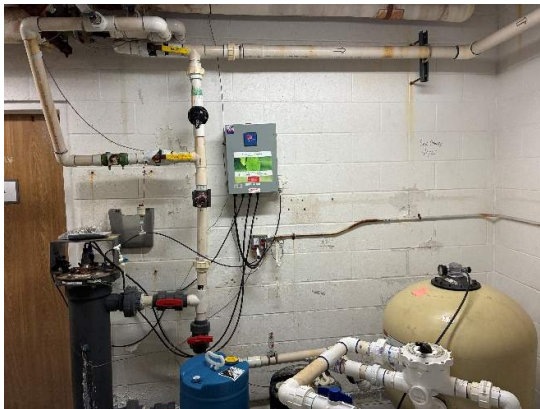
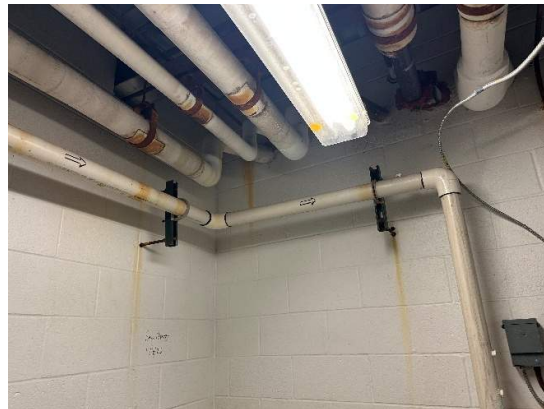
The bulk of the visible recirculation system piping uses Schedule 40 PVC piping, which is less robust than the Schedule 80 PVC typically recommended by modern aquatic industry standards for all exposed pool piping. This includes the influent and effluent heat exchanger piping, which was also observed to be Schedule 40 PVC, whereas modern industry standards recommend Schedule 80 CPVC due to its superior heat tolerance. The presence of some acceptable Schedule 80 PVC fittings/piping in the UV bypass and elsewhere throughout the system suggests recent, post-original-construction repairs by diligent staff.

The piping system lacks essential identifiers: arrows were observed indicating the direction of flow, but they were not color-coded, which violates MAHC (requiring colored arrows). Additionally, no posted piping and system schematic was observed in the mechanical room, which does not adhere to both Teton Health District code and MAHC.

C-H recommends color-coded arrows be applied on all recirculation pipes per the interval listed in the MAHC. A detailed system schematic (flow diagram) must be posted in the mechanical room to adhere to both the Teton District Health Code and the MAHC.

C-H recommends replacing all existing SCH 40 piping with SCH 80 piping throughout the mechanical room for improved longevity. The influent and effluent piping running from the heat exchanger should be replaced with SCH 80 CPVC piping to adhere to modern industry standards.

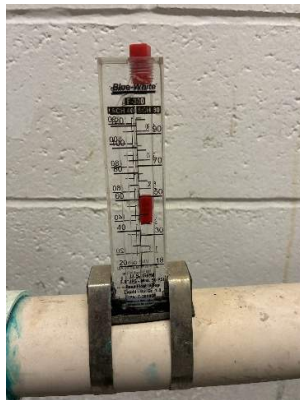
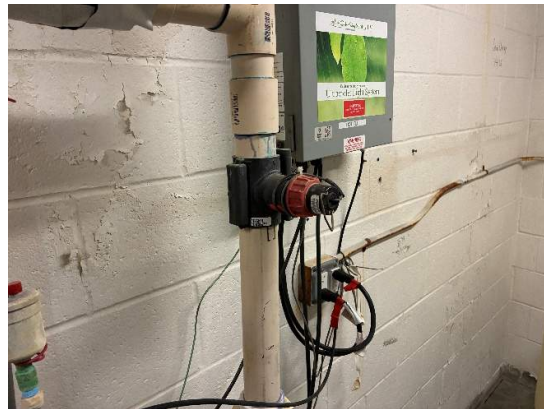
One (1) Signet rotary flow meter was installed on the spa piping but was not in operation at the time of C-H observation. A blue-white impact flow meter was installed as a substitute. The impact flow meter is not accurate enough to meet MAHC flow meter requirements.

Repair the signet rotary flow meter and ensure that it provides accurate readings to the operator.

During a full pool mechanical room replacement, ensure a 4-20mA signal Signet MagMeter is included to allow for feedback control with the recirculation pump VFD. This leads to significant energy savings following filter tank backwashing.

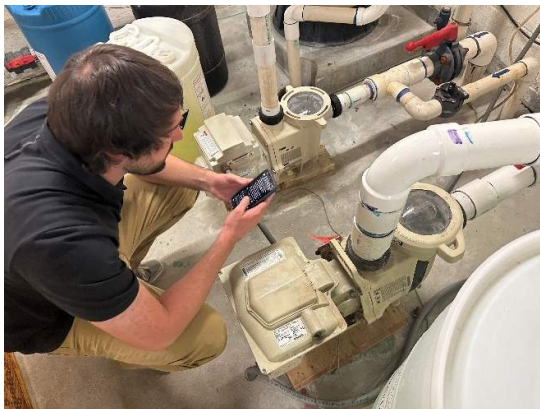
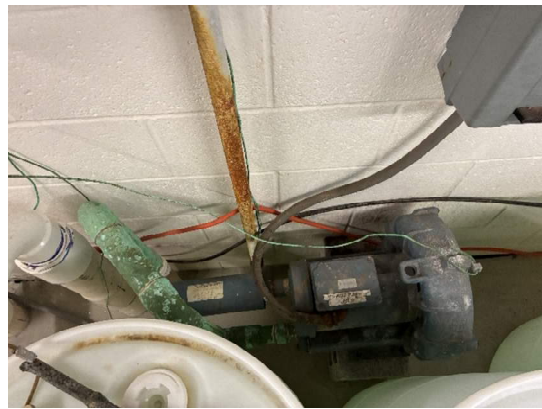
The recirculation system for the spa is driven by an Intelliflo VS 3.95HP pump, which was observed to be in good condition. The spa hydrotherapy pump is a 5HP WhisperfloXF. Both pumps feature an integrated strainer and self-priming capabilities. The pumps were observed to be missing both the suction and pressure gauges which do not meet MAHC requirements. This prevents operators from accurately monitoring the system's total dynamic head (TDH), diagnosing performance issues, and confirming the pump is operating within its anticipated flow range.

An air blower is provided and is operational for hydrotherapy in the spa. The blower appears to be in fair condition, but the accompanying copper piping is gathering some staining and corrosion.

Clean the air blower copper piping of any staining and corrosion.

In conjunction with a facility replacement, a pit should be installed to allow each operating pump to be placed below water level. This prolongs the longevity of pump motors, even if they are listed as self-priming pumps with low risk of cavitation.

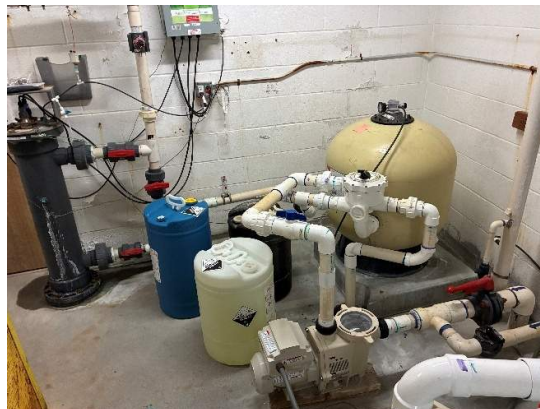
Valves and flanges at the spa appear to be in fair condition and are mostly composed of a Schedule 80 PVC per aquatic industry standard. The only valves recommended to be replaced are: the discharge valve at the recirculation pump, the influent/effluent valves for the heat exchanger, and the suction/discharge valves at the hydrotherapy pump.

Valve tags were observed to be missing, which complicates emergency shutdown procedures and routine maintenance.

C-H recommends installing valve tags on all valves within the recirculation system and providing a detailed valve chart to assist staff in diagnosing and remedying future maintenance issues easier.

Upon an entire pipe replacement in the mechanical room, C-H recommends all SCH 80 components to adhere to modern industry standards for increased durability and pressure resistance. All valves and flanges on the influent and effluent heater lines should be SCH 80 CPVC.

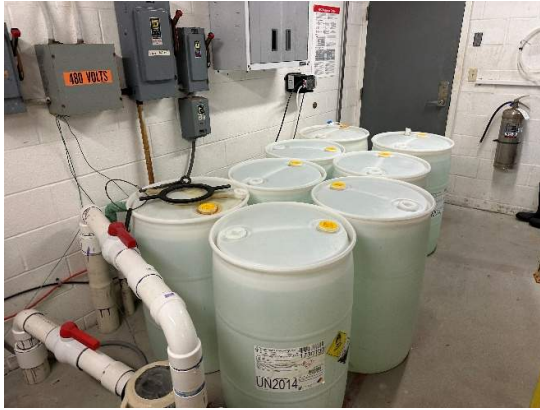
The spa utilizes hydrogen peroxide for its primary sanitization system. While this method is highly capable when applied effectively, its use is rarely implemented in the commercial aquatics industry. Hydrogen peroxide is generally considered a less conventional choice due to its associated high cost and the large quantity required to maintain proper residual levels for effective treatment, especially in the high-temperature environment of a spa. The hydrogen peroxide is stored in barrels which are not sealed; the chemical vapors escape and accelerate corrosion in the mechanical room. The Blue-white A-100M pump for this system was observed to be working properly.

The spa utilizes a UV system from a Sentry Chlorling unit as its supplemental disinfection treatment. This system is a critical component for destroying chloramines and inactivating pathogens like Cryptosporidium or Legionella, and it was observed to be operating at the proper intensity of 65 mJ/cm<sup>2</sup>. Despite its proper functional output, the unit was actively leaking and all associated flange bolts exhibiting significant rusting.

C-H recommends an automated calcium hypochlorite feeder for the spa in lieu of the hydrogen peroxide system. Using a calcium hypochlorite system ensures that all pools in the facility can operate on the same chemicals, which is best for consistency amongst staff. Additionally, this will be the best approach for cutting costs and ensuring the city can buy chemicals in bulk to receive the best possible price breaks.

C-H recommends implementing an automatic acid feed system similar to the other pools in the facility. This must be implemented to achieve code compliance.

Staff should prioritize repairing the leak on the Sentry Chlorling UV unit to reduce chances of the leak worsening and causing water loss within the mechanical room.

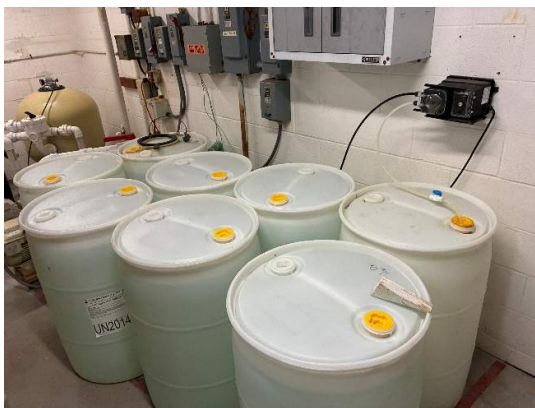
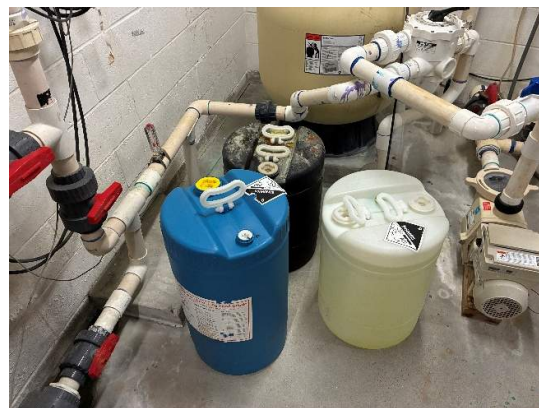
The spa lacks a dedicated, fire-rated chemical storage space, resulting in hazardous storage practices. During the inspection, chemicals were observed stored within the general mechanical room. There were seven (7) barrels of hydrogen peroxide, which are listed as a class 4 oxidizer.

This arrangement presents a fire and explosion hazard and directly violates IFC, which mandates that pool chemicals (specifically calcium hypochlorite and hydrogen peroxide) be stored in a segregated, ventilated, and properly rated environment to prevent dangerous reactions or interference with electrical infrastructure. Furthermore, the required NFPA diamond signage is not present on the mechanical room doors, and a functional safety shower/eyewash is missing from the space.

C-H recommends switching to calcium hypochlorite, which is a lower-level class of oxidizer per fire code. Once calcium hypochlorite is provided, purchase/install fire rated cabinets within the space for storage of chemicals to mitigate fire hazards. These cabinets will double the amount that is allowed to be stored within the space without becoming a hazard classification per the IFC.

It is imperative that muriatic acid and hydrogen peroxide are not stored within the same space. If these liquids/vapors combine, they form chlorine gas which is deadly to pool operators. C-H recommends storing all muriatic acid in the existing designated room.

Muriatic acid vapors from carboys should be contained with a sealed cap or a check valve to prevent accelerated corrosion of the pool mechanical equipment.

During a future full mechanical room renovation, C-H recommends that separate, properly fire-rated rooms be constructed to house chemicals and their respective feed systems, ensuring adequate segregation for safety.

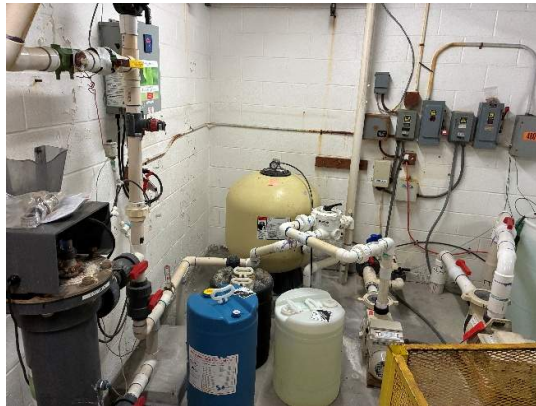
C-H did not observe an automated chemical controller for the spa mechanical system. Both Teton District Health District Code and MAHC require the usage of an automated system for the continuous monitoring and control of both the sanitizer and pH buffer systems in public pools and spas.

C-H recommends implementing a water chemistry controller with pump interlocks to adhere to all applicable codes. A more comprehensive controller that can integrate with the existing UV system (such as the BECSys7) is recommended.

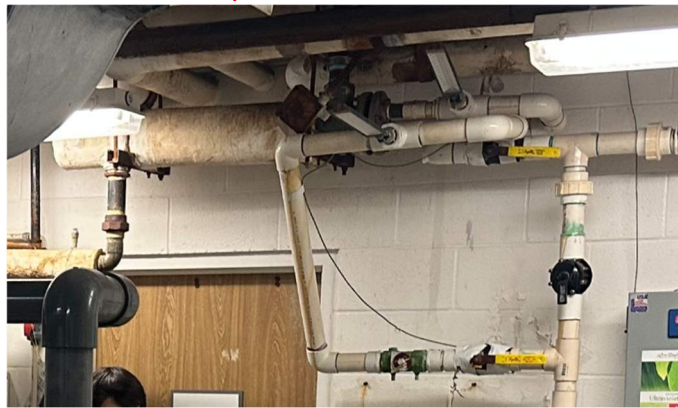
The spa system is currently heated indirectly via a central building boiler/heater that supplies hot water to a dedicated heat exchanger within the pool's recirculation system. The PVC SCH 40 influent and effluent piping show signs of aging.

All aging influent/effluent heater lines should be replaced with SCH 80 CPVC during the next significant amount of pool mechanical room work.

Unless the pool mechanical room is resized and more space is gained, there is not enough room for a standalone spa heater during a renovation. Therefore, during a future facility replacement, C-H recommends providing each pool recirculation system with its own dedicated heater. Standalone systems provide a level of redundancy for facilities with multiple bodies of water.

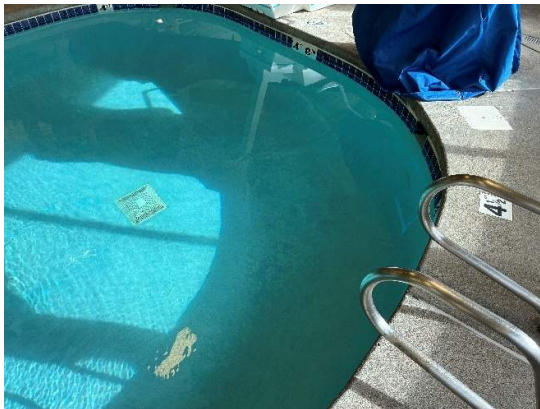
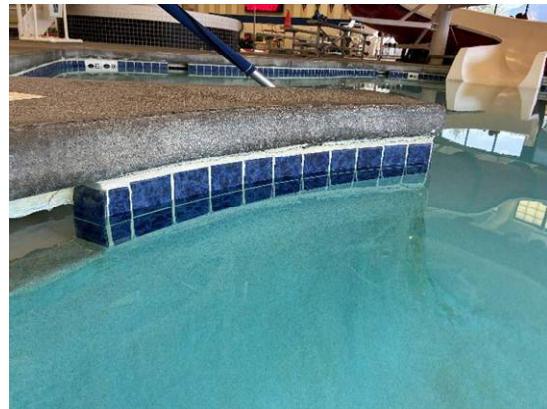
The splash pool is constructed of concrete with an aggregate plaster finish with a 6" waterline tile. The pool finish was observed to be in fair to poor condition, with some staining/chipping at the wing wall and delamination occurring beneath the basketball goal. Ownership was unable to specify the date of the last plaster replacement. The pool tile, which includes the waterline and the contrasting nosing tile on the stairs and the underwater bench, was all observed to be in fair condition. The sealant between the coping and tile is breaking and cracking along the entire pool perimeter.

Considering the age and condition of the plaster, it is recommended that the pool's plaster finish be hydroblasted to bare concrete and replaced entirely with a similar finish if the pool is to be used for at least an additional 5 years. If it is decided that the pool will be decommissioned and replaced soon, spot repairs and patches are recommended for the plaster and tile finishes as needed.

C-H recommends that the sealant between the waterline tile and coping be removed and replaced.

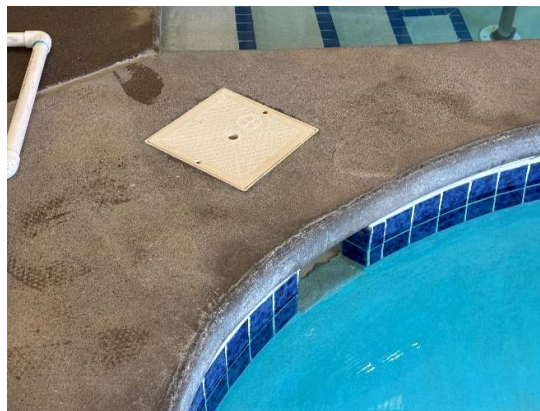
The splash pool utilizes a skimmer system for perimeter overflow, consisting of seven (7) Hayward SP-1082 skimmers total, which meets the quantities required by code. While a skimmer basket and deck access lid were present in each unit, no weir was observed on any of the skimmers. A weir is required per MAHC to ensure proper surface skimming and flow adjustment. Skimmers are an NSF-50 listed product as required by Teton Health District Code.

C-H observed equalizer lines were provided for each skimmer. However, each equalizer did not include a VGB-compliant cover.

C-H recommends installing VGB covers over all skimmer equalizer openings.

Verify that overflow weirs are provided in each skimmer, and have staff check the weirs on a regular basis to see if replacement is required.

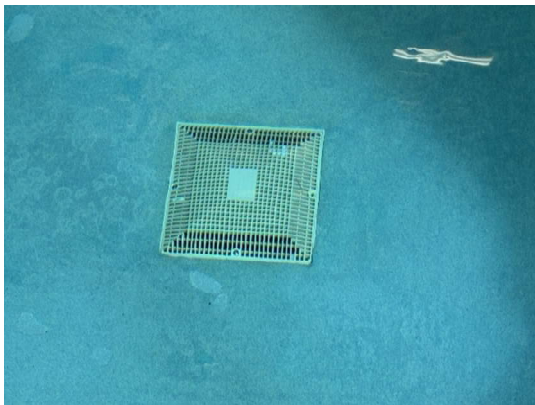
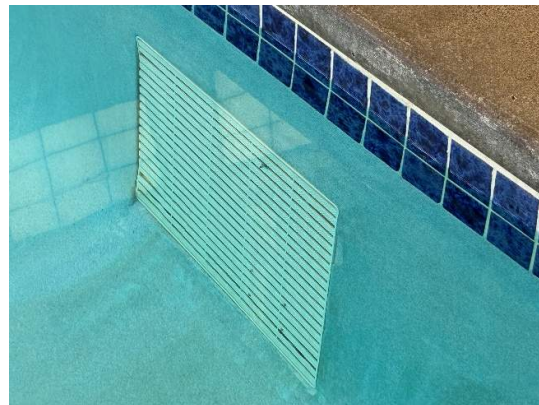
The splash pool includes one (1) 12"x12" recirculation main drain located in the pool floor. The drain grate appears to be 12"x12" MLD-FG-1212-WT by Neptune-Benson. Operations team to confirm.

The grating at the waterslide supply sump must be replaced with a VGB-compliant grate from Neptune-Benson, or similar.

Verify the lifespan of the grate at the pool floor and ensure it is replaced at the intervals recommended by the manufacturers described above.

With a new pool design, provide two (2) main drain grates and sumps to adhere to VGB without relying on a SVRS at the recirculation pump.

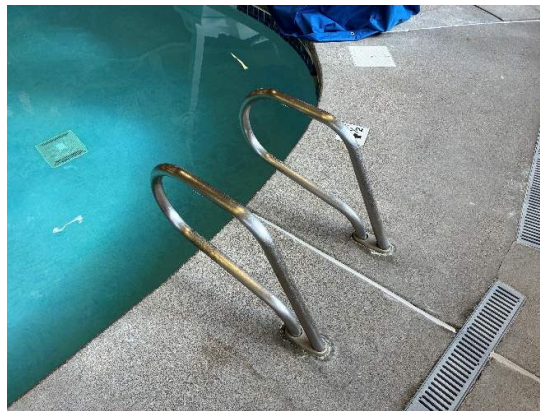
The splash pool features two (2) pairs of stainless steel grab rails that were generally observed to be in fair condition. The stainless-steel material of the rails themselves appears sound. However, the associated escutcheons (decorative covers where the rail meets the deck) were observed to have visible surface-level corrosion. The grab rails remain secure in their anchors, as they exhibit only a slight, acceptable amount of rocking.

C-H recommends cleaning and passivating all stainless-steel grab rails and escutcheons to inhibit future corrosion and extend the life of this equipment.
