The purpose of this workshop is to present the findings of the Counsilman-Hunsaker (CH) Aquatics Commissioning Report, review the condition and remaining service life of the Teton County / Jackson Recreation Center aquatic facilities, discuss current maintenance efforts, and obtain policy direction regarding future aquatics planning.

CH was retained to perform an independent assessment of the Recreation Center aquatic facilities, associated mechanical systems, and long-term capital needs. The assessment documents existing conditions, identifies code and operational deficiencies, estimates short-term investments necessary to maintain operations, and outlines long-term replacement considerations.

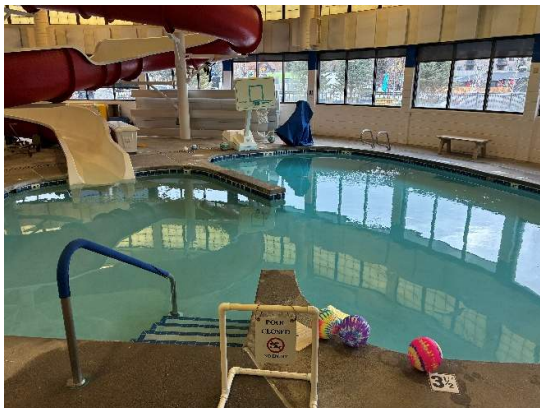
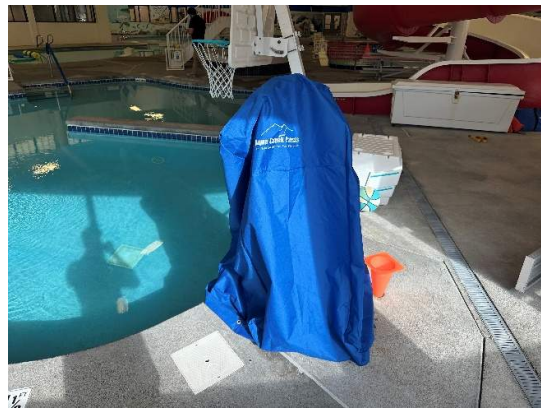
The splash pool's means of entry and exit meet current ADA compliance requirements. Since the pool perimeter is under 300', one primary means of accessible entry/exit must be provided (a ramp or a pool lift). The splash pool features an Aqua Creek Ranger 2 pool lift which fulfills this requirement. The condition and operation of this lift was not observed, as it was covered during the visit.

One traditional stair entry into the splash pool is present with a handrail that appears to be in fair condition. C-H observed surface corrosion on the handrail anchor. The presence of this rail at the stair entry fulfills the Teton Health District Code requirement.

Staff to confirm that the lift has a fully charged battery and the cover is removed during all open hours at the facility, as required per ADA.

C-H recommends cleaning and passivating all stainless-steel stair rails, anchors, and escutcheons to inhibit future corrosion and extend the life of this equipment.

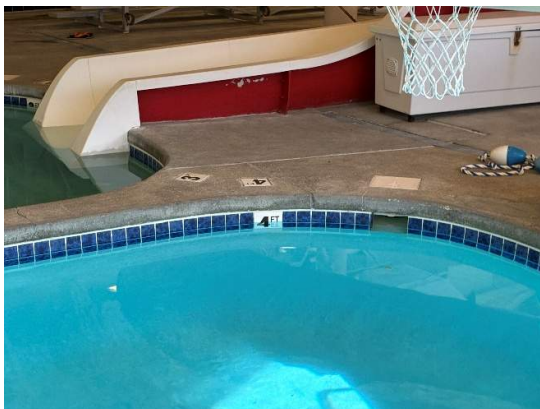
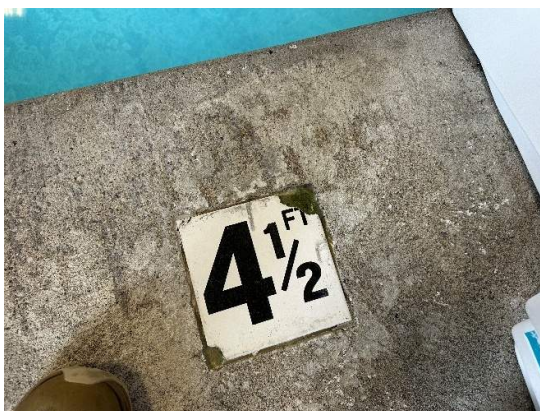
The splash pool includes tile horizontal and vertical depth markers and vinyl adhesive horizontal "NO DIVING" warning markers. While the depth markers were observed to be properly spaced within 25' along the pool perimeter, one (1) additional warning sign is necessary to be fully compliant with MAHC. This sign must be installed near the water basketball hoop to meet MAHC standards that require "NO DIVING" markers be clearly visible and spaced at no more than 25' intervals around any pool where the water depth is 5' or less.

C-H observed one (1) horizontal depth marker on the south end of the pool to be chipped at the corner and damaged.

C-H recommends the application of a vinyl "NO DIVING" warning sign beside the water basketball hoop to ensure full compliance with MAHC. All damaged or substandard tile or adhesive markings should be replaced.

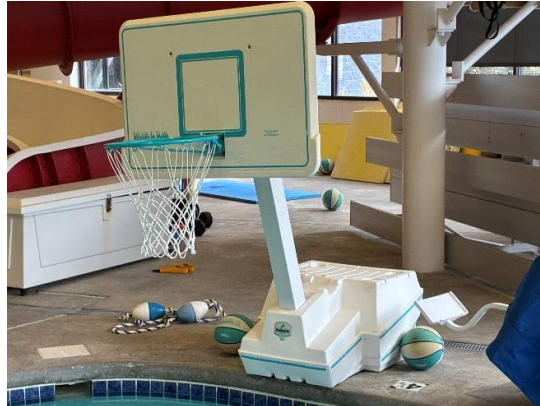
C-H observed one (1) basketball hoop in the splash pool to be in good condition. The basketball playing area is appropriately sectioned off from the waterslide with a safety rope.

During new pool designs, provide a permanent basketball goal that includes a sleeve anchor so that it can be permanently mounted within the deck in-lieu of a water-weight base.

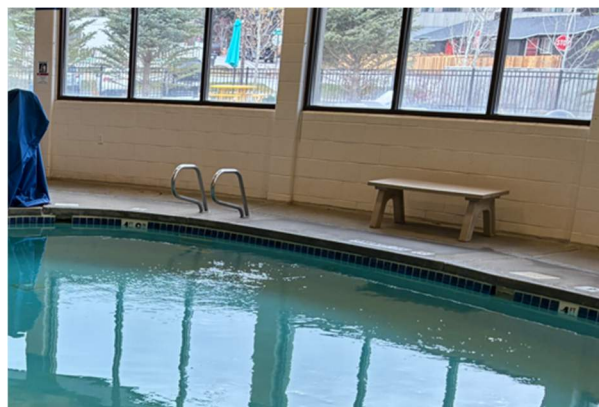
As a "general use" pool, the splash pool is subject to the Teton Health District Code requirement mandating a minimum of 8' of unobstructed deck clearance around the entire perimeter of the pool vessel. C-H observed that the splash pool is in violation of this requirement on one side of the pool.

Nothing can be done as a repair or renovation to correct this code compliance issue.

In future pool designs, deck clearances must be considered to adhere to applicable local codes.

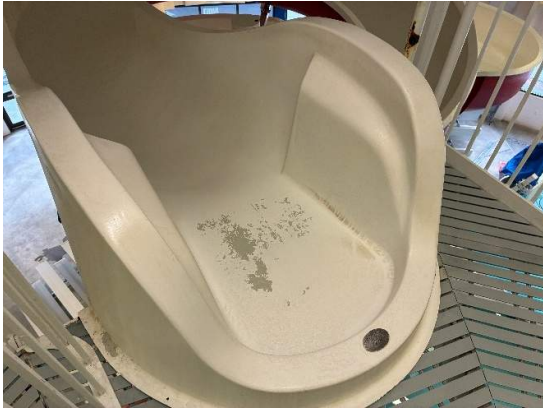
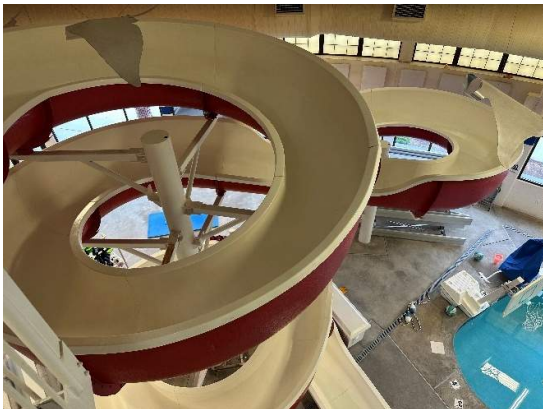
The facility features a large, 21ft tall Whitewater waterslide that is original to the pool's construction. The slide was observed to be in fair condition, having previously received both new interior coatings and a new external layer of paint over its lifespan. The current interior flume coating remains in fair condition, with wear and abrasion noted only at the slide entrance point.

The supporting slide tower structure was also in fair condition, although areas of surface-level corrosion (rusting) were present on both the stair railings and the vertical slide support columns. Access to the flume is provided by stairs made of fiberglass T-bar which include a contrasting nosing. Staff noted that replacing sections of these fiberglass stair treads is a common and annoying occurrence.

C-H did not observe an emergency E-stop located on the slide tower, which goes against typical aquatic design practices. While proper signage was in place to indicate to patrons that the waterslide was closed, other signage required by MAHC were not observed by C-H.

The feature itself is in violation of the Teton Health District Code, which limits waterslide height to a maximum of 12' —a requirement the current slide far exceeds. This height violation is further complicated by the splash pool water depth being insufficient as well. Teton Health District code requires a minimum water depth of 6' at the flume exit for a slide of the maximum allowed 12' height, yet the observed water depth at the splash pool was only 3'. *It is important to note that MAHC does not align with these standards and simply requires that waterslide depths at landing be determined by the waterslide manufacturer.*

Coordinate with Whitewater and furnish/install new waterslide instructions and warning signs at the base of the tower.

C-H recommends contacting a waterslide restoration company to eliminate existing rust, provide new fiberglass steps/platform, refurbish the waterslide stair tower coating, and provide a new gel coat at the slide interior. Whitewater can be contacted for this, as well as specific waterslide repair companies such as SafeSlide Restoration. Contact information can be found in Appendix A.

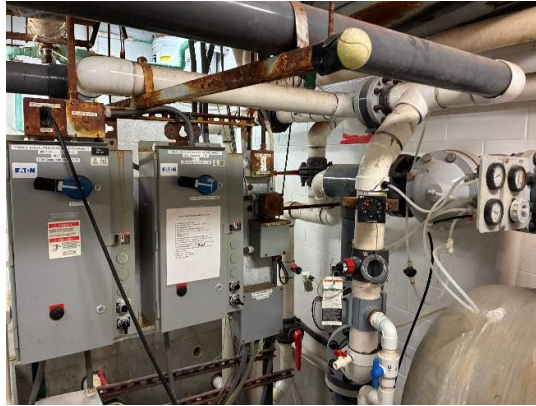
The bulk of the visible recirculation system piping uses Schedule 40 PVC piping, which is less robust than the Schedule 80 PVC typically recommended by modern aquatic industry standards for all exposed pool piping. This includes the influent and effluent heat exchanger piping (which was observed to be copper) whereas modern industry standards recommend Schedule 80 CPVC due to its superior heat tolerance. Furthermore, the piping supports were observed to be corroded and rusted, indicating a need for maintenance or replacement to ensure long-term integrity and proper alignment of the plumbing runs.

Some Schedule 80 PVC fittings and pipe are present in the UV system bypass that suggest recent, post-original-construction additions/repairs by diligent staff.

The piping system lacks essential identifiers: no color-coded arrows were observed indicating the direction of flow, which violates both Teton Health District code (requiring arrows) and MAHC (requiring colored arrows). Additionally, no posted piping and system schematic was observed in the mechanical room, which does not adhere to both Teton Health District code and MAHC.

The muriatic acid injection point was observed to be downstream of the Accu-Tab sanitizer injection point. This sequence does not follow modern industry standards as the pH buffer is typically injected upstream to assist in cleaning the calcium hypochlorite effluent line of any build-up.

C-H recommends color-coded arrows be applied on all recirculation pipes per the interval listed in the MAHC. A detailed system schematic (flow diagram) must be posted in the mechanical room to adhere to both the Teton District Health Code and the MAHC.

The injection points for the Accu-Tab and muriatic acid systems should be swapped to prevent clogging of the Accu-Tab feed lines, a common maintenance issue.

C-H recommends replacing all existing SCH 40 piping with SCH 80 piping throughout the mechanical room for improved longevity. The influent and effluent piping running from the heat exchanger should be replaced with SCH 80 CPVC piping to adhere to modern industry standards. In conjunction with the piping replacement, all existing pipe supports should also be replaced.

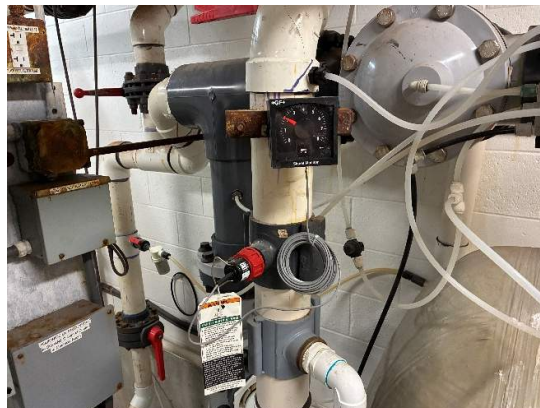
One (1) Signet rotary flow meter was installed on the splash pool piping, which is accurate enough, installed appropriately, and is acceptable per all code requirements.

Ensure that a 1-hour minimum turnover rate is specified on any new waterslide plunge pool design.

During a full pool mechanical room replacement, ensure a 4-20mA signal Signet MagMeter is included to allow for feedback control with recirculation pump VFDs. This leads to significant energy savings following filter tank backwashing.

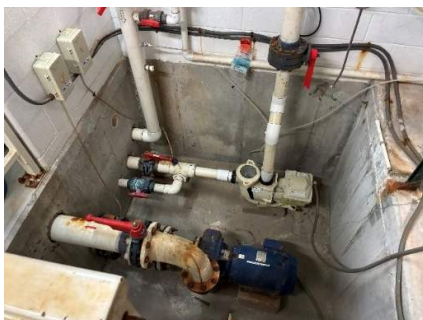
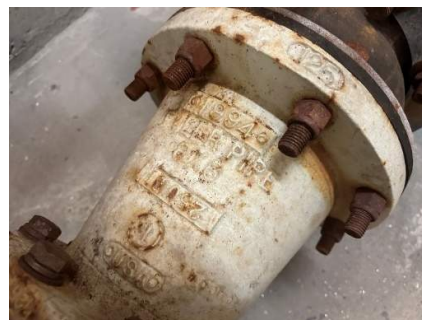
The splash pool recirculation system is driven by a plastic, 5 HP Pentair WhisperfloXF with an integrated strainer. The pump is new and was replaced in 2023. The flow rate varies widely on this system according to staff, from 140gpm to 280gpm based on how recently the filter has been backwashed. Only the highest level (240gpm) is acceptable for an waterslide plunge pool turnover, roughly equating to 1 hour.

The waterslide system is driven by a metallic, 15HP Pentair Aurora pump. This pump is notably missing a strainer, which does not adhere to both Teton District Health Code and MAHC standards.

Both the recirculation and the waterslide pumps are located within a pump pit and therefore achieve the industry-preferred condition of flooded suction (where the pump intake is below the pool's water level by at least 2'). The elevation of the pump compared to the pool water level assists the pump to prevent cavitation and straining the motor.

The pumps are missing pressure and vacuum gauges, which are required by MAHC. These measure the pressure differential across each pump, which gives the operator insights into the flow rate of the pool system, power consumption, as well as performance of each pump.

The pumps do not include VFDs, which would allow for speed adjustments to optimize flow, reduce energy consumption, and manage pressure spikes that can damage equipment.

A strainer needs to be added to the existing 15 HP waterslide pump. Since the pump is below water level, valves on either side of the strainer must also be installed to meet Teton Health District Code requirements.

Pressure and vacuum gauges should be installed to meet the MAHC requirements for system monitoring. Furthermore, VFDs should be implemented on each pump, but especially the recirculation pump to allow the system to run more efficiently, save energy, and extend the lifespan of the new pump motor.

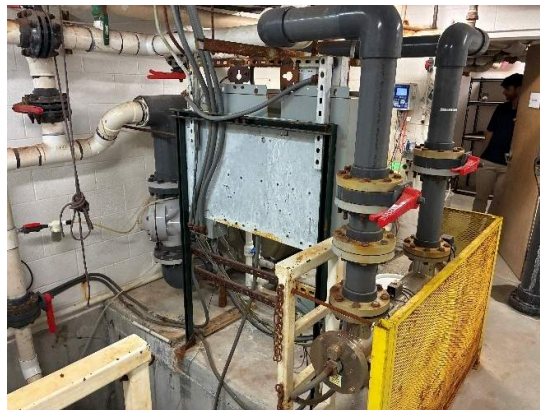
The valves and flanges throughout the mechanical room were observed to be in fair condition. Many of the installed valves meet the modern industry standard Schedule 80 PVC material for pool mechanical room application.

However, valve tags were observed to be missing, which complicates emergency shutdown procedures and routine maintenance.

C-H recommends installing valve tags on all valves within the recirculation system and providing a detailed valve chart to assist staff in diagnosing and remedying future maintenance issues easier.

Upon an entire pipe replacement in the mechanical room, C-H recommends replacing all SCH 40 components with SCH 80 to adhere to modern industry standards for increased durability and pressure resistance. All valves and flanges on the influent and effluent heater lines should be replaced with SCH 80 CPVC.

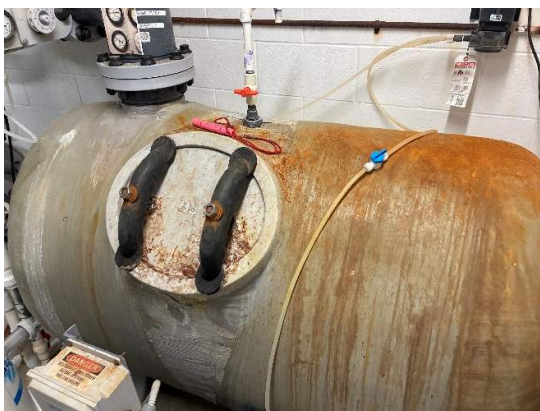
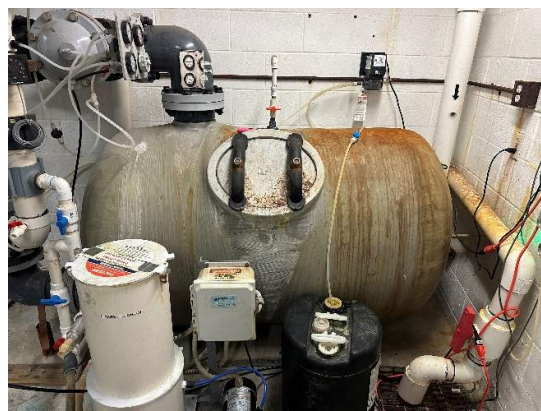
The splash pool utilizes one (1) Stark SA72 filter system with a semi-automatic backwash functionality. The filter system was observed to have a manual air relief system present, which satisfies the requirement set forth by MAHC for safe operation. Staff stated that the filter media is old, and is overdue for a change.

Ownership reported that when the backwash cycle is performed for an excessive duration, sanitary waste line backs up, indicating an undersized or blocked backwash waste line. It should be noted that the original design documents included two (2) filter tanks, and the original sanitary capacity may have been sized for smaller tanks. This is likely the reason that a single tank overwhelms the sanitary line during backwash if a blockage is not present.

The filter backwash system is a semi-automatic method, relying on actuated valves to operate. Staff noted that these valves break down easily and require repairs often.

C-H recommends switching to a dual-filter tank system during a pool mechanical room renovation. 36" diameter vertically oriented tanks should be used to ensure ceiling heights and door clearances can be maintained. The new face piping should include manual backwash valves which will reduce the repair frequency required by staff.

The dual tank system should not only assist with filtration at the pool, but will also ease the backwash flow rates routed to the existing sanitary connection.

Utilization of glass filter media and an electronic flocculant (such as Clear-Flow) would further increase the quality of the sand filtration at the splash pool. Alternatively, a regenerative media filtration system could also be explored for additional cost.

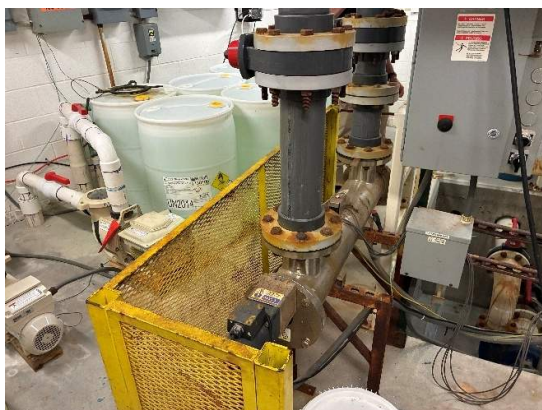
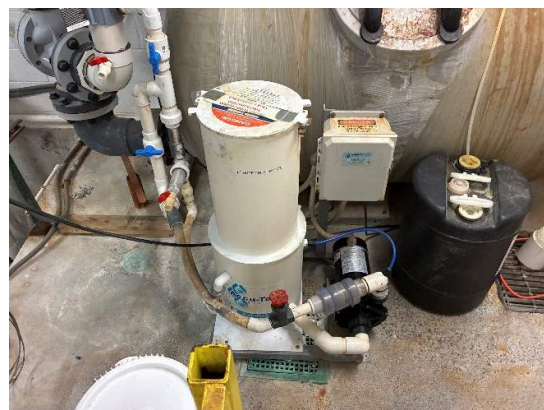
The splash pool utilizes an Accu-Tab 1030 sanitizer system and booster pump for primary water treatment, which was observed to be in fair condition. The feed lines were observed to be clear and properly feeding the system, with no signs of excessive clogging or degradation.

Using muriatic acid as the sole pH buffer is a common and effective industry practice for lowering pH in commercial pools. However, it quickly reduces the pool's total alkalinity (TA), which is the water's natural buffering capacity. Low TA can lead to unstable pH (known as pH "bounce") and corrosive water. If the fill water has a higher TA, then this standalone system is sufficient.

If water chemistry management has been an ongoing concern for Ownership, which may be the case based upon observed amounts of sodium bicarbonate on-hand, C-H recommends a comprehensive domestic water analysis be performed to evaluate the facility's potable source water. The results of this analysis are critical for understanding the baseline alkalinity and mineral content, which directly influence the stability of the splash pool's pH. Depending on these findings, the integration of a carbon dioxide or sodium bisulfate system could be utilized to supplement the existing muriatic acid system, providing superior water quality to the facility.

Repair and recommission the existing Aquionics UV secondary sanitation unit.

**With a full facility replacement, provide a centralized pool mechanical room for all bodies of water. This will reduce the amount of muriatic acid lines traveling throughout the facility, which will therefore reduce the risk of harmful chemical leaks.**

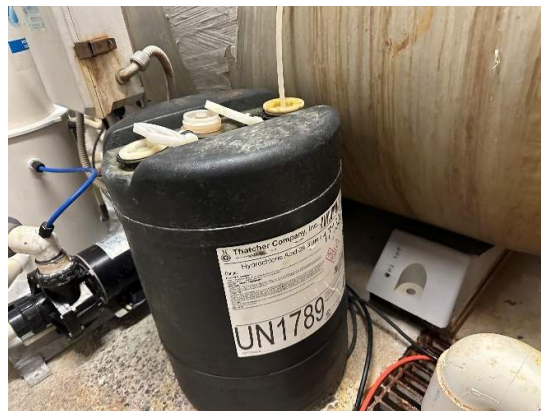
The splash pool lacks a dedicated, fire-rated chemical storage space, resulting in hazardous storage practices throughout the facility. During the inspection, chemicals (in this case muriatic acid) were observed stored within the general mechanical room. This arrangement presents a fire and explosion hazard and directly violates IFC, which mandates that pool chemicals (specifically calcium hypochlorite) be stored in a segregated, ventilated, and properly rated environment to prevent dangerous reactions or interference with electrical infrastructure.

Furthermore, the required NFPA diamond signage is not present on the mechanical room doors. While these storage conditions are substandard, the facility is in compliance with the MAHC regarding immediate first aid, as a functional emergency eyewash unit was observed and accessible within the pool mechanical room space.

Provide fire rated cabinets within the space for storage of calcium hypochlorite to mitigate fire hazards. These cabinets will double the amount that is allowed to be stored within the space without becoming a hazard classification per the IFC.

Muriatic acid vapors from carboys should be contained with a sealed cap or a check valve to prevent accelerated corrosion of the pool mechanical equipment.

Provide NFPA diamond signage on the mechanical room door.

During a future full mechanical room renovation, C-H recommends that separate, properly fire-rated rooms be constructed to house chemicals and their respective feed systems, ensuring adequate segregation for safety.

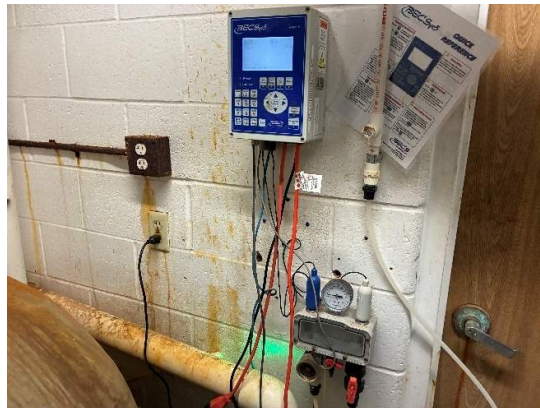
The splash pool's water chemistry is monitored and controlled by one (1) BECSys5 Water chemistry controller. This unit was observed to be in good condition and reported to be working properly.

If recirculation pump interlocks are not already in place for calcium hypochlorite and muriatic acid, consult with an electrical contractor to ensure that these interlocks are installed.

With a new pool, provide a more complex controller that can integrate with UV systems, dual- pH Buffer, and VFDs, such as the BECSys7.

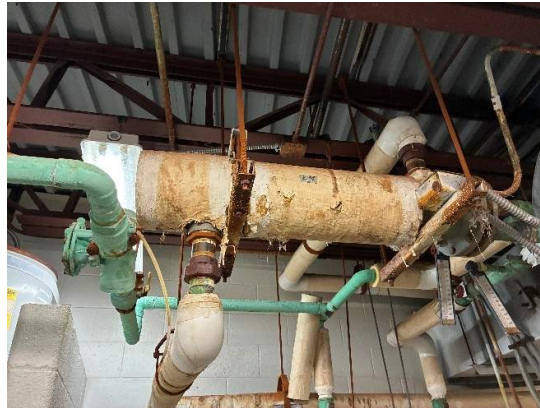
The splash pool system is currently heated indirectly via a central building boiler/heater that supplies hot water to a dedicated heat exchanger within the pool's recirculation system. The copper influent and effluent piping is showing signs of aging and corrosion.

All aging influent/effluent heater lines should be replaced with SCH 80 CPVC during the next significant amount of pool mechanical room work.

Unless the pool chemical room is repurposed, there is not enough room for a splash pool heater during a renovation. Therefore, during a future facility replacement, C-H recommends providing each pool recirculation system with its own dedicated heater. Standalone systems provide a level of redundancy for facilities with multiple bodies of water.

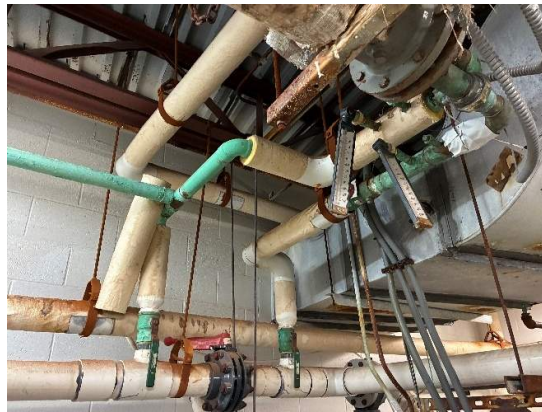
The splash pool currently utilizes a manual fill system for make-up water, which C-H observed inside the mechanical room tee'ing into the heat exchanger piping.

The make-up water line should be re-routed to the main recirculation line in lieu of the piping connected to the pool's heat exchanger.

An automatic water level control system is a more complex addition to skimmer pools when compared to pools that have in-mechanical room surge tanks. An abandoned supply or suction line would need to be re-used to create a "wet-well" in the mechanical room in which sensors can be placed. Otherwise, the deck would need to be torn out in order to route pipe or conduit back to the pool mechanical room.

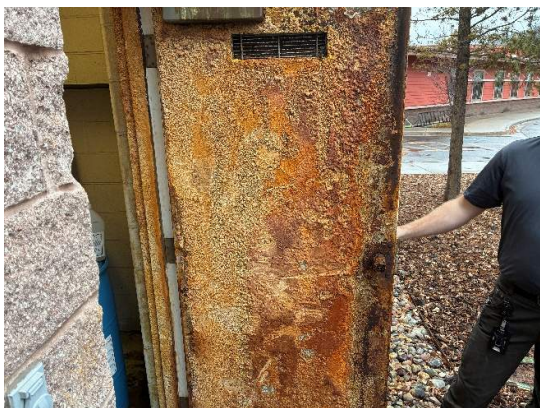
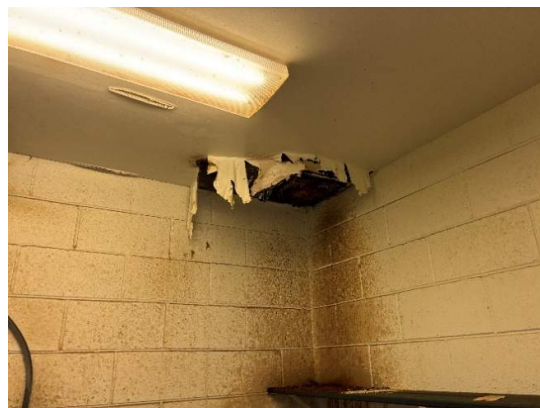
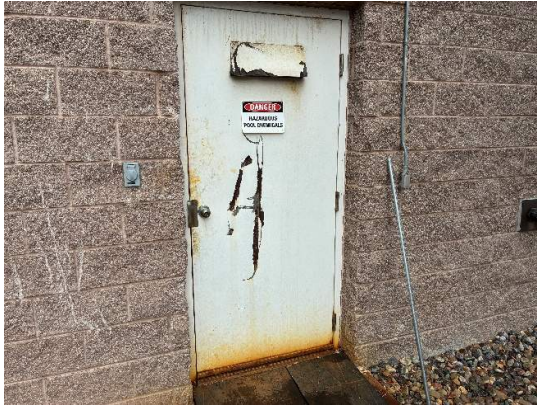
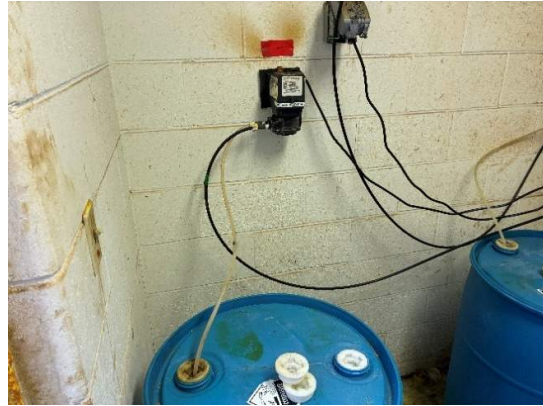
Muriatic acid is a highly corrosive chemical that requires proper ventilation. The acid barrels were not observed to have a sufficient ventilation system, sealed lids, or vent check valve components. All acid barrels must be completely sealed and not allow any acid vapors into the pH buffer room. All acid barrels should be housed in a room with mechanical ventilation per IFC.

All metallic hardware, conduit, and various electrical fixtures within the room showed significant signs of corrosion and deterioration.

No emergency eyewash was observed within the acid room. MAHC requires all pool chemical storage spaces to have an eyewash provided.

Insufficient NFPA diamond signage was found on the Acid Room door.

The acid storage room needs a complete renovation and replacement of all hardware and electrical fixtures. Consult an architect for this work.

NFPA requires a proper diamond hazard signage for all rooms housing flammable chemicals.

All muriatic acid tanks and carboys should be sealed with a threaded cap or a vent check valve at all times to prevent accelerated corrosion of storage spaces and associated equipment.

Upon major facility renovation, ensure sufficient muriatic acid rooms are provided beside the pool mechanical rooms to limit long runs of this hazardous chemical. Provide an emergency shower/eyewash as required per MAHC and OSHA.
